3-6 基本設計概要

3-7 基本設計図

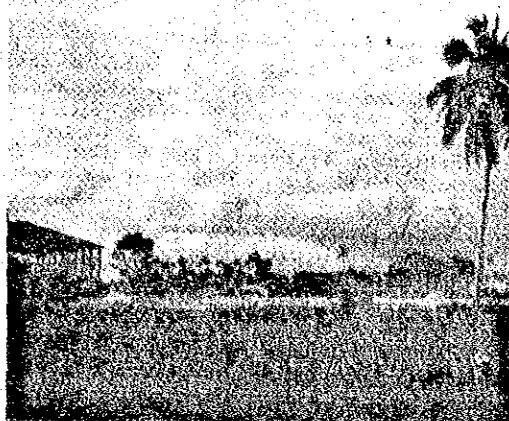
Cumulo-Nimbus clouds form as warm air from the north meets cold air from the south, over Nuku'alofa. Clouds continued to gather and warm-front rain fell.

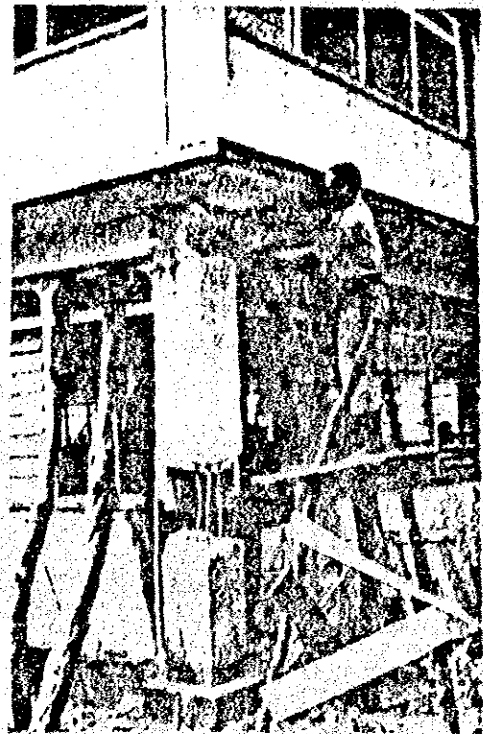
FIGURE 9: TAILULU COLLEGE, NUKU'ALOFA

There were very few reinforced concrete frame buildings which did not include at least a few block walls. However, one building without blockwalls, the Tailulu College used by 650 pupils, was damaged and left in a seriously weakened condition. This building is a two-way reinforced concrete frame eight bays by four bays each of 4.25m, being two storeys high with provision for a third storey (fig. 9). All ground floor columns showed severe cracking or spalling at the top and bottom of the windows (figs. 10, 11) and the structure was close to collapse during the earthquake. The failure mode of the 300 x 300mm columns was flexural due to the very light and poorly placed steel (fig. 12). The extent of movement was particularly apparent at the stairs which were extensively damaged where they joined the slabs but in this instance the diagonal bracing effect of these stairs was fortuitous and may well have saved the building. The recommended minimum strengthening provides for two infill concrete shear panels on each face of the building. In several other buildings the presence of non structural unreinforced blockwork or other rigid elements caused cracking away from the ends of the column (fig. 11) - a type of damage easily predicted by theoretical considerations, i.e. attracting seismic shears due to increase in frame stiffness and altered behaviour of the column itself. Examples of this cracking were also found at the Viola Hospital, the new Government Administration Building and a new classroom block at Queen Salote College. In a stronger earthquake this effect could have led to serious failures.

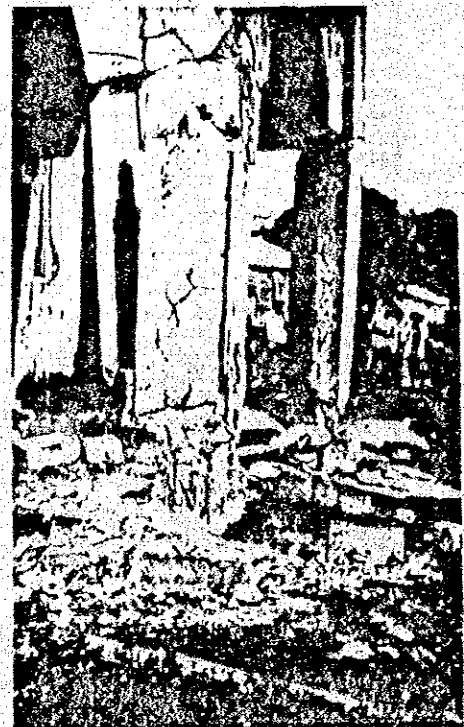
FIGURE 23: END WALL SUPPORTING TOWER -
 ROMAN CATHOLIC CHURCH, KOLOVAI, TONGATAPU.
 WALLS OF WEAK MASS CORAL CONCRETE

Buildings without bond beams, and particularly those made of solid coral block with little mortar e.g. Prime Minister's building, Fig. 3, and St. John's College chapel exhibited severe vertical cracking as the various parts moved in different directions. Towers on churches moving out of phase with the main building generally caused separation, with some cracking up to 75mm wide or failure of the tower, fig. 25,

These are predominantly single storey. Apart from Nuku'alofa where there are several two and few three storey buildings the only substantial structures are churches. Churches are found in almost every other block in all villages and in many cases have walls up to 6 metres high and towers approaching 15 metres in height. Horizontal seismic loads do not appear to be considered in their design and there is only nominal tying down of trusses. Damage to two churches is illustrated in figures 23, 24 and 25.
