14 Section of Geological Investigations for Underground Type Powerhouse Site (Upperstream Scheme) E.L.(m) r 900 800 Surgetank 700 <u>UPH-01</u> <u>Tunnel</u> -600 500 -400 Surgetank 400 m -300 Tailrace L₂₀₀ Scole Powerhouse 100 200(m) Upper Cagayan River
Diduyon Hydroelectric Project
The Republic of The Philippines Japan International Cooperation Agency Section of Geological Investigations for Underground Type Powerhouse Site (Upperstream Scheme)

A large scale typhoon attacked Luzon Island in October, 1979. The project area was also damaged by the typhoon; the roads were heavily damaged, many bridges were washed away, many wooden culverts were also washed away, and the village roads and logging roads were damaged in many places. The progress of the field investigations was affected badly by the damage caused by the typhoon.

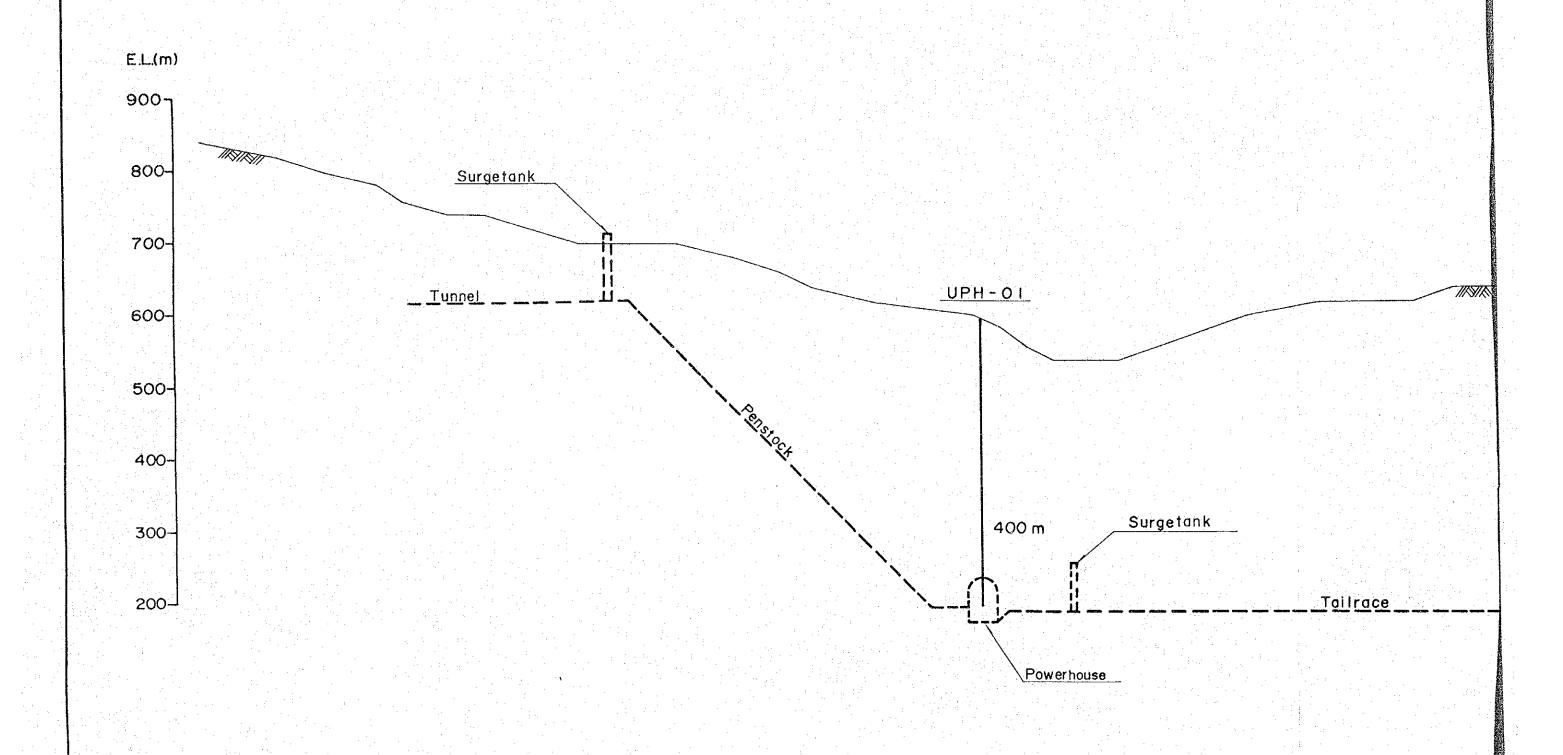
Fig. 14-14 Section of Geological Investigations for Underground Type Powerhouse Site (Uppersta
