REPORT ON TOPOGRAPHIC MAPPING PROJECT
FOR
UPPER STREAM AREA OF NEGARA RIVER BASIN
SOUTH KALIMANTAN, REPUBLIC OF INDONESIA
(Second Year Work)

- Aerial Photography
- Pricking, Field Identification
- Field Completion
- Aerial Triangulation, Stereo Plotting
- Compilation

MARCH 1985

JAPAN INTERNATIONAL COOPERATION AGENCY

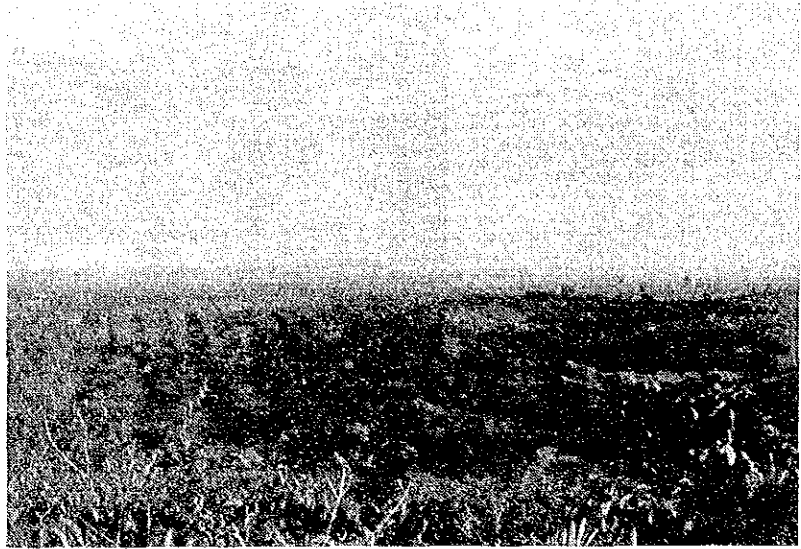
Rubber trees immediately
after plantation. →

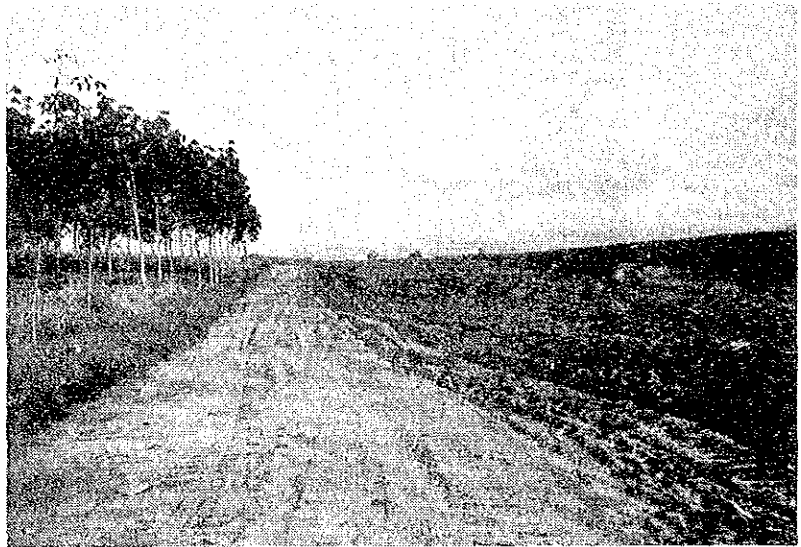
Newly developed land for
rubber plantation and
field. →

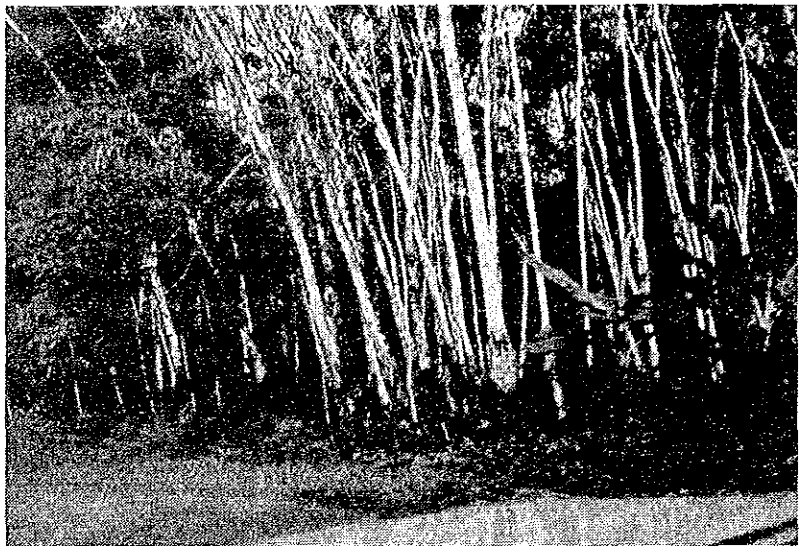
Rubber plantation
left uncared. →

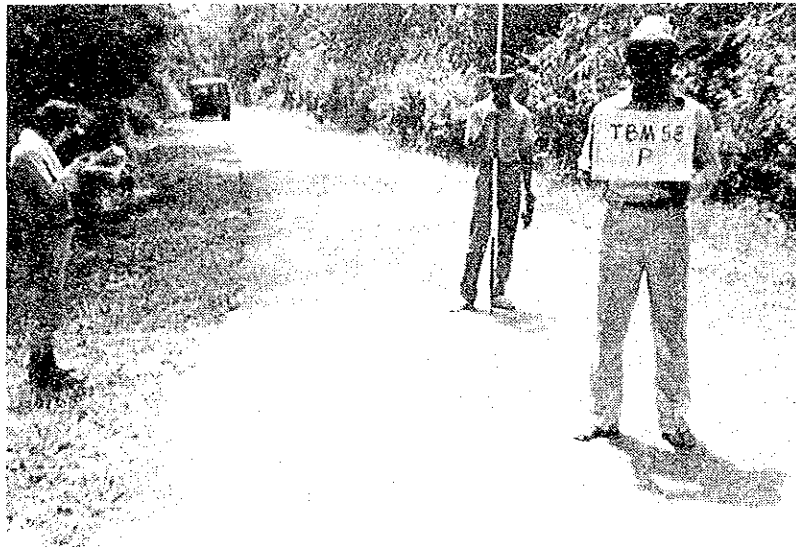
Field completion
work on road

Plane table survey on the
newly constructed highway
which connects Tanjung
and Murungpudak.

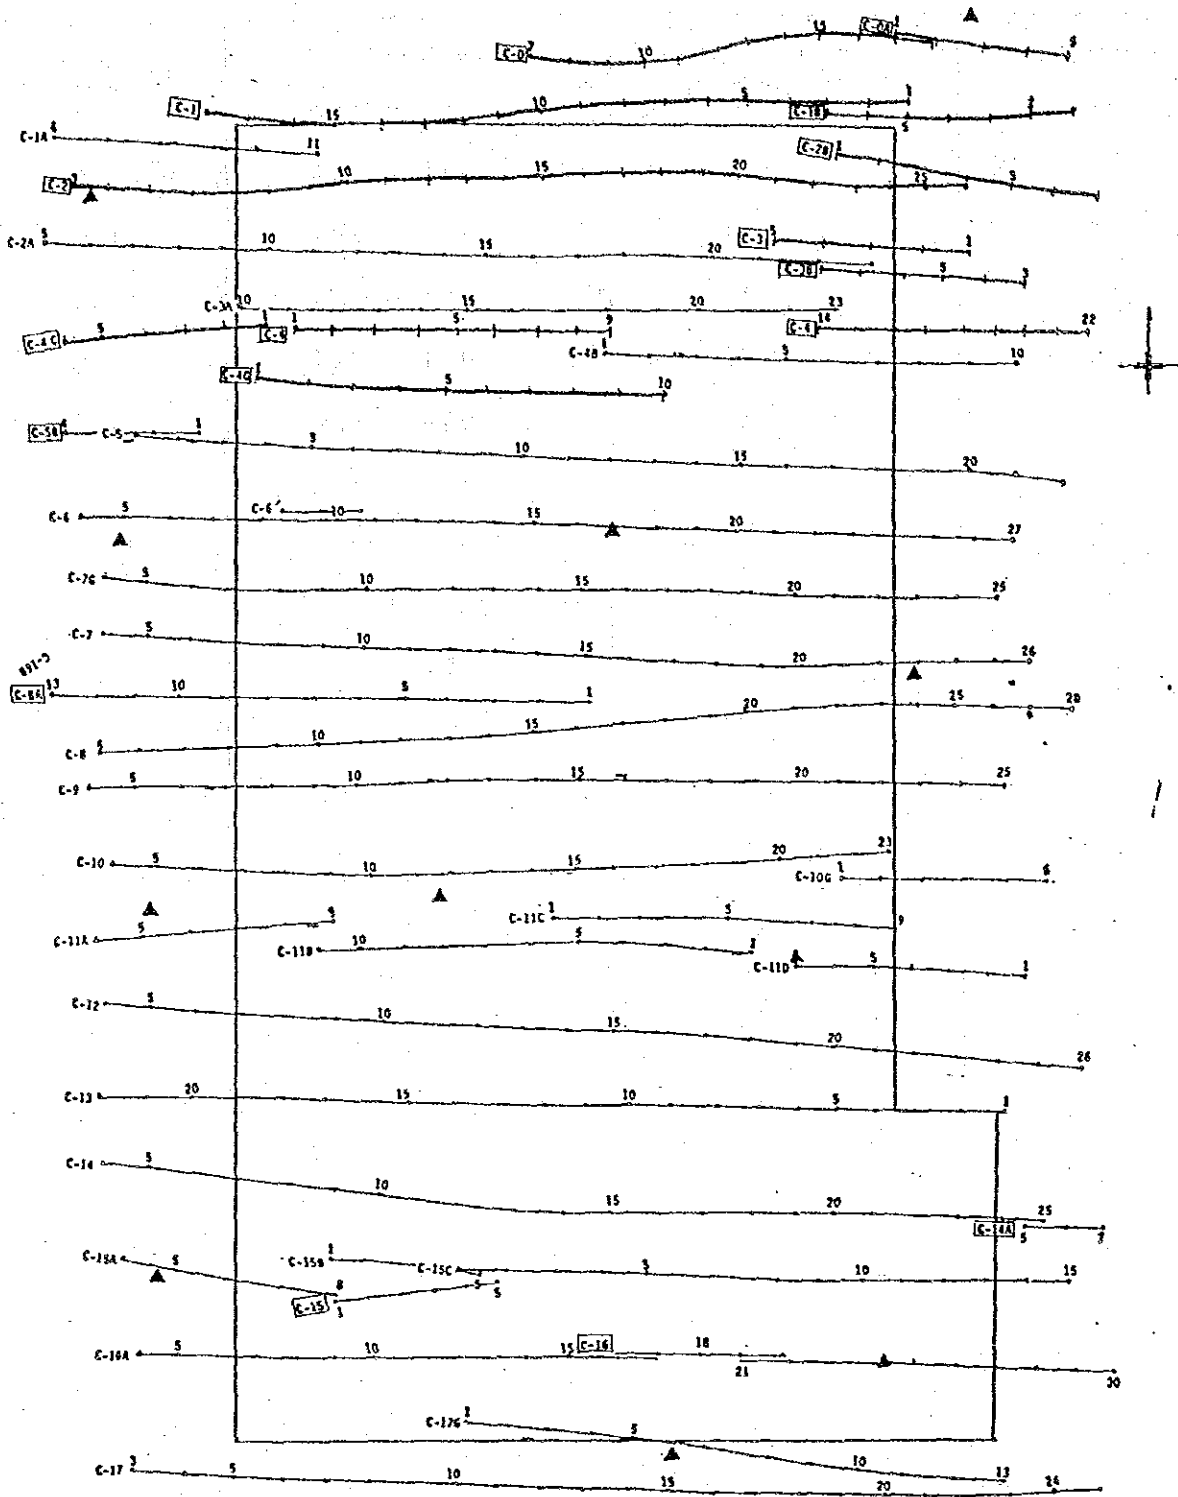
Fig. 1 Index Map of Aerial Photography

Photo scale about 1:50.000

- [C-0] Course of Aerial Photography (the 2nd year)
- C-6 Course of Aerial Photography (the 1st year)

Aerial photography and the check work had been executed within the contract period. However, owing to the difficulties to identify the actual terrain features with the topographic map used for this flight plan, it was necessary to take pictures of more courses than those estimated in the original plan.

- 3) Number of flight course covered: 16 courses
- 4) Number of photos taken : 160 sheets
- 5) Total flight distance : 448 km

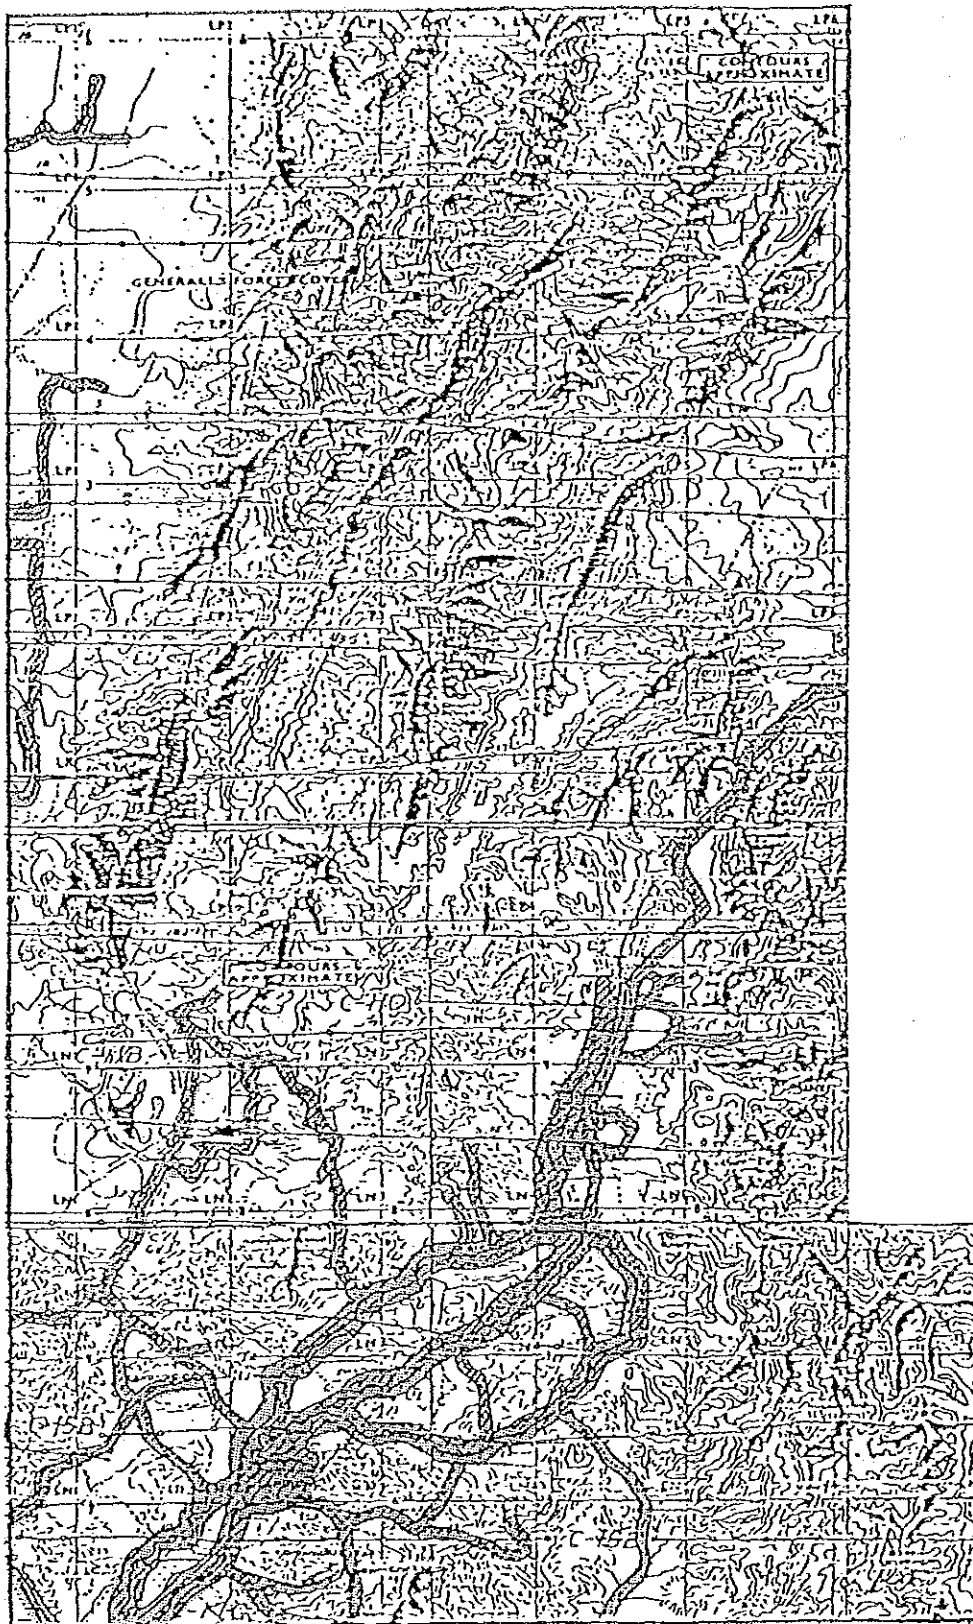
Fig. 3 Plan of Field Identification

▨ — Field reconnaissance area

Field identification was executed for items to be expressed on the map for the stereo-plotting and compilation work. For 578 km² of the total project area of 6,500 km², the area along the main roads, the field survey was made according to the contact prints of the aerial photographs, which were carried by the survey team, and the rest of the area was made by photographic interpretation according to criteria got by the field survey.
