REPORT
ON
FOREST INVENTORY SURVEY
IN
HONDURAS
(Aerial Photography & Signalization Works)

April 1981

Japan International Cooperation Agency
(J.I.C.A.)

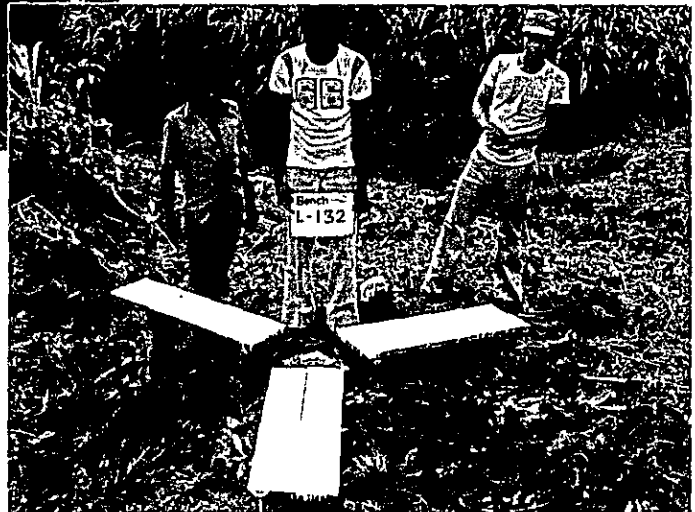
Aerial Signal for Existing Bench Mark

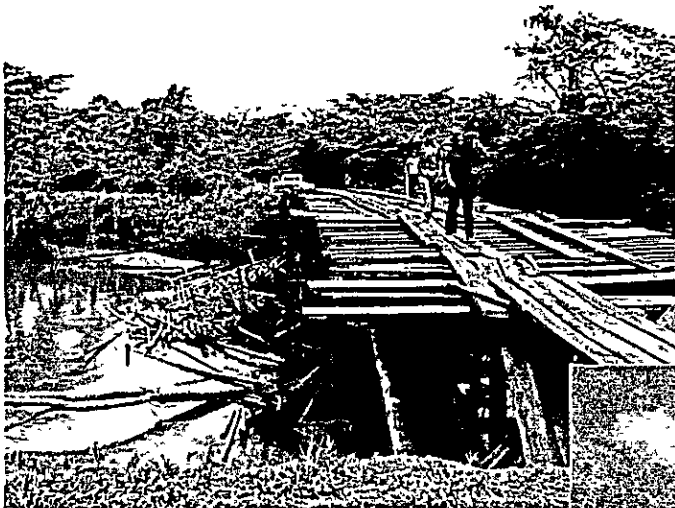
Washed Away Bridge at 1.3 km East of Rus Rus

Since a part of the wooden bridge (about 10 m) located 1.3 km south of Rus Rus village was swept away, vehicles could not cross the bridge. It could only be crossed on foot. Although no recent traces of vehicle traffic were observed on the west site of this bridge, condition of the road measuring about 4 m wide was fair.

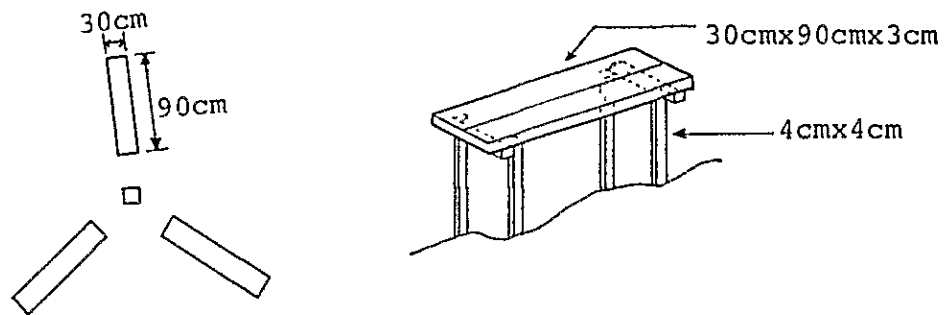
To clearly identify the location of aerial signals on aerial photographs, the size and shape of each aerial signal were determined as illustrated in Fig. III-1 while taking into account the photographing scale of 1:20,000.

- (1) As illustrated in Fig. III-1, the aerial signals basically consist of three vanes, each measuring 90 cm wide by 30 cm deep by 3 cm thick, coated with white paint.
- (2) To maintain the strength of the aerial signals, square boards, each measuring 4 cm by 4 cm, were used as support members.
- (3) While taking into account shape and topography of the project area, the location of aerial signals were planned as shown in Fig. III-2.
- (4) The aerial signals were established to minimize eccentricity. If eccentric establishment was unavoidable, eccentric elements were planned to be measured by plane table surveying or by using a compass. It was decided to record the measured data of eccentric elements in the specified record sheets (Format III-1 and III-2).

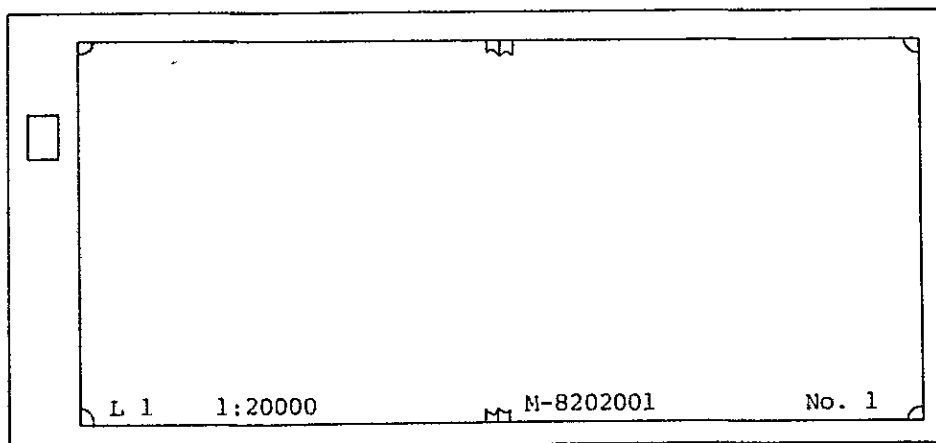
Fig. III-3

L - 1 1:20000 M-8102001 No. 1

L = Flight Line
Photo-Scale = 1:20,000
M = Mosquitia
81 = Year
02 = Month of year
001 = Roll number
N. 1 = Aerial Photographed number
