PRELIMINARY DESIGN OF GASTRO-ENTEROLOGICAL RESEARCH CENTER

IN THE REPUBLIC OF BOLIVIA

September 1977

Japan International Cooperation Agency

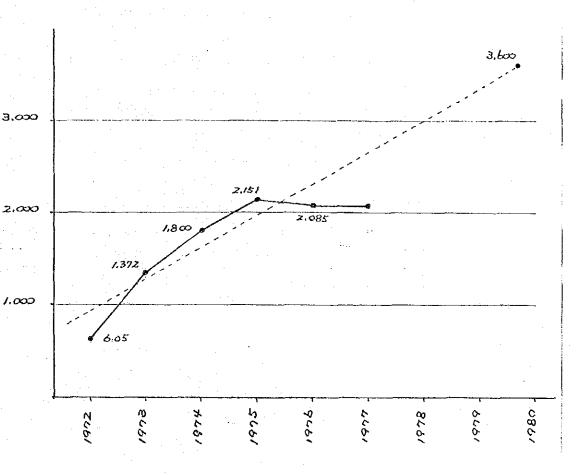
• This graph shows the growth rate of the construction industry by means of annual investment of the last several years and the assumed value in 1980, in which the assumed values for the years after 1977 were made on the basis of investments in public works designated by a 5-year plan of the government of Bolivia.

The growth rate in 1976 and 1977 was low mainly because of a cement shortage in La Paz. The actual decrease was about 3% compared to 1975.

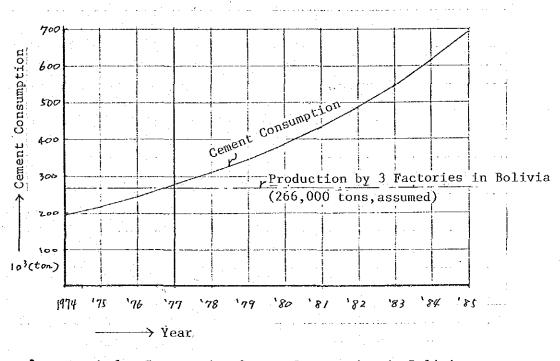
Graph for Forecasting Cement Consumption in Bolivia

Since cement consumption is proportional to the investment in construction, shortage in construction materials in the future should be taken into consideration. Hence, effective measures should be fully prepared for construction of the Research Center.

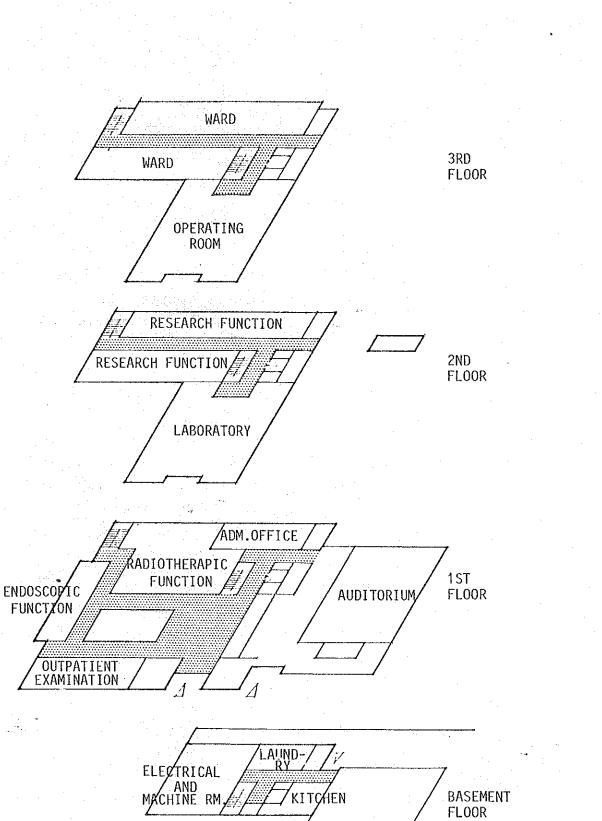
As for floor structure, solid slabs will be used taking into consideration the number of equipment pipes to be used because of COMPOSITION FO FLOORS

PENTHOUSE FLOOR

the specific requirement of the Research Center.

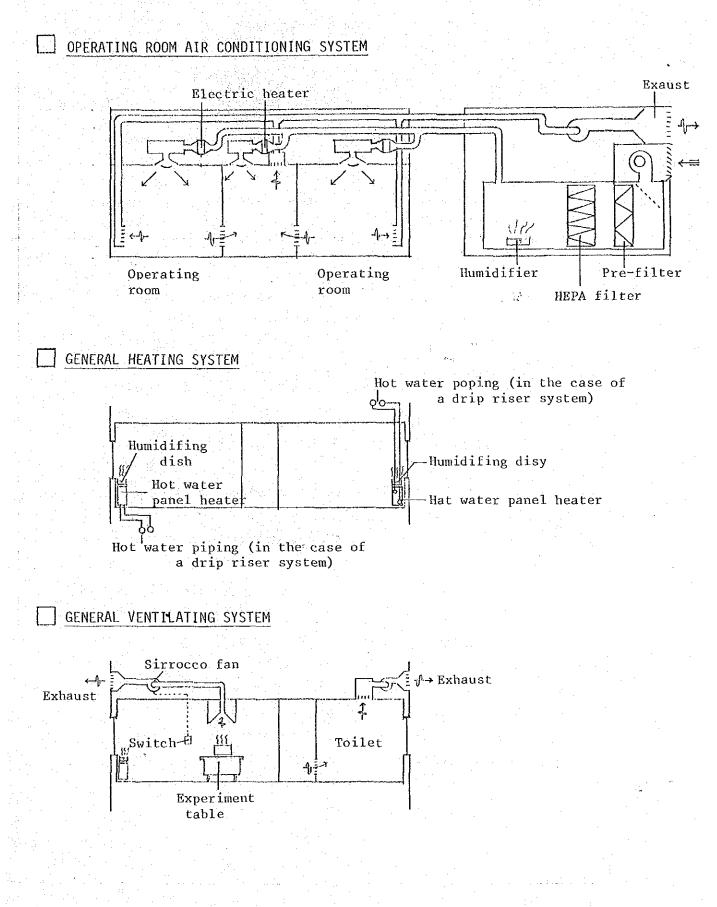
4) Temperature and humidity design conditions

a da serie de la constante de l Constante de la constante de la c	Operating room	General room	Outdoor air
Winter	Temperature	24°C+2°C	22°C+3°C	0°C
	Humidity	49% <u>+</u> 5%		15%
0	Temperature	25°C <u>+</u> 2°C	-	20°C
Summer	Humidity	40% Up		73%
