**Master Plan
for
Land Erosion and Volcanic Debris Control
in the Area of Mt. Merapi**

March 1980

JAPAN INTERNATIONAL COOPERATION AGENCY

SUPPORTING REPORT A
GEOMORPHOLOGY

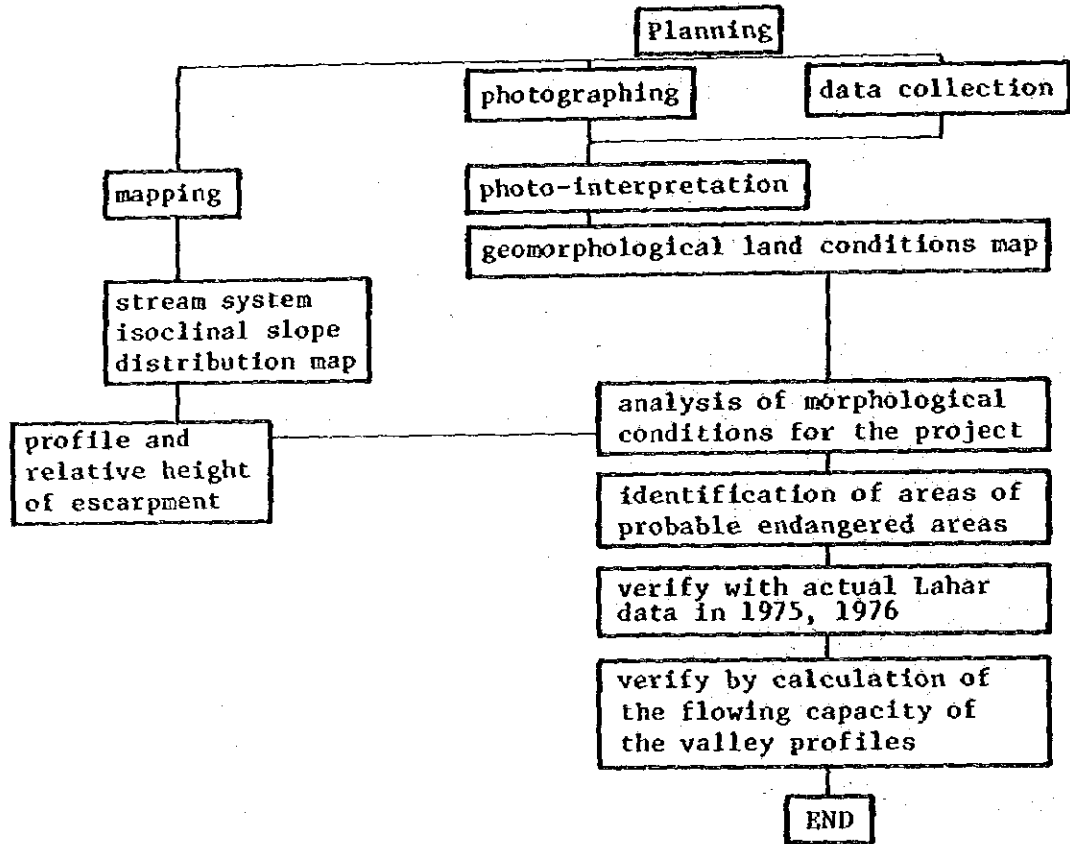
Fig. 3 Work Flow

An outline of the flow of work is shown in Fig. 3.

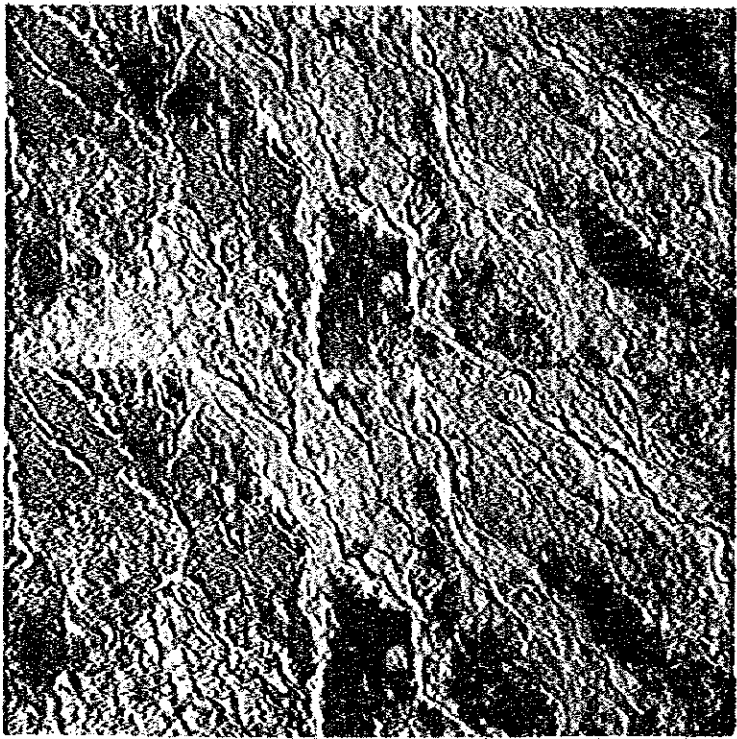
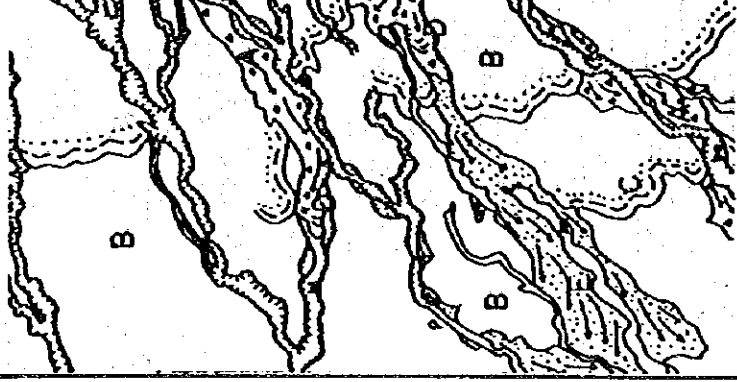
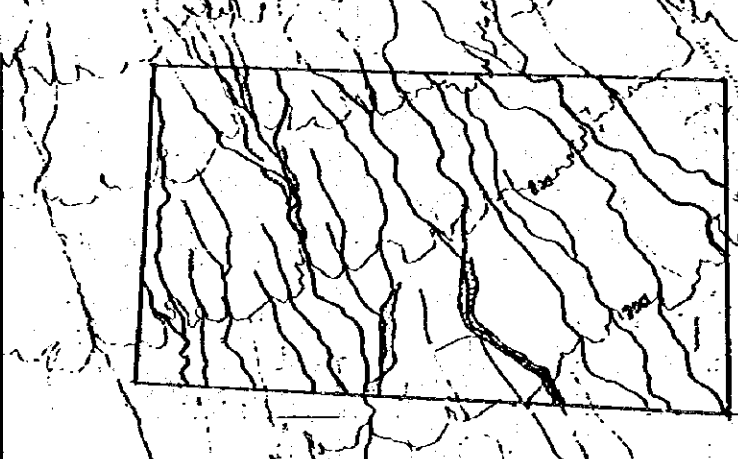
Name of Place	Location	Topographic Map	Classification
Julang Jero, KAB. MABELANG	Southwestern foot of Mt. MERAPI	Gn. MERAPI	Deposits of nuée ardante d'avalanche

<p>Explanation:</p> <p>This area is located at the foot of Mt. Merapi on its southwestern slope. The geographical features in this area change with each new volcanic eruption and the resulting erosion. During the eruption in 1969, Nuée Ardante d'avalanche covered the upper reaches of the valleys and slopes in Type I area. Nuée Ardante d'avalanche flowed down K. Blongkeng and buried its valley. After that, the upper reach of K. Blongkeng changed its course to that of K. Puth by flowing through the K. Juranjero. The same case can be observed on the K. Batang. In this case, K. Batang was buried and its upper reach changed course and flowed into K. Bebung. Generally, lahars starts spreading just at the point of the Breaking Zone on the mountainside. This phenomenon is similar to that of an alluvial fan which is formed at the mouth of the valleys. However, lahars spread takes place at two, three or more points along the same river.</p>

<p>PHOTO DATA: Strip Number: VIII-14.15 Photo Scale: 1:40,000 Flying Height: 3160 meters Camera: RC-70 Focal Length: 88.78 mm Film: Kodak Date: 27 October 1976 Photography: PENAS</p>		<p>Interpretation:</p> <p>b: K. Blongkeng p: K. Puth be: K. Batang be: K. Bebung</p> <p>A. Deposits of Nuée Ardante d'avalanche: The deposits of Nuée Ardante d'avalanche appear in the area where the tone is relatively light and an irregularly-shaped me-like pattern is seen.</p> <p>B. Mountainside Composed of Volcanic Debris (Upper Zone): This morphology can be seen in almost all of the photo. This is a gently sloping area.</p> <p>C. Breaking Zone: The Breaking Zone of the slope can be observed in area B extending from the upper to the lower part of the photo in the center.</p> <p>D. Former Valley Buried by Nuée Ardante d'avalanche: This morphology can be seen at K. Batang and K. Blongkeng. Nuée Ardante d'avalanche flowed down along the valley and stopped here. The deposits buried the valley.</p> <p>E. Deposits of Lahars: Deposits of Lahars appear as a whitish tone and are seen mainly along K. Puth.</p>

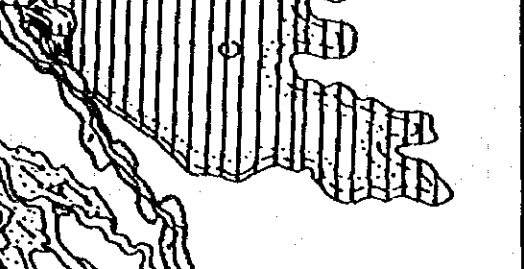
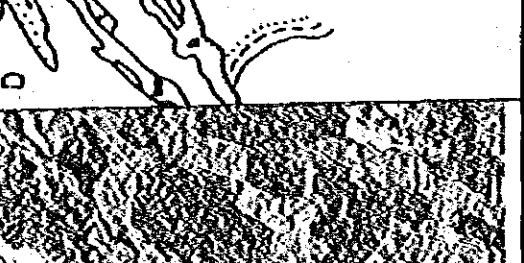
Name of Place	Location	Topographic Map	Classification
Lombong 2, KAB. MAGELANG	Lower reach of K. Bebeng	MUNTILAN	Deposits of recent lahar
<p>Photo Interpretation Card</p>

<p>PHOTO DATA:</p> <p>Strip Number: VII-12.14 Photo Scale: 1:40,000 Flying Height: 3960 meters Camera: RC-10 Focal Length: 88.78 mm Film: Kodak Date: 21 October 1976 Photography: PENAS</p> <p>Interpretation:</p> <p>be: K. Batang be: K. Bebeng k: K. Kurasak</p> <p>A. Deposits of Lahar: The area in the central part of the photo is white in tone. This area contains deposits of a lahar which occurred in 1969. The irregular lines observed on the deposits were caused by the flow direction of the lahar.</p> <p>B. Deposits of Nuée Ardante d'avalanche: The area in the upper part of the photo where the tone is light is covered by deposits of Nuée Ardante d'avalanche.</p> <p>C. Mountainide Composed of Volcanic Debris (Upper Zone): This morphology can be seen in the right-hand part of the photo as a gently undulating slope.</p> <p>D. Mountainide Composed of Volcanic Debris (Lower Zone): This morphology can be seen in the left-hand part of the photo. In this area, the slope inclination is rather gentle and the surface of the ground is smooth.</p> <p>Explanation:</p> <p>This area is located in lower reach of K. Bebeng. K. Bebeng continuously changes and these changes cause disasters when Mt. Merapi erupted in 1969. Nuée Ardante d'avalanche occurred and flowed down the mountain side. On the lower parts of the slope, it flowed along the rivers. Afterwards, lahar flowed down along K. Bebeng and destroyed villages. The lahar overflowed the valley just at the Breaking Zone and at the bend in the river course.</p> <p>E</p> <p>Former River Bed: The former river bed can be seen in the upper part of the photo, on the left side of K. Kurasak. Although it looks like an uncertain Shallow Valley, it is a former river bed of K. Kurasak.</p>

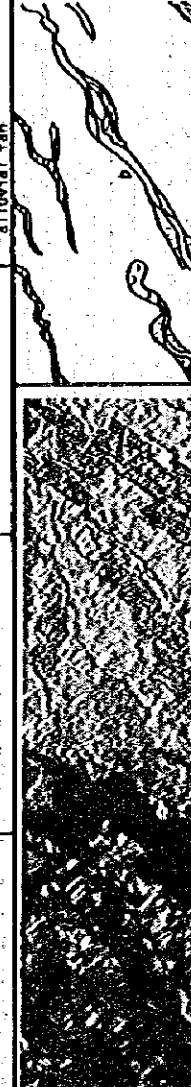
Banjarcjo, KAB. SLOMAN	Lower Reach of K. Kurusak	SALAM	Mountainside composed of volcanic debris, alluvial fan

<p>Interpretation:</p> <p>k: K. Kurusak b: K. Batang d: K. Progo</p> <p>A. Mountainside Composed of Volcanic Debris (Lower Zone): This morphology which is smooth and gentle can be observed in almost all parts of the photo.</p> <p>B. Breaking Zone of Slope Caused by Volcanic Debris Flow: This morphology can be observed faintly to the left of K. Kurusak.</p> <p>C. River-Bed: The area where the tone is rather light and an irregularly-shaped net-like pattern appears, is the river-bed of the K. Kurusak.</p> <p>D. Alluvial Fan: This morphology can be observed in the central part of the photo. The shapes of the fields are irregular in this area. Former river-beds appear as net-like patterns.</p>	<p>Explanation:</p> <p>This area is located in the lower reach of the K. Kurusak. In this area, the K. Kurusak does not dissect the valley except at the lowest reach near K. Progo. Flood waters overflowed the banks and spread over this area causing materials to accumulate. Thus, a fan was formed in this area. Longitudinal dykes have been constructed to protect the villages. However, in 1976, a Lahar destroyed the dykes and caused a lot of damage to the villages.</p> <p>E. Former River-Bed: This morphology, which appears as a net-like pattern, can be observed in the central part of the photo. The tone of this area is rather dark.</p> <p>F. Eroded Terrace: This morphology can be observed in the lower-left part of the photo. The surface of the terrace is smooth. The terrace is a little lower than the general surface of the ground.</p>	<p>PHOTO DATA:</p> <p>Strip Number: CV7-13,14 Photo Scale: 1:40,000 Flying Height: 2880 meters Camera: RC-10 Focal Length: 88.78 mm Film: Kodak Date: 18 October 1976 Photography: PEMS</p>

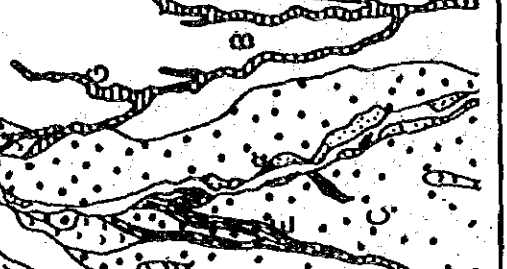
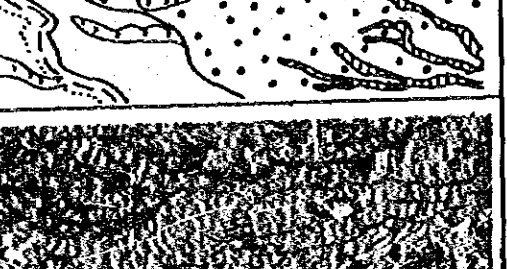
Name of Place	Location	Topographic Map	Classification
Gillman, Kab. Sulaw	Middle Reach of K. Kuning	BUTUH	Alluvial Fan
<p>Photo Interpretation Card</p>

<p>PHOTO DATA: Strip Number: CVI-9,9 Photo Scale: 1:40,000 Flying Height: 2800 meters Camera: RC-10 Focal Length: 88.78 mm Film: KODAK Date: 18 October 1976 Photography: PENAS</p>
<p>Interpretation: K. Kuning</p> <p>A. Mountainside Composed of Volcanic Debris (Upper Zone): This morphology can be observed in the upper part of the photo. The slope in this area is undulating.</p> <p>B. Mountainside Composed of Volcanic Debris (Lower Zone): This morphology can be observed in the right-hand part of the photo. The inclination of the slope is quite gentle and the surface is smooth.</p> <p>C. Alluvial Fan: This morphology can be seen in the central and lower parts of the photo. It is difficult to distinguish the alluvial fan and mountainside composed of volcanic debris (Lower Zone) by photo interpretation.</p> <p>D. Uncertain Shallow Valley: A typical example of this morphology can be observed in the upper part of the photo. These valleys are U-shaped and do not have clear escarpments.</p>			<p>Explanation: This area is located in the middle reach of K. Kuning. This photo shows the Breaking Zone which divides the upper and lower zones. The alluvial fan is formed in the lower zone where the valley of K. Kuning becomes shallower. Lahar and flood waters flowed over the banks and materials accumulated. Original volcanic debris also flowed down into this area thereby making the composition of this area an alternation of alluvial materials and volcanic debris.</p>

<p>E. Former River-Bed: This can be seen in the alluvial fan. It forms a shallow and unclear valley.</p> <p>F. Accumulation Terrace: Accumulation terraces developed along K. Kuning. They are very low compared with general mountain slopes.</p> <p>G. Small Valley: These valleys have clear escarpments but their depths, widths and lengths are minimal. They developed on the general flood slopes.</p>			<p>Interpretation: K. Kuning</p> <p>A. Mountainside Composed of Volcanic Debris (Upper Zone): This morphology can be observed in the upper part of the photo. The slope in this area is undulating.</p> <p>B. Mountainside Composed of Volcanic Debris (Lower Zone): This morphology can be observed in the right-hand part of the photo. The inclination of the slope is quite gentle and the surface is smooth.</p> <p>C. Alluvial Fan: This morphology can be seen in the central and lower parts of the photo. It is difficult to distinguish the alluvial fan and mountainside composed of volcanic debris (Lower Zone) by photo interpretation.</p> <p>D. Uncertain Shallow Valley: A typical example of this morphology can be observed in the upper part of the photo. These valleys are U-shaped and do not have clear escarpments.</p>

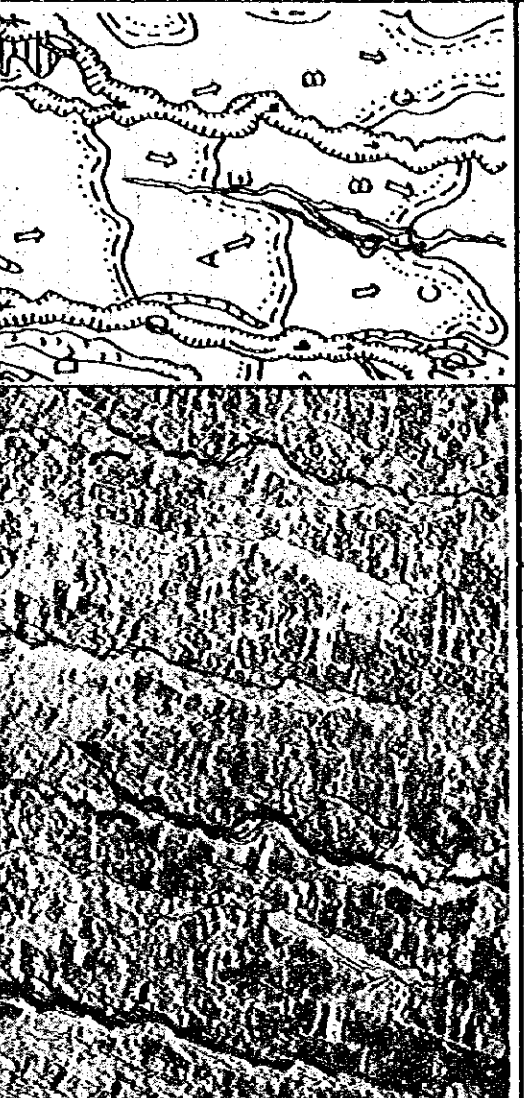
Name of Place	Location	Topographic Map	Classification
Kaliurang, KAB. SLEMAN	Upper Reach of K. Boyong	Gn. HERAPI	Mountainside composed of volcanic debris (Upper Zone)

<p>PHOTO DATA:</p> <p>Strip Number: VII-15.17 Photo Scale: 1:40,000 Flying Height: 3960 meters Camera: RC-10 Focal Length: 88.78 mm Film: Kodak Date: 21 October 1976 Photography: PENAS</p>			
<p>Interpretation:</p> <p>b: K. Boyong k: K. Kuning</p> <p>A. Mountainside Composed of Volcanic Debris (Upper Zone): This morphology is distributed extensively in the area covered by this photo. Area A was formed by volcanic debris flowing down along the K. Boyong.</p> <p>B. Mountainside Composed of Volcanic Debris (Upper Zone): This morphology, which can be seen in the right-hand part of the photo, is the same morphology as that of area A. But, the deposits of area B are from the K. Kuning; this makes them a different "unit".</p> <p>C. Breaking Zone: In areas A and B, several gaps or steps have formed on the slope. In the upper part of the photo, the Breaking Zones are rather clear, but in the lower part of the photo, these Zones are not very clear.</p> <p>D. Uncertain Shallow Valley: These valleys are observed along the K. Boyong. They do not have clear escarpments surrounding them.</p> <p>E. Shallow Valley: These valleys have developed on the side of the mountain. They have clear escarpments which have been eroded by streams. The transversal valley is basically U-shaped.</p>

<p>Explanation:</p> <p>This area is located on the southern slope of Mt. Merapi. Kaliurang can be seen in the upper part of the photo. Volcanic debris flowed down along K. Boyong and K. Kuning and spread out to form fan-like topography.</p> <p>In this area, volcanic debris spread out from the valley. As a result, the areas on either side of the valley were built up and the rivers flowed in the higher part of the debris flow. The boundary which divides the debris flow from K. Boyong and K. Kuning can be seen faintly in the photo.</p> <p>In the lower left-hand part of the photo, an Uncertain Shallow Valley can be seen extending from the bend in the K. Boyong. A lava disaster can easily occur under such topographical circumstances.</p>

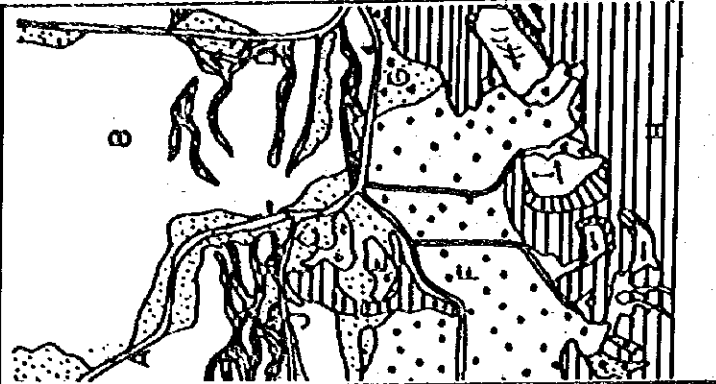
Rised Up River-Bed

Strip Number: IV-4-5
 Photo Scale: 1:40,000
 Flying Height: 2880 meters
 Camera: RC-10
 Focal Length: 88.78 mm
 Film: Kodak
 Date: 27 October 1976
 Photography: PEMS

- u: K. Horo
- d: K. Dengkeng
- A. Rised Up River Bed: In the central part of the photo, some linear land forms can be seen whose level is higher than the general level of the ground. This is a Rised up river-bed.
- B. Alluvial Plain: This morphology has a smooth surface. It is distributed along the upper part of the photo.
- C. Sand-Bar, Natural Levee: There are sand-bars or natural levees along the rivers. This area is a little higher than surrounding areas.
- D. Former River Bed: This morphology appears as a dark zone belt in the Alluvial Plain.
- E. Swamp: This area can be observed in the central part of the photo. This generally is dark in tone.
- F. Alluvial Fan: This can be observed from the central to the lower parts of the photo. It has a gentle inclination.

- G. Piedmont Plain: This can be observed in the right-hand part of the photo.
- H. Hills: This morphology can be seen in the lower part of the photo. The general slope is rather steep.
- I. Slump: This can be observed in the Hill area.
- J. Local Sediment Deposited by Flood: This morphology can be observed in the left-hand part of the photo. It is a little higher than the natural levee and sand-bar.

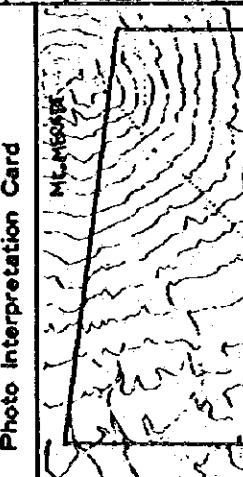
Name of Place	Location	Topographic Map	Classification
Kaliurang, KAB. SLEMAN	Middle Slope of Mt. MERAPI	Gn. MERAPI	Volcanic morphology
Photo Interpretation Card

<p>PHOTO DATA:</p> <p> Strip Number: CXX - 8.9 Photo Scale: 1:40,000 Flying Height: 5130 meters Camera: RC-10 Focal Length: 88.78 Film: Kodak Date: October, 1976 Photogeography: PENAS </p>
<p>Interpretation:</p> <p>k: Kaliurang b: K. Boyong ku: K. Kuning g: K. Gendol be: K. Becong</p> <p>A. Volcanic Deposits of Old Merapi: This morphology which is eroded, can be observed from the upper right-hand to the lower left-hand sides of the photo.</p> <p>B: Former Lava Flow Deposits: This morphology can be seen in the central part of the photo. Flowing units of lava can also be observed. Some of them have ridges which follow the direction of the flow. This phenomenon indicates that the deposits are highly viscous.</p> <p>C. Mountainside Composed of Volcanic Debris (Upper Zone): This morphology can be seen in the lower part of the photo. This area is flatter than areas A and B and is fan-shaped.</p> <p>D. Deposits of Nuee Ardente d'avalanche: This morphology can be observed in the upper left-hand part of the photo. The tone of the area is rather light. This</p>	<p>Explanation:</p> <p>This area is located on the southern slope of Mt. Merapi. The distinction between the old and new Mt. Merapi areas is quite clear in the photo. Old Mt. Merapi, composed of lava and volcanic debris, is quite eroded now. Step-like formations caused by different layers are seen on the steep slopes. Highly viscous materials from new Mt. Merapi have caused levee-like ridges to form along the edges of the lava flow. This morphology can be observed in the area covered by lava.</p> <p>The upper mountainside has highly undulating topography compared with the lower part of the mountain. This might be caused by the viscosity of materials. The materials on the upper slope have a rather high viscosity. Materials on the lower slope may have very low viscosity because they are not undulating but rather alluvial fan-shaped.</p> <p>The area has often been covered by volcanic deposits. Vegetation is sparse.</p>
