REPUBLIC OF INDONESIA

**STUDY REPORT
ON
THE REMOVAL
OF
SUNKEN VESSELS**

MARCH 1980

JAPAN INTERNATIONAL COOPERATION AGENCY

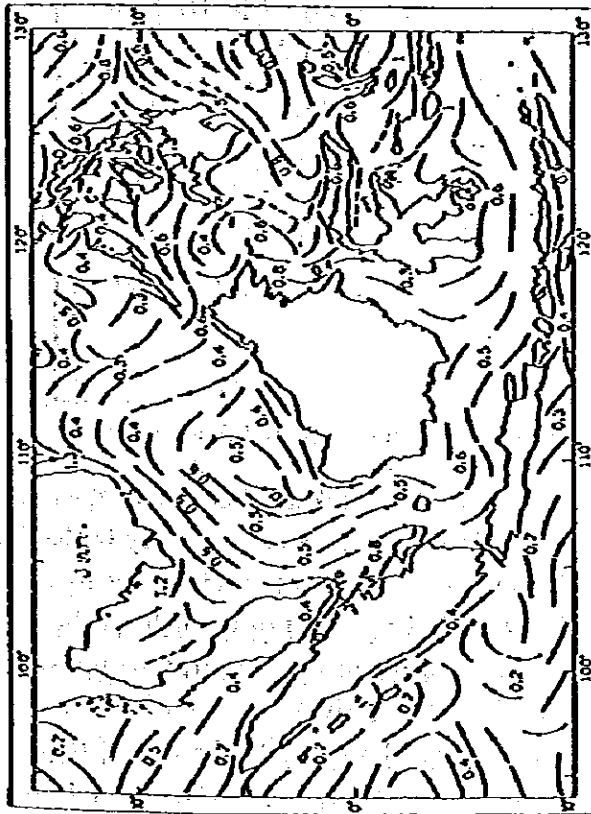
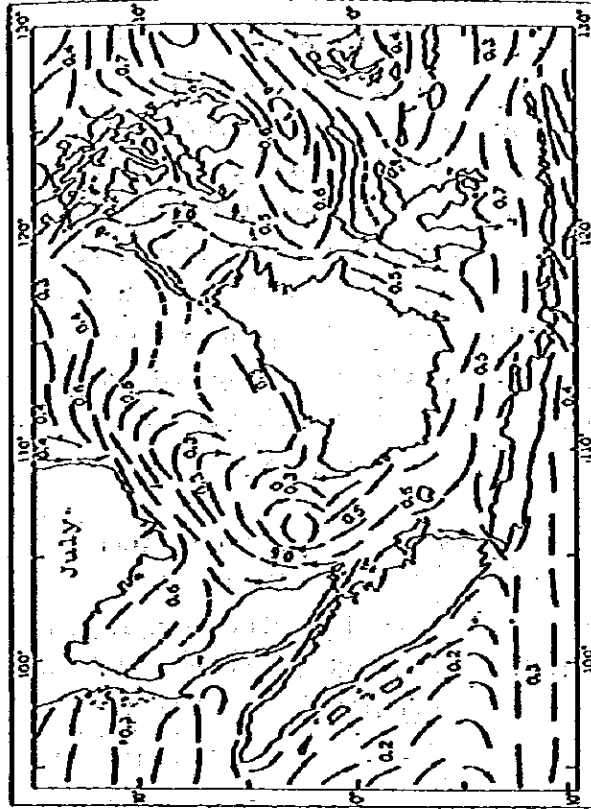
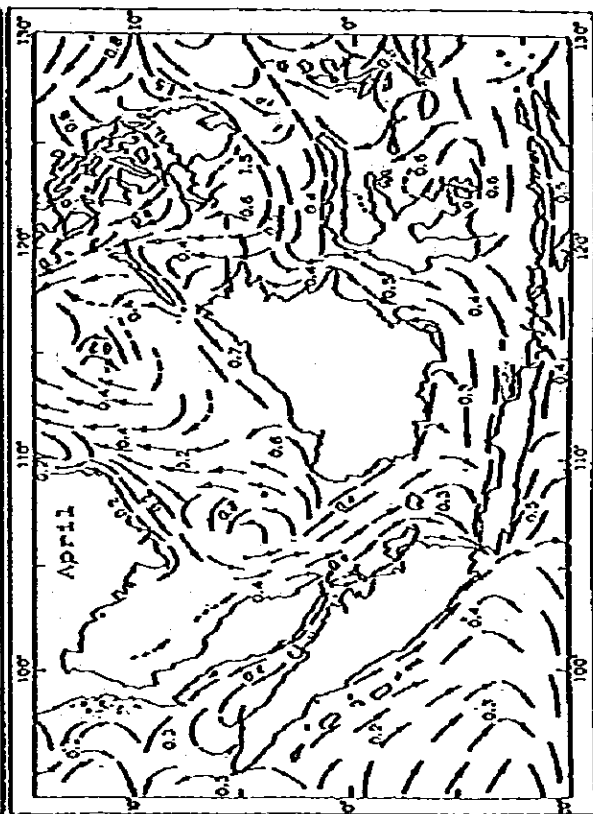
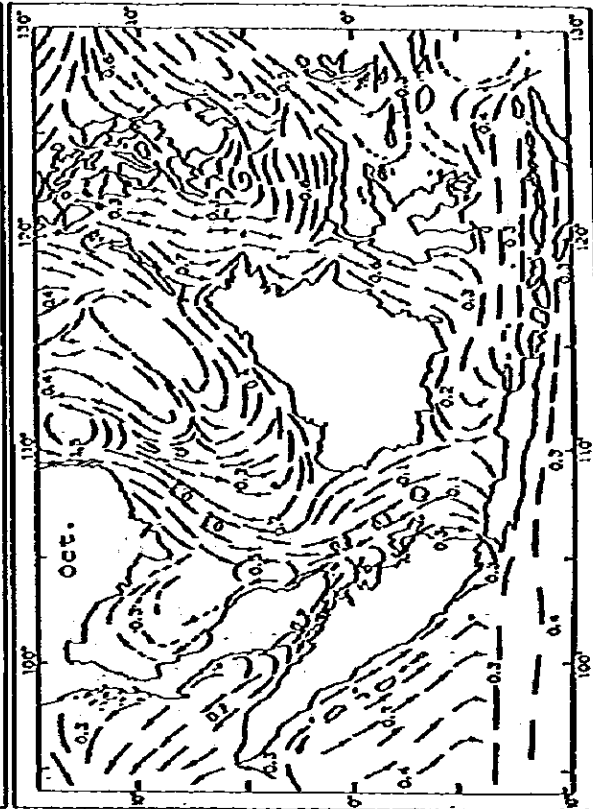
Plan 1-1-1

Ocean current (kn)

Source: Japan Maritime Agency

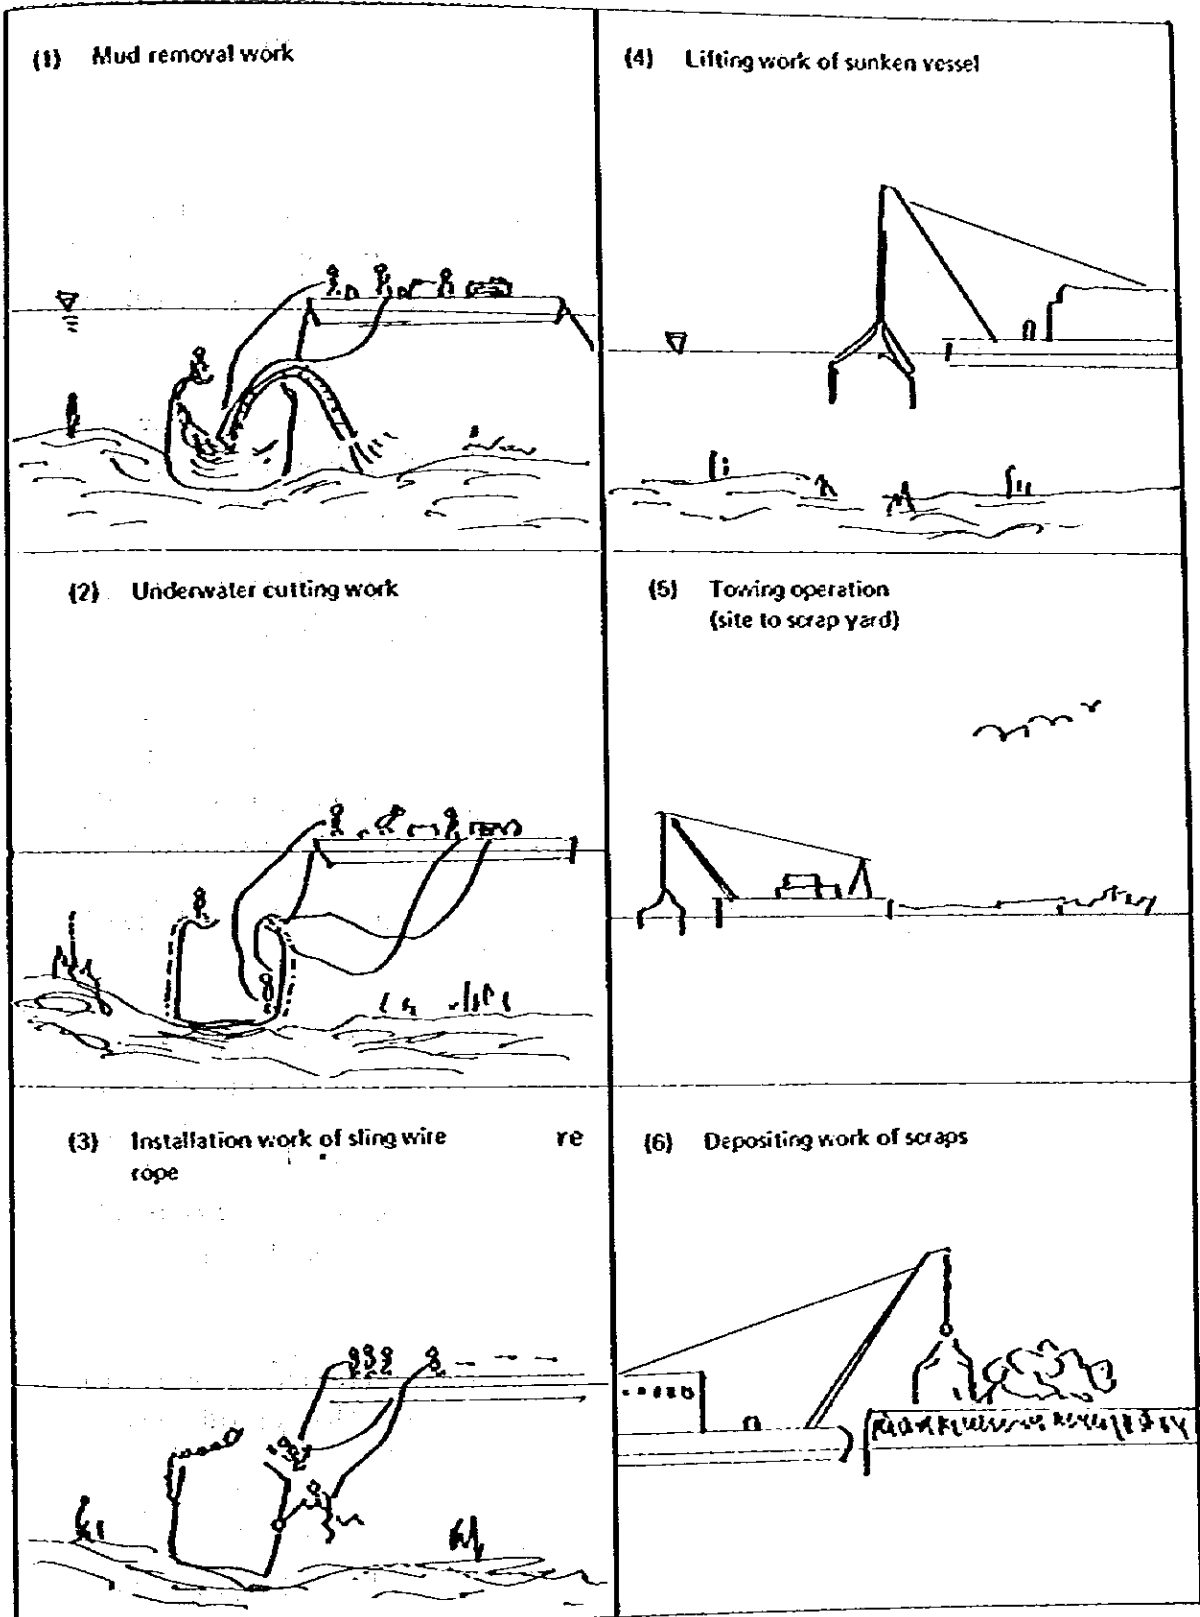
Plan 4-2-13

After depositing, divers start to release the sling wire rope. In case of having bundled the block, be careful for the sling wire ropes so as not to spoil them since they were laid underneath the block. (see plan 4-2-13).
