REPORT ON TOPOGRAPHIC MAPPING PROJECT

EAST KENYA AREA, REPUBLIC OF KENYA

(Fifth Year)

JAPAN INTERNATIONAL COOPERATION AGENCY

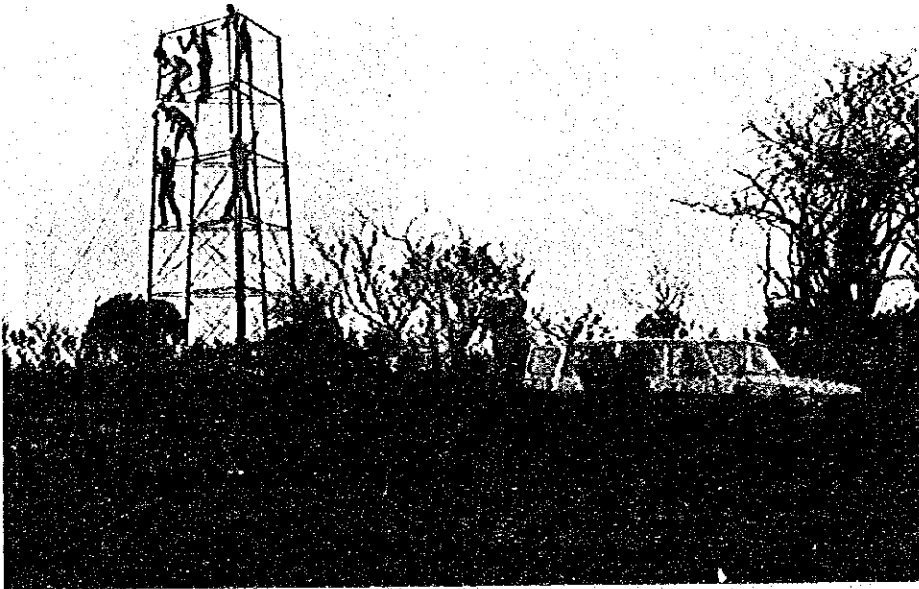
Construction of observing tower.

The points requiring eccentric observation turned out to be 184-ST5 and 192-S6. Towers were built at these points. The towers were transported in a large rented truck for the road distance of approximately 100 km from the Base Camp at Malindi to the Sub Camp at Galana and in the team's truck for the 75 km from the Sub Camp to Point 184-ST5 and the 30 km to Point 192-S6 in two

installments for each tower. The towers were erected right on the point at 184-ST5 and at an eccentric distance of 15.91 m at 192-S6, standing to the heights of 15.32 m and 15.17 m from the ground respectively.

It took two days to build the tower at each point working from the Sub Camp and one day each to dismantle them. A total of four units of high observing towers, two 15 m units and two 20 m units, were used. After the pricking work was completed, they were checked up to be presented to the S.K. as a gift of the Survey Team.
