**Report on Topographic Mapping Project
for
East Kenya Area, Republic of Kenya**

(First Year)

Signalisation

Selection of Traverse Points

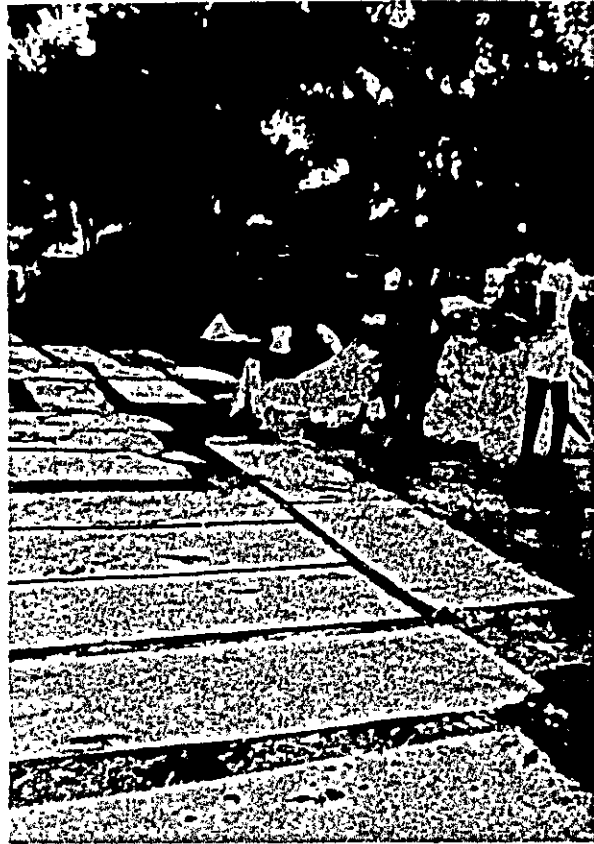
*Preparation of materials for
aerial signals at base camp*

The shape and size of signals were determined in accordance with the specifications as shown in appended Diagram 2. Appropriate materials were selected according to the conditions of the site.

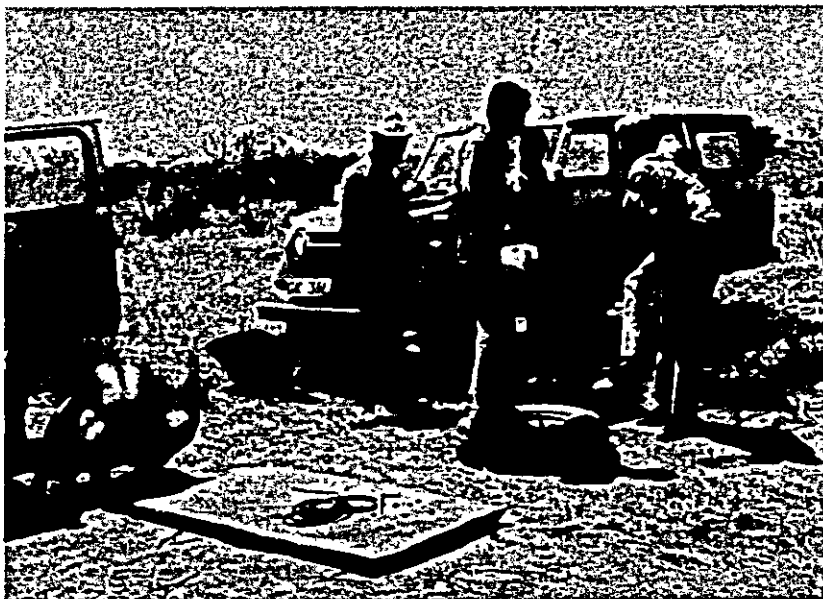
Repairing eleventh flat tyre of the day

Thanks to the efforts of Mr. Sugita, a professional mechanic, none of the brand-new vehicles posed serious problems in actual operation despite rough use over bad roads day after day. However, flat tyres were caused from time to time by thorns. This is because operational requirements frequently necessitate travel by vehicles over untrodden paths in

the bush. As a means of preventing blowouts, 7.00-16 (6-ply) tyres with which the Land Cruisers were originally equipped were replaced with 7.50-16 (8-ply) tyres, one-grade higher. In order to protect equipment and materials, a *special body* was attached to the cargo portion of one of the trucks. Also, a roof carrier was mounted on each Land Cruiser so as to enable them to carry long materials and equipment. It was not until the end of almost all field activities that all the vehicles were equipped with a roof carrier.
