# Report on Topographic Mapping Project for Musoma Area, Republic of Tanzania

(Second Year)

March 1975

Japan International Cooperation Agency

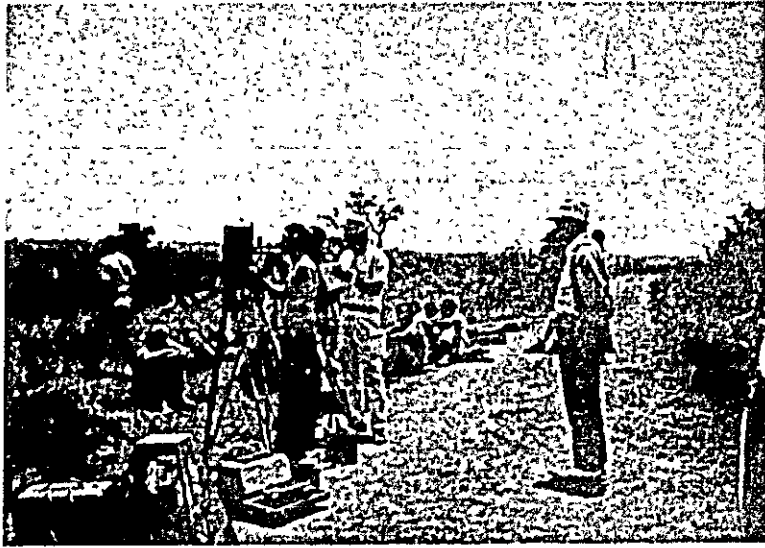
*Photo point survey*
