**Report on Topographic Mapping Project
for
Musoma Area, Republic of Tanzania**

(First Year)

(Part I) Control Point Survey

(Part II) Aerial Photography

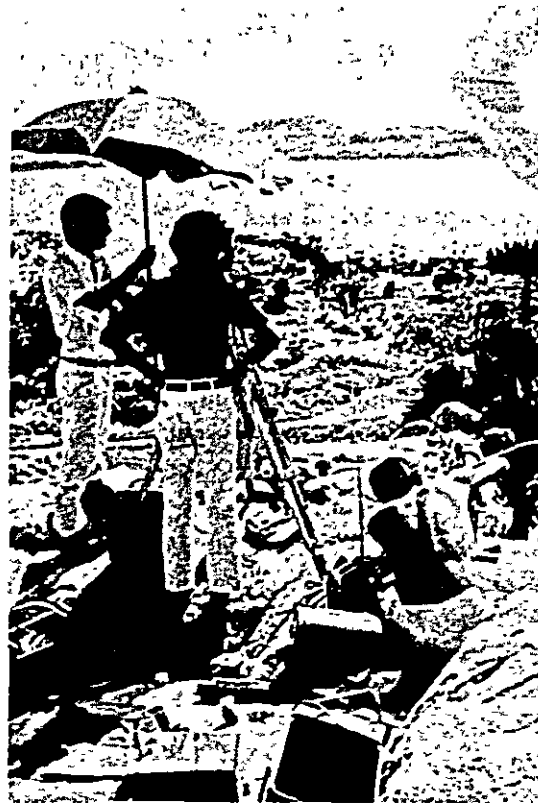
The traverse observations included angle measurement and distance measurement. A WILD T3 or Kern DKM 3A was used for angle measurements. Horizontal directions were observed in six sets and vertical angles were observed simultaneously from both directions at three times, with signal lamps or heliotropes as the target.

A Tellurometer MRA Model 101 was employed for the distance measurement. The distance measurements were made in two sets both backwards and forwards (one set consists of two coarse readings and ten fine readings). An aneroid barometer (BAROMEK, made in England) and an air psychrometer were employed for meteorological observations, and observations were conducted four times in one set.

A scene of traverse observation

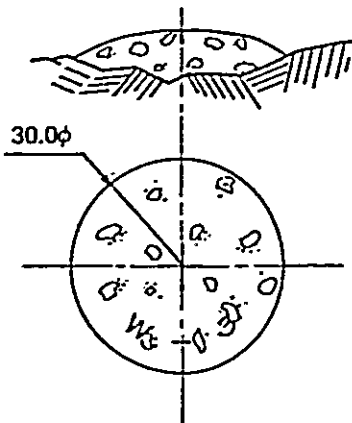
figure 3
 S=1:10
 unit: cm

A concrete beacon containing a cartridge case was employed as a monument in normal terrain, for which concrete was placed on the spot. For a monument in rocky terrain, a hole was chiseled in the rock, into which a cartridge case was directly cemented. A total of four witness marks were set up around the survey point.

Witness Mark : figure 3
 Signalization: figure 4

Figs. 1, 2, and 3 in Appended Diagram 1 are sectional drawings with plans of the monument and the witness mark.

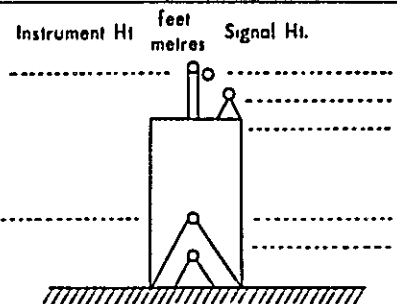
Diagram 2

HORIZONTAL & VERTICAL ANGLE OBSERVATIONS.										Station: JAN 317

<p style="font-size: small; margin: 0;">Instrument Hi feet metres Signal Hi.</p>				Notes on observing			Observer: K.Y.			Date: 27-9-'73 Sin Page 3 of 3 3		
				Conditions:			Booker: T.A.					
							Reduced: T.A.					
							Checked: K.Y.					
							Ins. No. T3-83067					
							Weather: Fine					
			Visibility: Good									
Station	Face	Signal		Reading		Mean	Reduced. Read'g			Remarks		
				A	B							
5-ST-3	R	Hello	16:10	0	0	32, 8	33, 0	65, 8	0	0	0, 0	
4-ST-3	L	Lamp		184	52	52, 0	52, 2	104, 2	184	52	38, 4	39.8
				4	52	50, 0	50, 0	100, 0	184	52	41, 3	
				180	0	29, 4	29, 3	58, 7	0	0	0, 0	
				210	12	15, 6	15, 6	31, 2	0	0	0, 0	
	L			35	04	34, 2	33, 7	67, 9	184	52	36, 7	37.6
	R			215	04	37, 9	37, 9	75, 8	184	52	38, 5	
				30	12	18, 5	18, 8	37, 3	0	0	0, 0	
	R			60	18	02, 7	02, 9	05, 7	0	0	0, 0	
				245	10	23, 4	23, 4	46, 8	184	52	41, 1	39.8

The results of observations were entered in the designated field notebook, and field inspection of the entries was conducted twice by the observer and supervisor. Appended Diagrams 2 - 4 show these field notebooks.
