APPENDIX III

LAND USE AND VEGETATION CONDITIONS

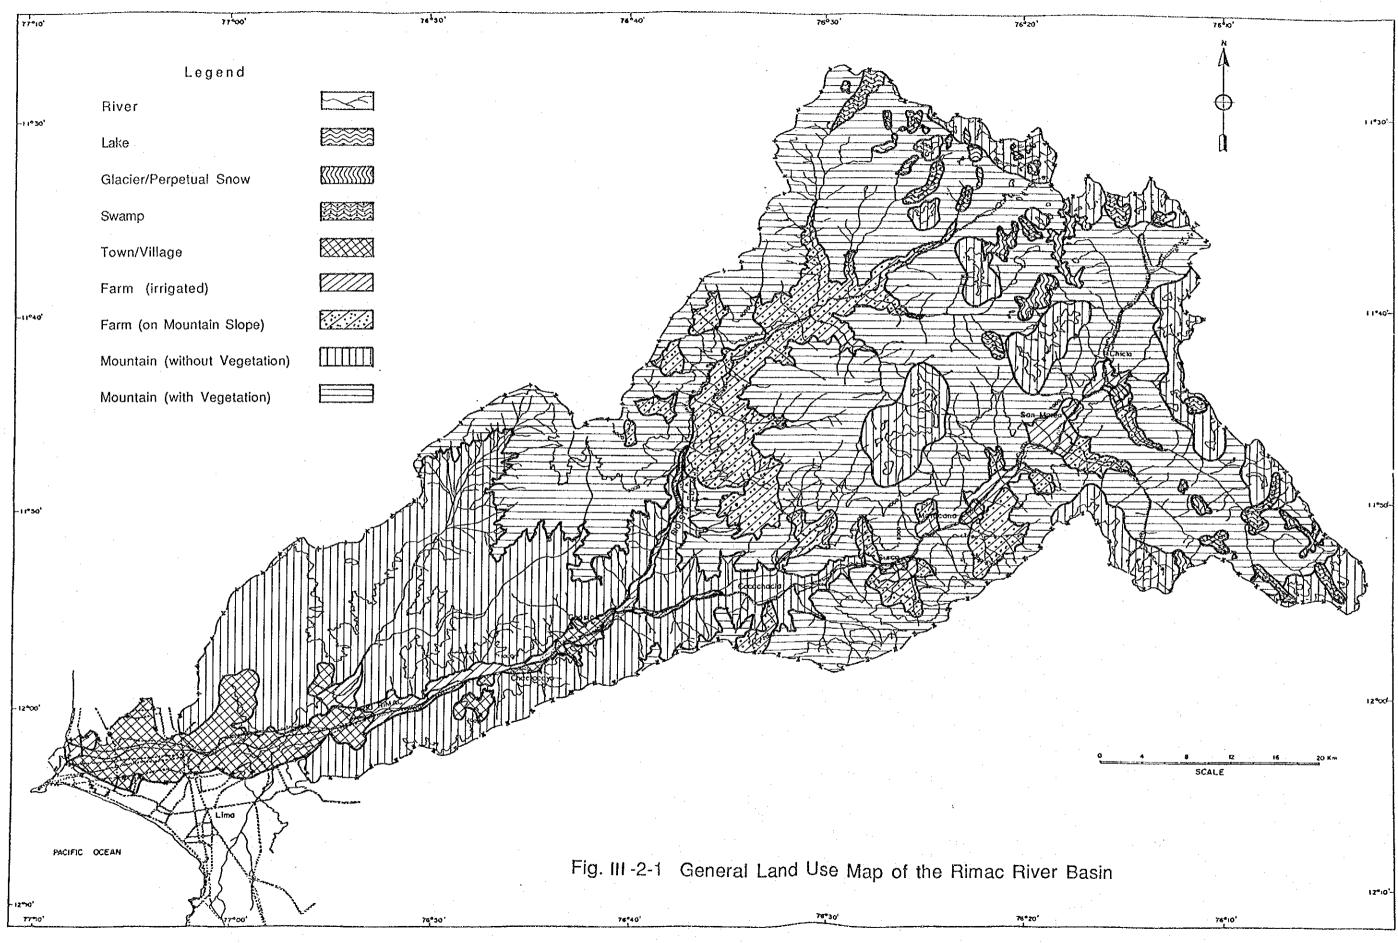
The general land use conditions of the whole basin are shown in Fig. III-2-1 which was processed from the land use classification map prepared in 1/100,000 scale.

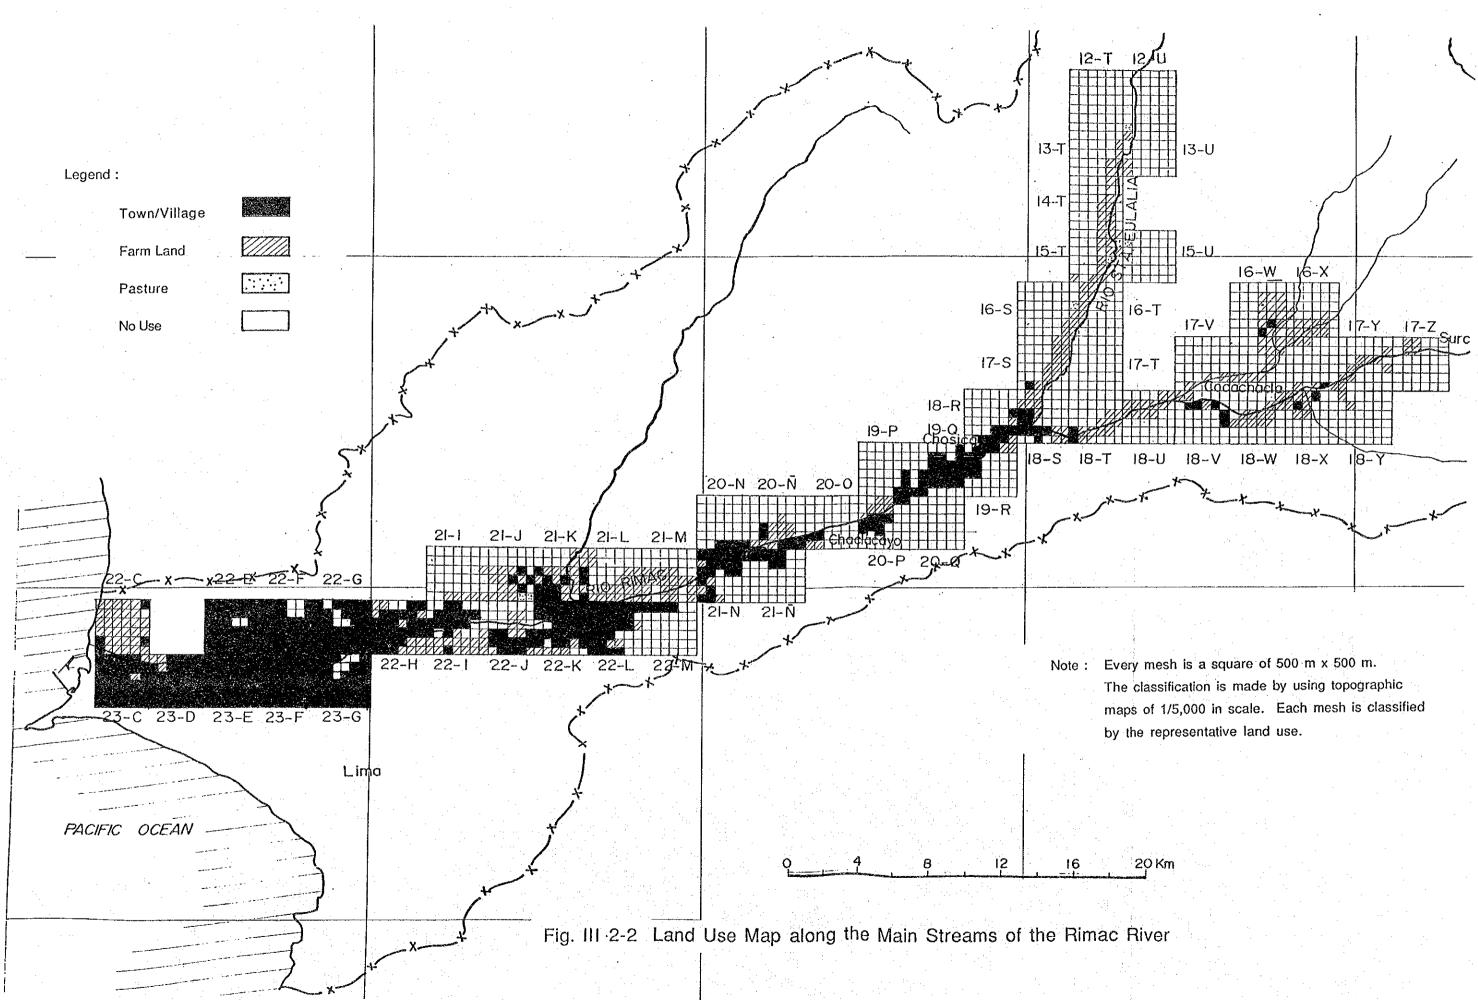
The Land Use Condition in the areas along the Rimac river and the Sta. Eulalia river is shown in Fig. III-2-2. The classification in this figure is made from the classification of every square with 500 m meshes on map of 1/5,000 in scale. Though the more specific classification is made in every mesh of 500 meters, the classification on the figure is shown by the most representative use in each square. That is, the detailed classification can not be seen in the figure. However, it seems to be available to see the distribution of main land use along the main river of which surrounding areas have high possibility to suffer disaster due to flood inundation, debris flow, slope failure, etc.

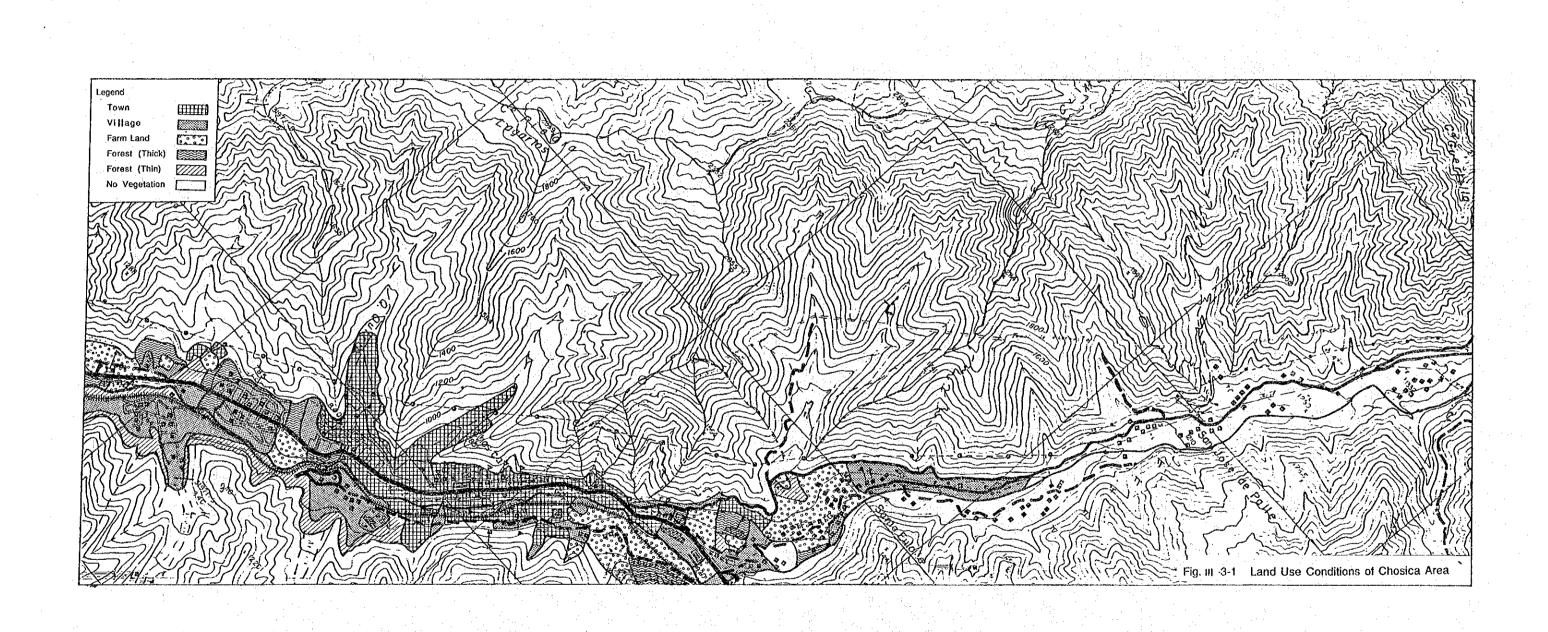
The Land Use conditions of each area are shown in Fig. III-3-1 to III-3-5.

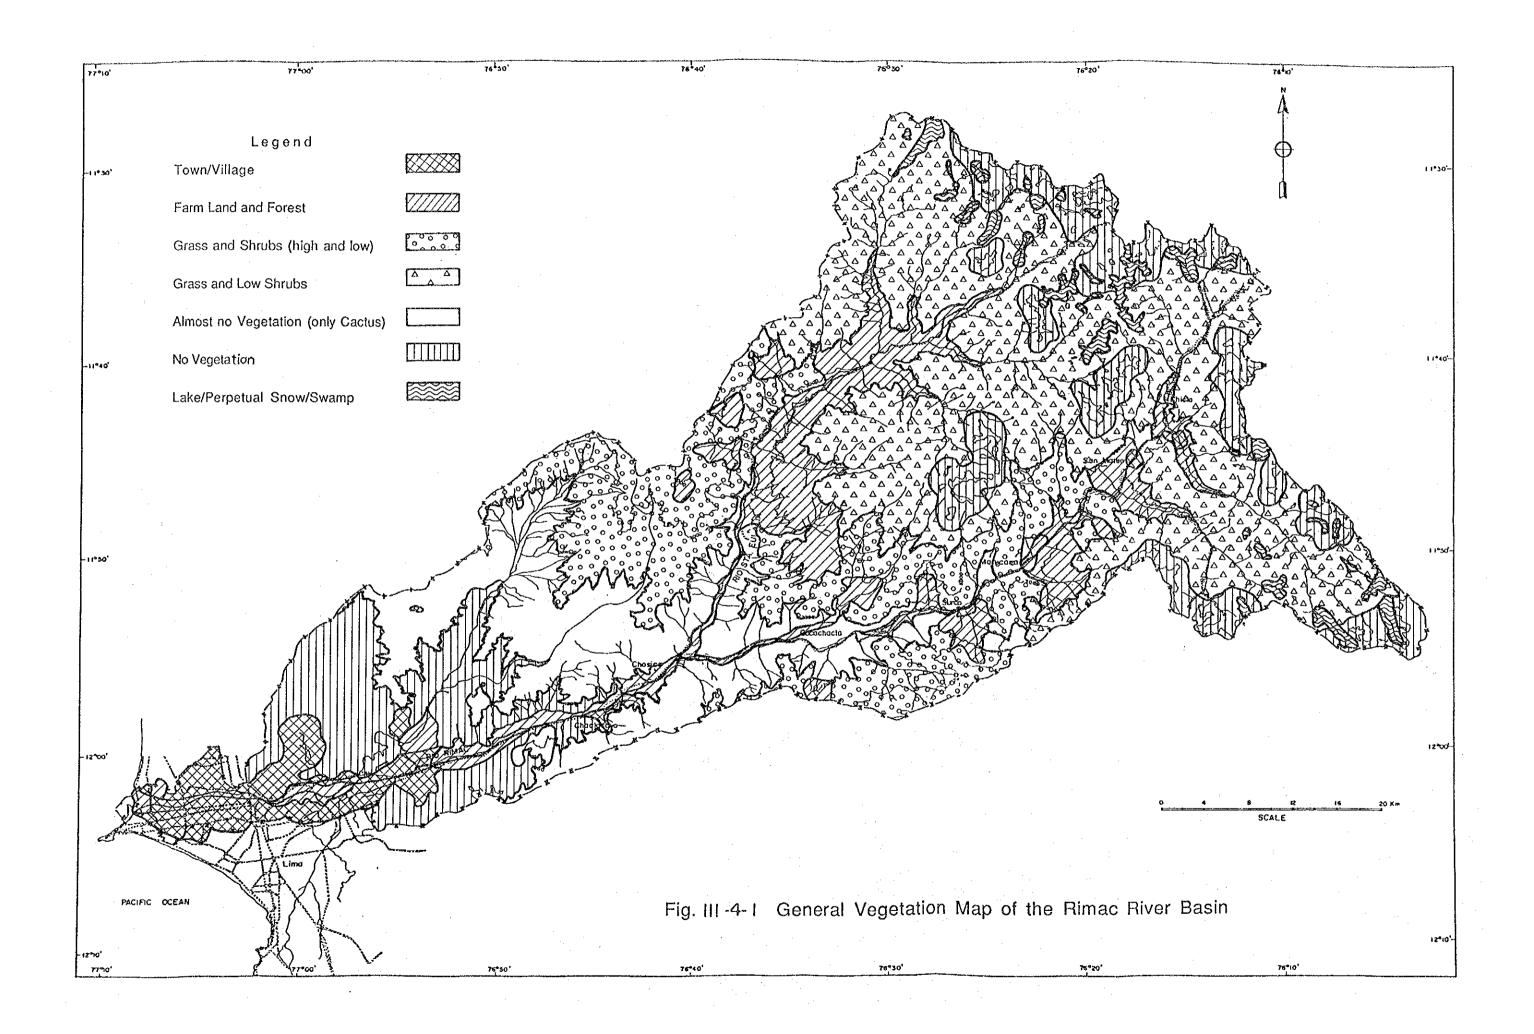
The condition of vegetation in the basin is roughly shown in Fig. III-4-1. The ratio of each classification is obtained as follows:

More detailed ecological or vegetative map are not to be Vegetation condition is generally made for this study. Vegetation condition is generally classified based on difference of altitude. In accordance with this classification, the vegetation of each zone is described as follows:
