ANNEX - X

**PROFILE
OF
PROJECT AREA**

**LHUNTSHI AND MONGAR
INTEGRATED AGRICULTURAL DEVELOPMENT PROJECT**

ANNEX-X PROFILE OF PROJECT AREA

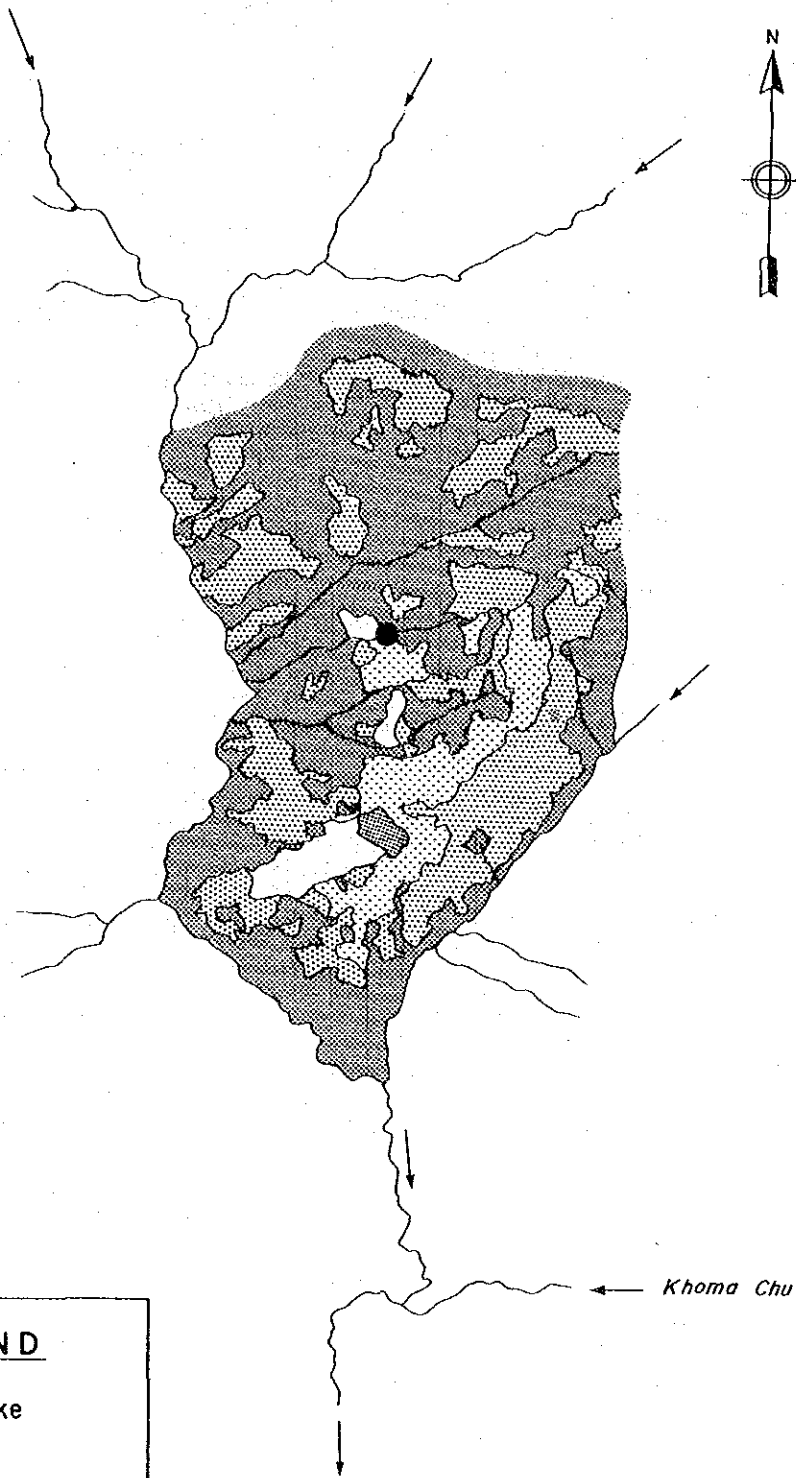
PRESENT LAND USE MAP OF PANG KHAR PROJECT AREA

Present land use is illustrated in attached land use map.

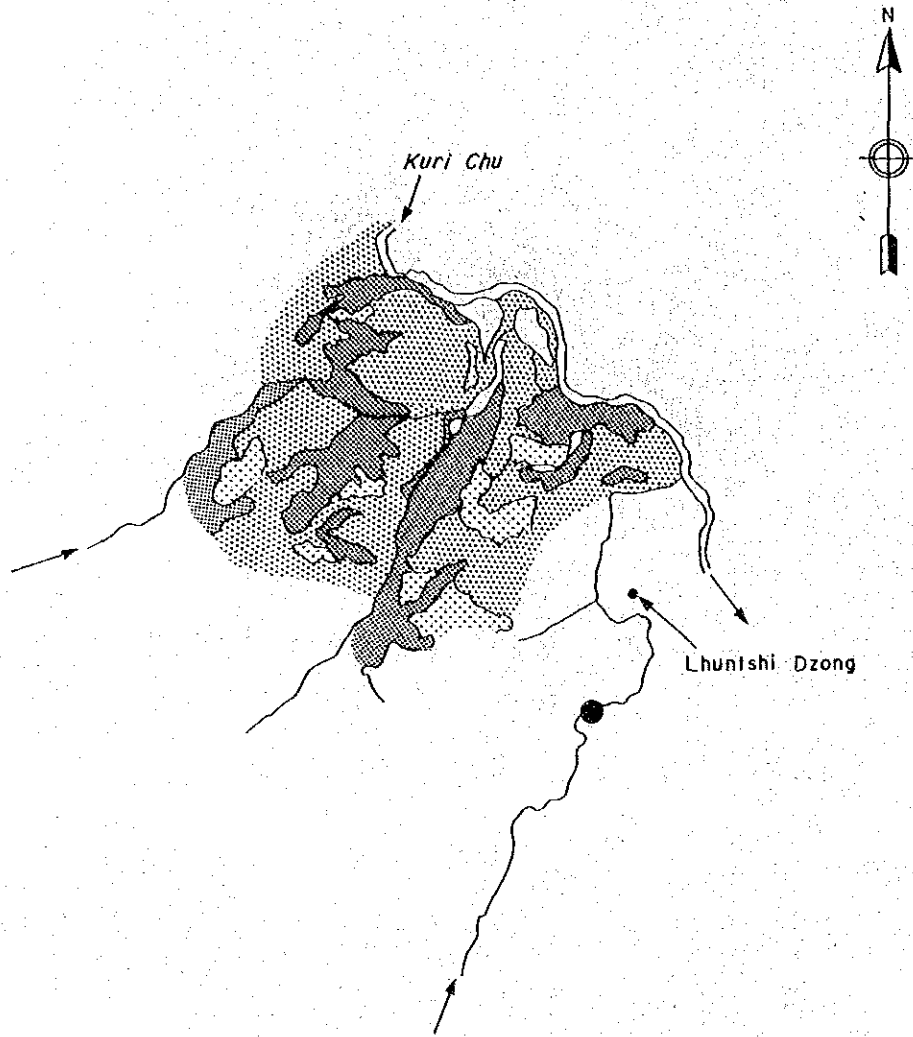
PRESENT LAND USE MAP OF GANGZOOR PROJECT AREA

Present land use is illustrated in attached land use map.
