幹線道路主要橋梁改修計画調査

ファイナル・レポート  
第2巻  
(本編)

国際協力事業団

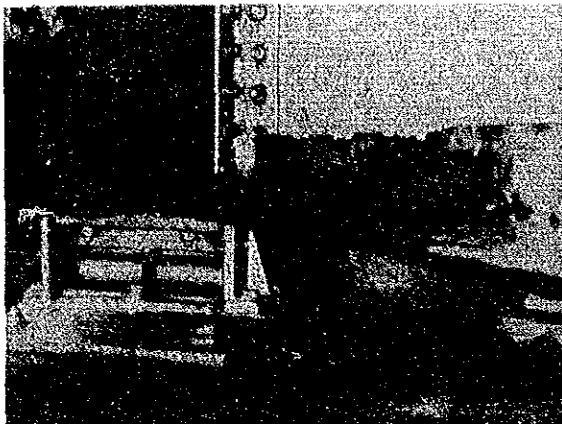
主要部材：

鋼桁の断面欠損

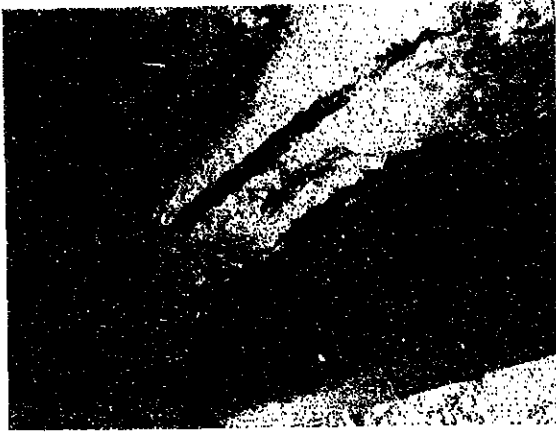
コンクリート桁：

スパン中央のコンクリート桁  
のはげ落ち

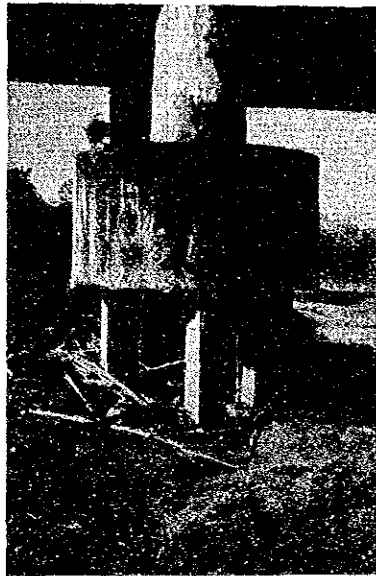
基礎工：

河床の局部洗掘による露出した杭基礎

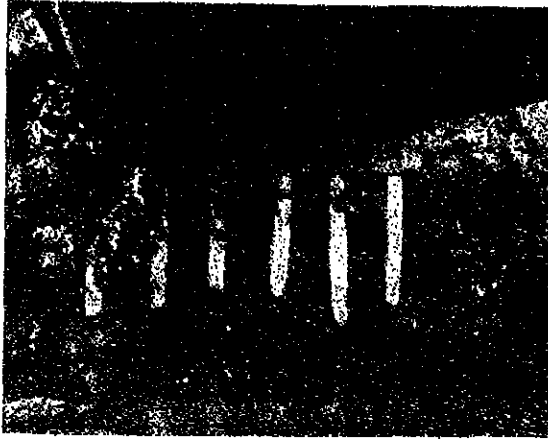
橋台：

法面保護の流失による  
露出橋台

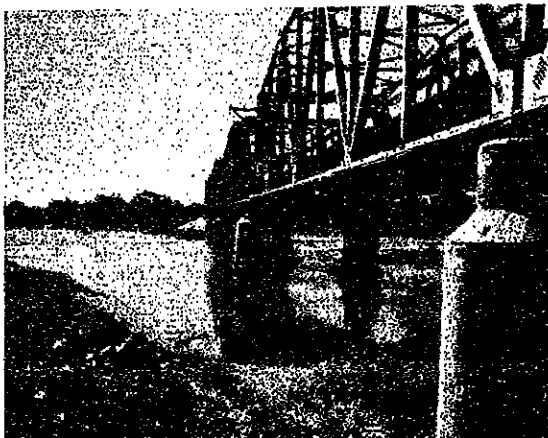
河川流：

橋軸と平行に流れる河川流

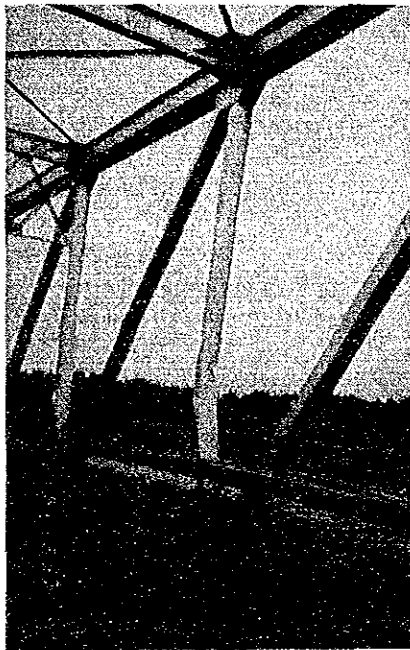
橋梁幅員：

狭い橋梁幅員による車輛衝突の  
損傷
