Republic of the Philippines
DEPARTMENT OF PUBLIC WORKS AND HIGHWAYS

**FEASIBILITY STUDY
ON
REHABILITATION AND MAINTENANCE
OF
BRIDGES ALONG ARTERIAL ROADS**

**FINAL REPORT
VOLUME I
(SUMMARY)**

JUNE, 1989

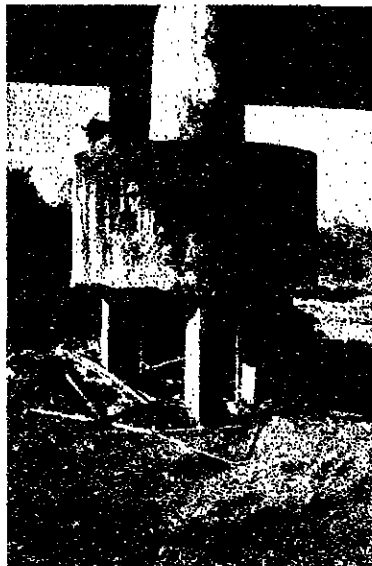
FOUNDATION :

Exposed pile foundation due to local scouring of the river bed

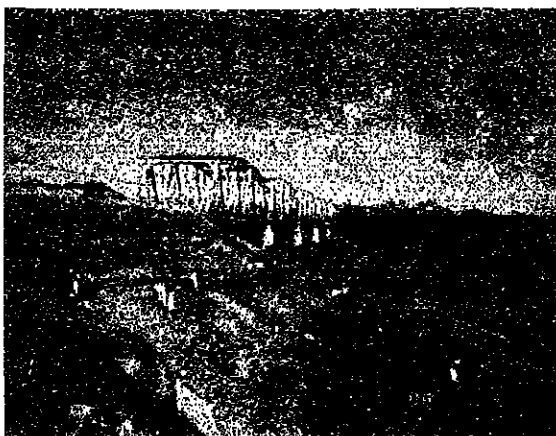
RIVER BANK :

Washed - out river bank under construction

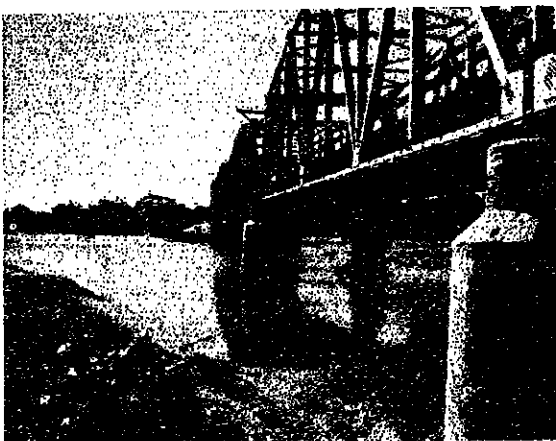
RIVER CURRENT :

River current is flowing in parallel with the bridge axis

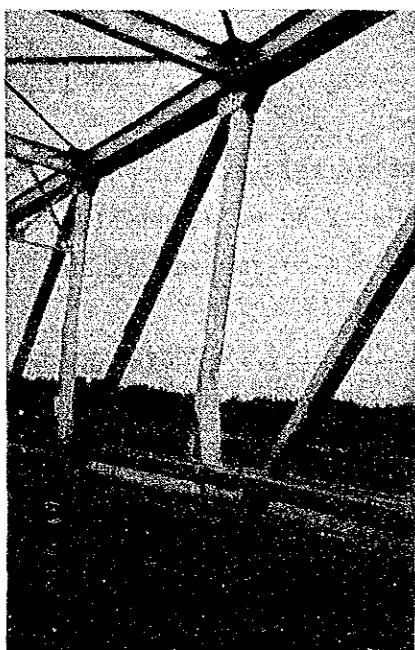
BRIDGE WIDTH :

Damaged by collision of vehicles due to
narrow width of the bridge
