FEASIBILITY STUDY
ON
REHABILITATION AND MAINTENANCE
OF
BRIDGES ALONG ARTERIAL ROADS

FINAL REPORT
VOLUME V
(INSPECTION AND MAINTENANCE REPORT)

JUNE, 1989

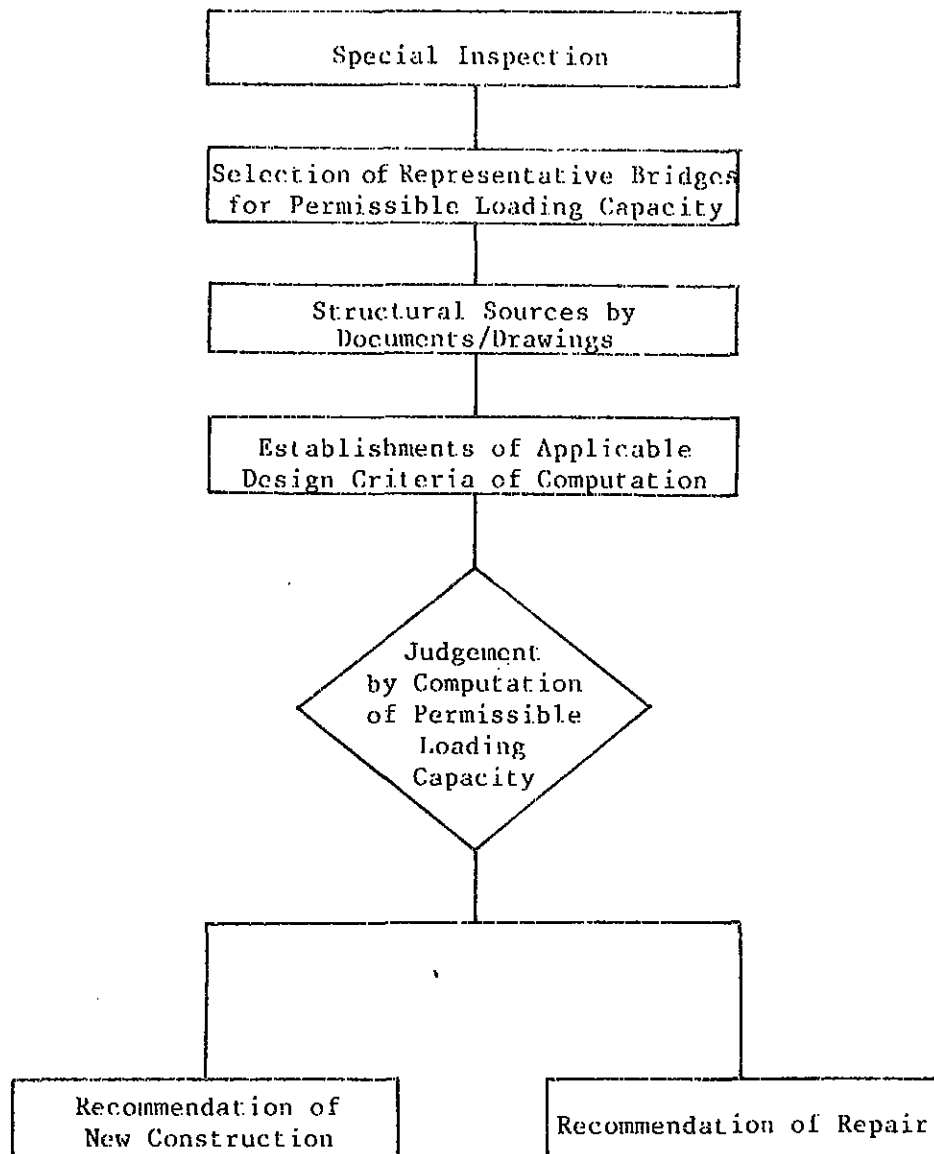
FLOW DIAGRAM FOR JUDGMENT OF NEW CONSTRUCTION OR REPAIR IN ACCORDANCE WITH COMPUTATION OF PERMISSIBLE LOADING CAPACITY

To judge whether rehabilitation or repair of bridge is needed, permissible loading capacity is a prerequisite. For this analysis, M 13.5 (135 KN) loading is considered as critical loading to examine the minimum required duration of the existing bridge. The examining procedure can be referred to the flowing flow diagram for judgement of new construction or repair through computation of permissible loading capacity. The judgement will be made in accordance with the following criterion.

$P < 135 \text{ KN}$: New Construction of Bridge

$P \geq 135 \text{ KN}$: Repair of Bridge

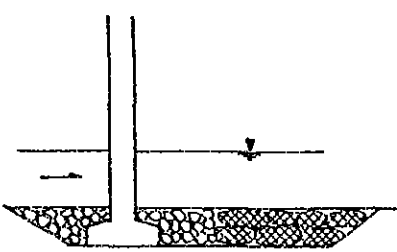
<p>15) River Bed Protection</p> <p>The riverbed around the pier and abutment are protected with gabion, concrete block and pitching stone.</p>

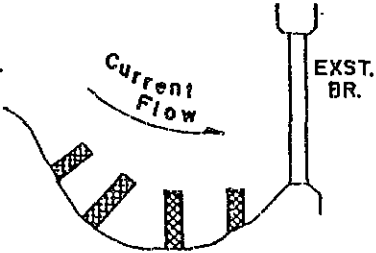
<p>16) Groyne</p> <p>Stone masonry is provided to control river current flow at the place where current flow is rushing or curving sharply.</p>

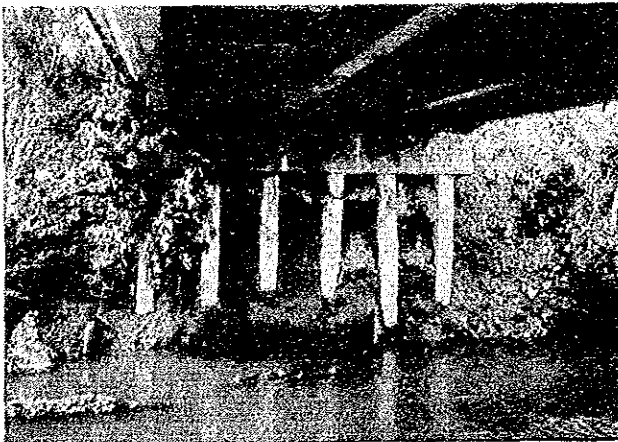
EXPOSED ABUTMENT AFTER
WASHING AWAY OF SLOPE
PROTECTION
