| NO. | (10) | DESCRIPTION | WIDENING PIER CAP/BEARING SHEET | | |

| REHABILITATION | | METHOD | SHEET NO. |
|---|---|---|---|
| 1. | REFERENCE: | BR. NO. 54 TAGAMUSING, REGION - II | |

| NO. | (11) | DESCRIPTION | REINFORCEMENT OF SUBSTRUCTURE (1) | |

CHAPTER 5
INSPECTION AND MAINTENANCE FOR
MAGAPIT SUSPENSION BRIDGE

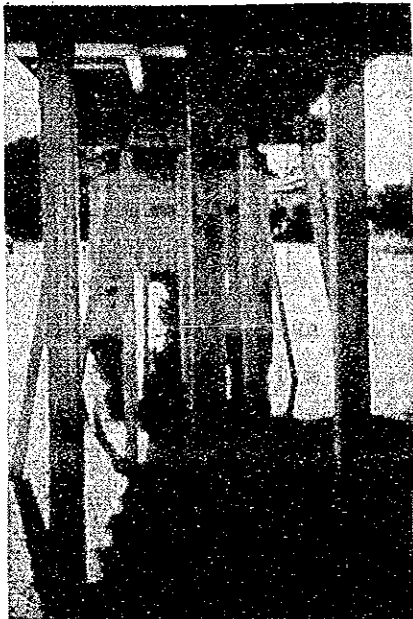
BENT PILE DESIGNED
LOW STANDARD CRITERIA

| REHABILITATION | | METHOD | SHEET NO. | 36/49 |
|---|---|---|---|---|
| - To replace the low standard pier into appropriate standard pier. | | | | |

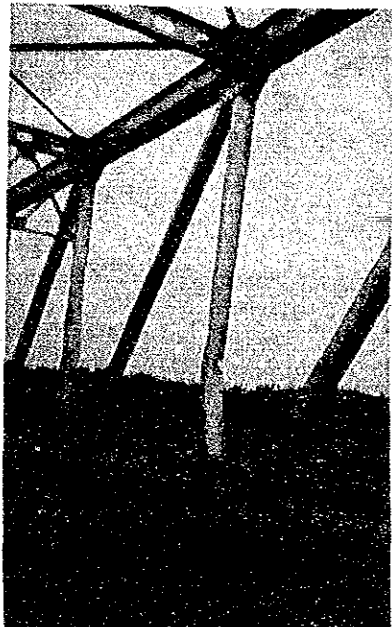
PHOTO 2

BRIDGE WIDTH:

Damaged by collision of
vehicles due to narrow width
of the bridge

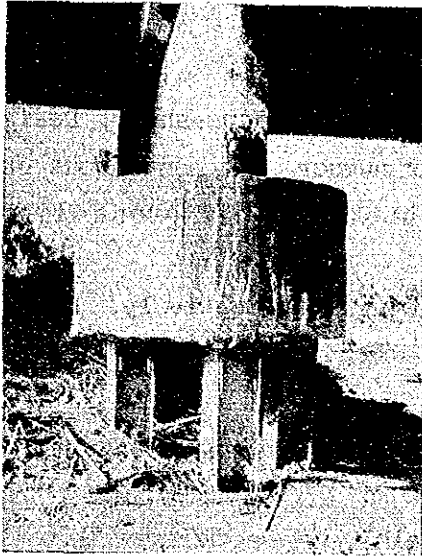
PHOTO 7

FOUNDATION:

Exposed pile foundation due to local scouring of the river bed

- Check on whether piles are exposed by scour (PHOTO 7). In cases where the piles are exposed, check loss of section through scaling and spalling.
- Check the settlement. Differential settlement can cause serious damage to the abutments and piers. Damage due to differential settlement is often seen as crack between adjoining wing wall or in the abutment stem. Uniform settlement of all the foundations of a bridge may have little effect upon the structures. However, a simply supported stringer bridge and a continuous bridge are more susceptible to these damages even on the uniform settlement.

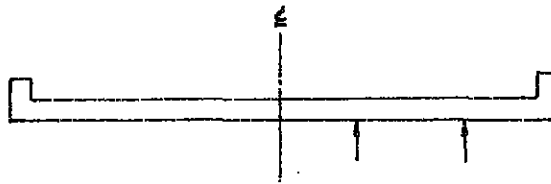
2) Location of test pits

a) RCDG

b) Concrete Slab
