BASIC DESIGN STUDY REPORT  
ON  
THE PROJECT  
FOR  
THE IMPROVEMENT OF RURAL WATER SUPPLY  
IN  
THE REPUBLIC OF THE SUDAN

MAY, 1989

JAPAN INTERNATIONAL COOPERATION AGENCY

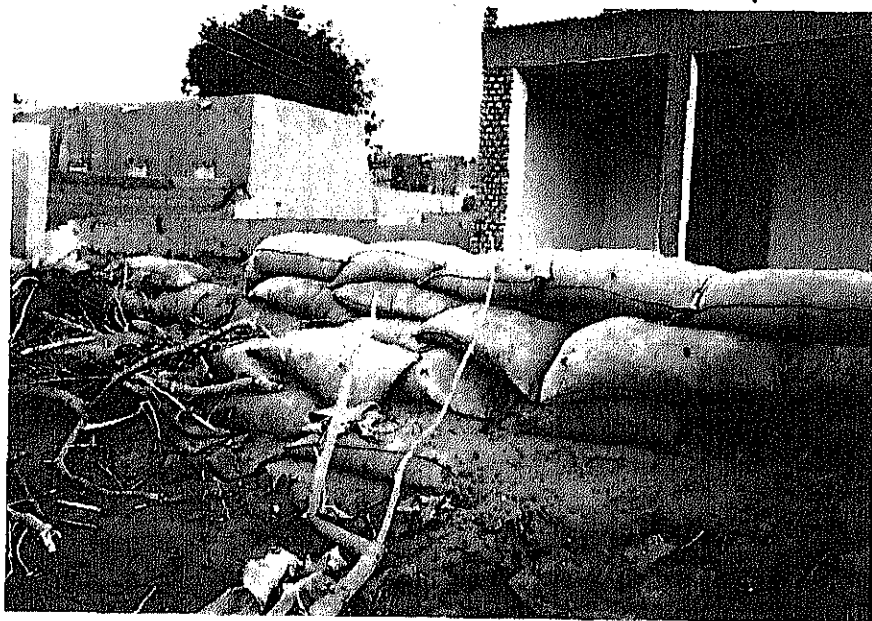
TEMPORARY BARRIER (MADE BY SAND BAGS) FOR  
FLOOD PROTECTION AT HOSH BANAGA VILLAGE, SHANDI

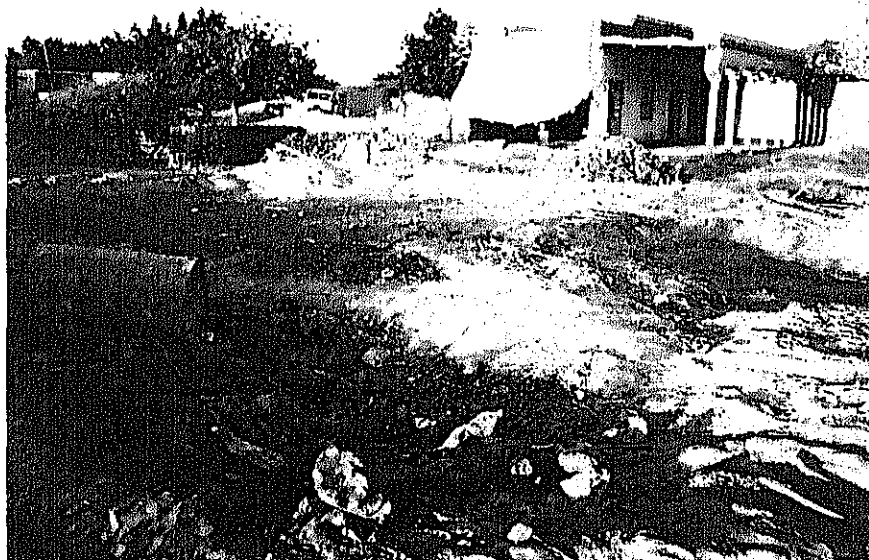
SITUATION OF FLOOD DAMAGE AT HOSH BANAGA VILLAGE, SHANDI

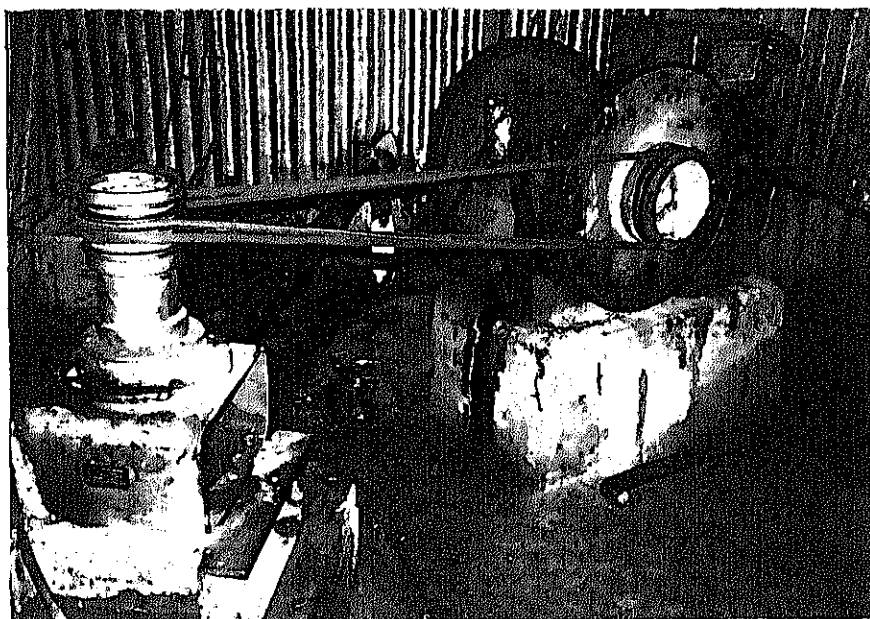
EXISTING WATER YARD INSTALLED AT HOSH BANAGA VILLAGE, SHANDI  
(PUMPING SYSTEM WHICH REHABILITAION FOR FLOOD DAMAGE IS NECESSARY)

Due to the flood of 1- to 2-meters above the river water level, existing water supply facilities are forced to stop operation with pumping machines (diesel engine driven, bore hole pump with a belt) submerged and the shafts and the engines badly rusted. Furthermore, the vast inflow of sand accompanying the flood caused pump houses, elevated tanks, and fences to be submerged 50 cm underground. Some elevated tanks were slanted after their foundations were washed away in the flood.

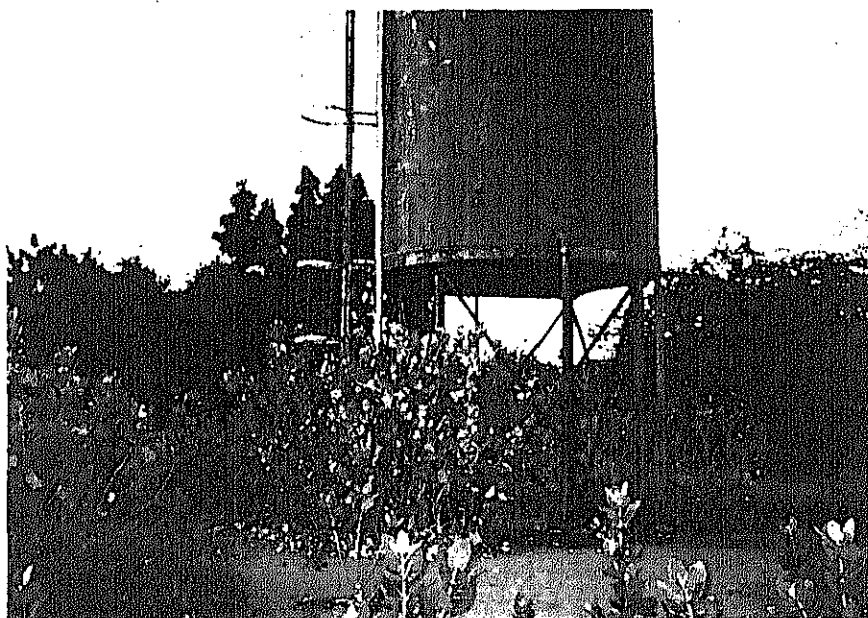
EXISTING WATER YARD INSTALLED AT HOSH BANAGA VILLAGE, SHANDI  
(INCLINATION OF ELEVATED TANK DUE TO FLOOD DAMAGE)

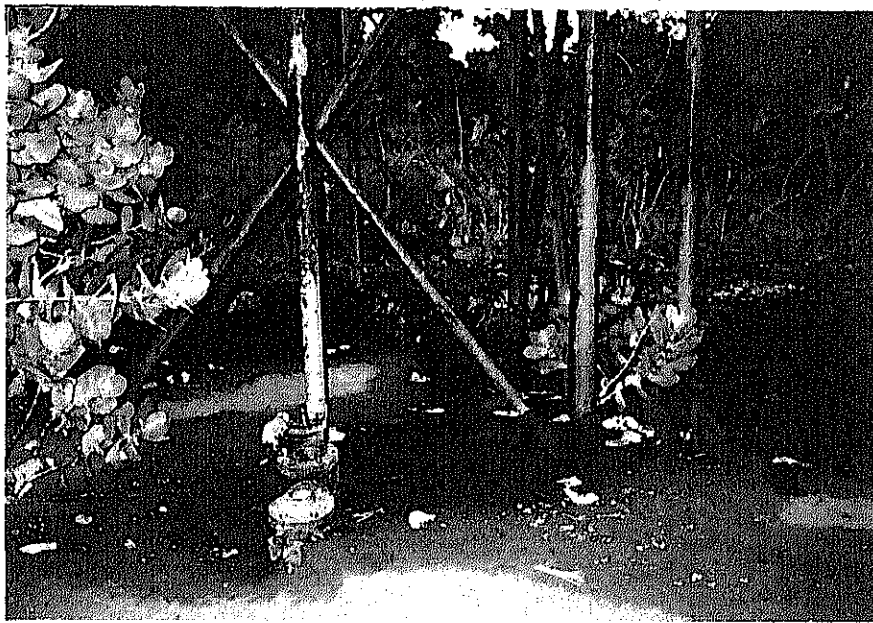
EXISTING WATER YARD INSTALLED AT HOSH BANAGA VILLAGE, SHANDI  
BURIED BASE OF ELEVATED TANK DUE TO INFLOW OF SAND CAUSED  
BY FLOODING OF THE NILE

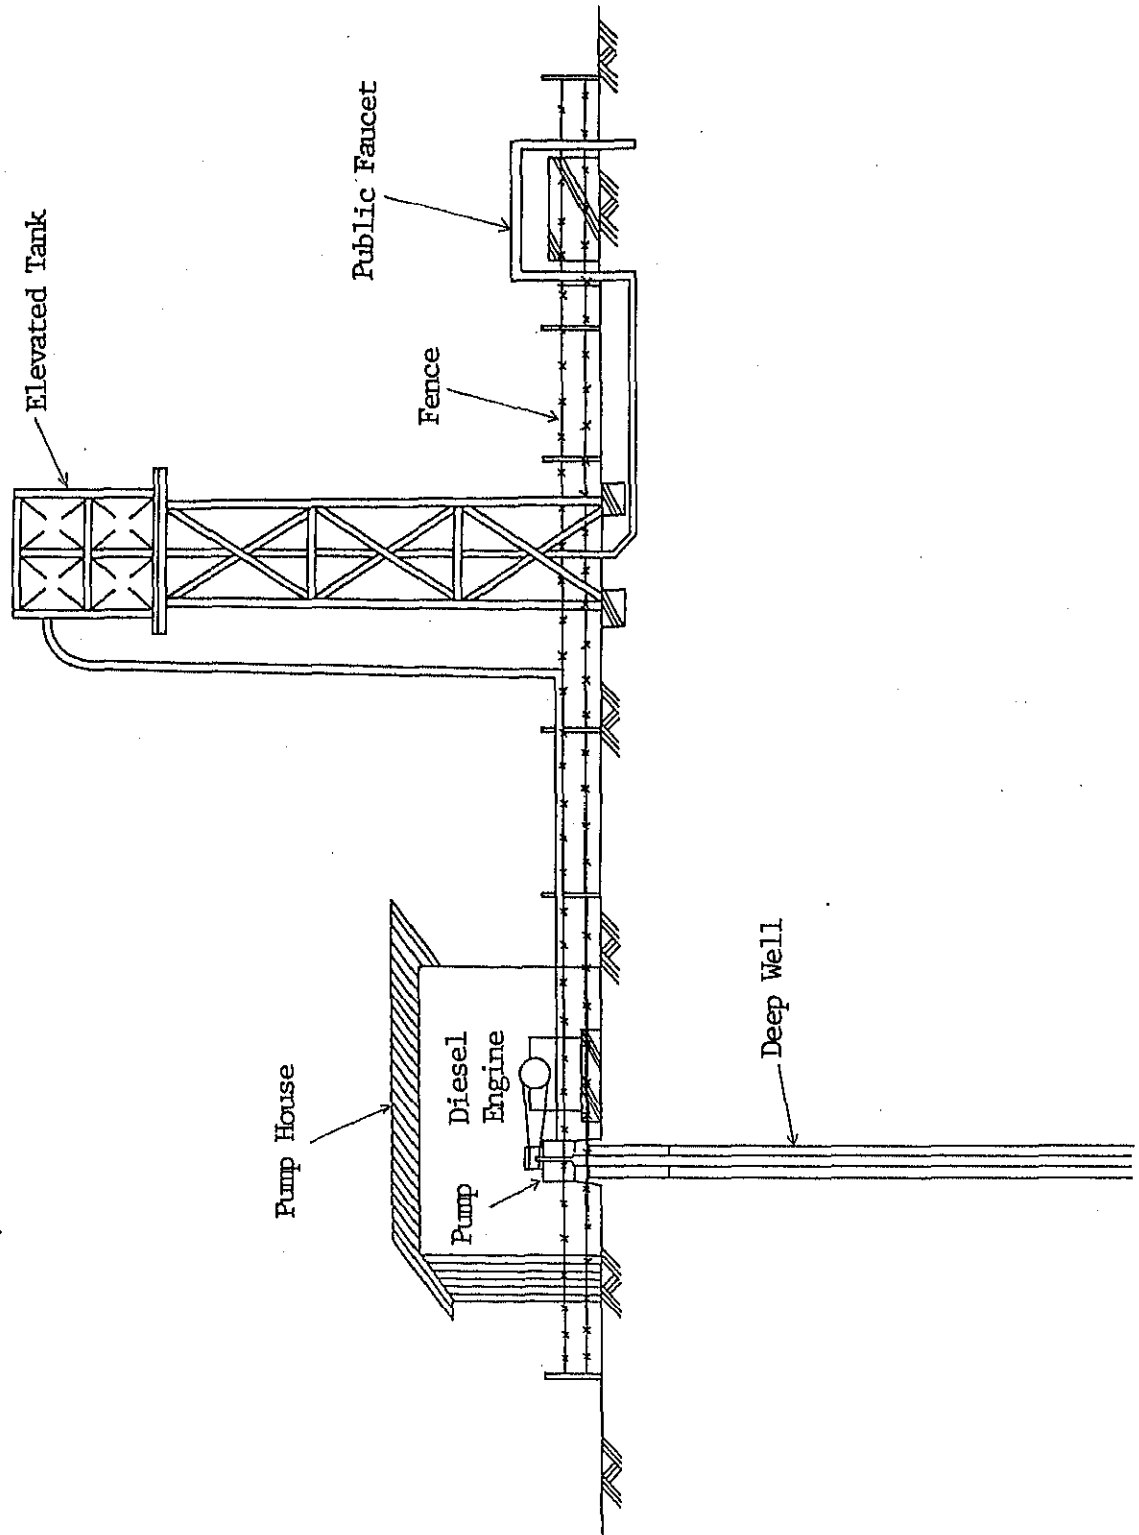
Fig. 4-1 Typical Drawing of Water Supply Facility  
(Water Yard)

Of these water supply facilities, water yards are widely distributed throughout the nation, water facilities using surface water are operated in certain limited areas along the Nile, and hafirs are only used in the Central, Kordofan, and Darfur Regions that have a relatively stable amount of rainfall. While hand pump facilities with a bore hole are most frequently observed in the Kordofan Region, hand pumps with shallow wells are mostly used in other areas. However, the latter is a private property in most cases, as are also hand-dug shallow wells.

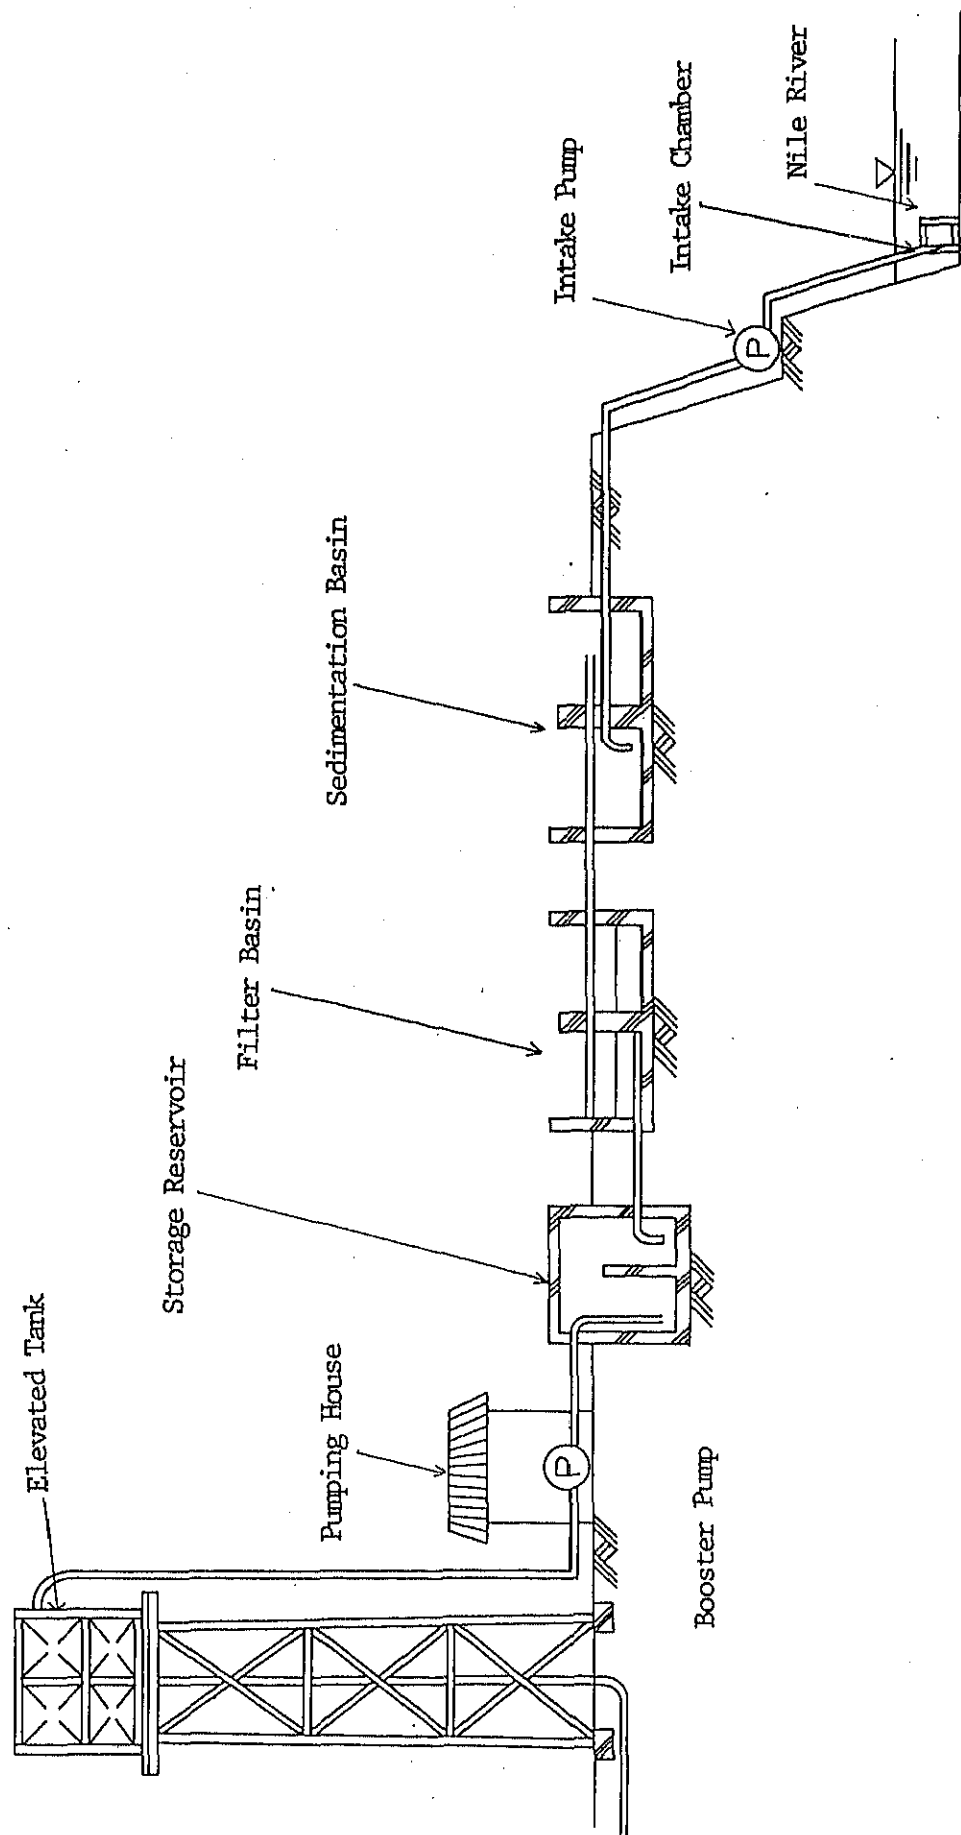
Fig. 4-2 Typical Drawing of Water Supply Facility  
(Water Supply Facility Using Surface Water)

Water supply facilities using surface water function in the following manner: 1) pumping up water (muddy water containing clay and organic substances) from the Nile; 2) feeding the water into a sedimentation basin, filtering basin, and storage tank located close to the river bank; 3) sending the water up to an elevated tank. Booster pumps were submerged and badly rusted as in the case of pumping machines in water yards. Some concrete sedimentation basins and filtering basins (5 m in diameter and 4 m in depth) were forced out of use with their bottom submerged by the vast inflow of river water and sand.
