GEOLOGICAL DATA

1. DRILLING LOGS

GOVERNMENT OF MALAYSIA
STUDY
ON
KELANTAN RIVER BASIN - WIDE FLOOD MITIGATION
JAPAN INTERNATIONAL COOPERATION AGENCY

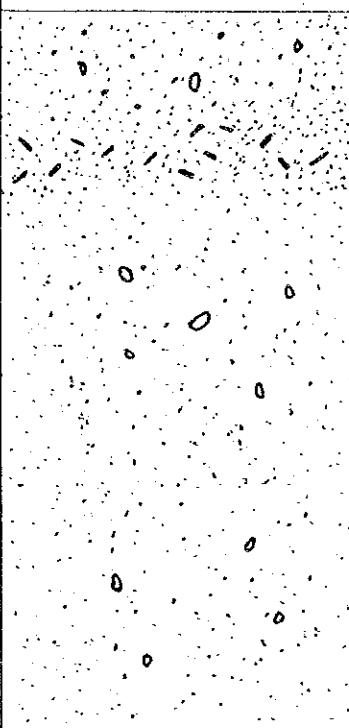
Test - Pit No : D.TP - 1 Method of Excavation : Man power

0 - 2.00m <u>SAND</u> Medium, with many mica flakes scattered gravel up to 3 cm maximal size, well-sorted, dry, yellowish - brown	SA - 2	0.75m
0.3m 0.5m		0.30 - 0.50 m Containing approximately 10% wood fragments by volume.		
1.0m				
2.0m

REMARKS: 5m in distance between D.TP-1 and D.TP-1
Ground - surface uncovered by plants

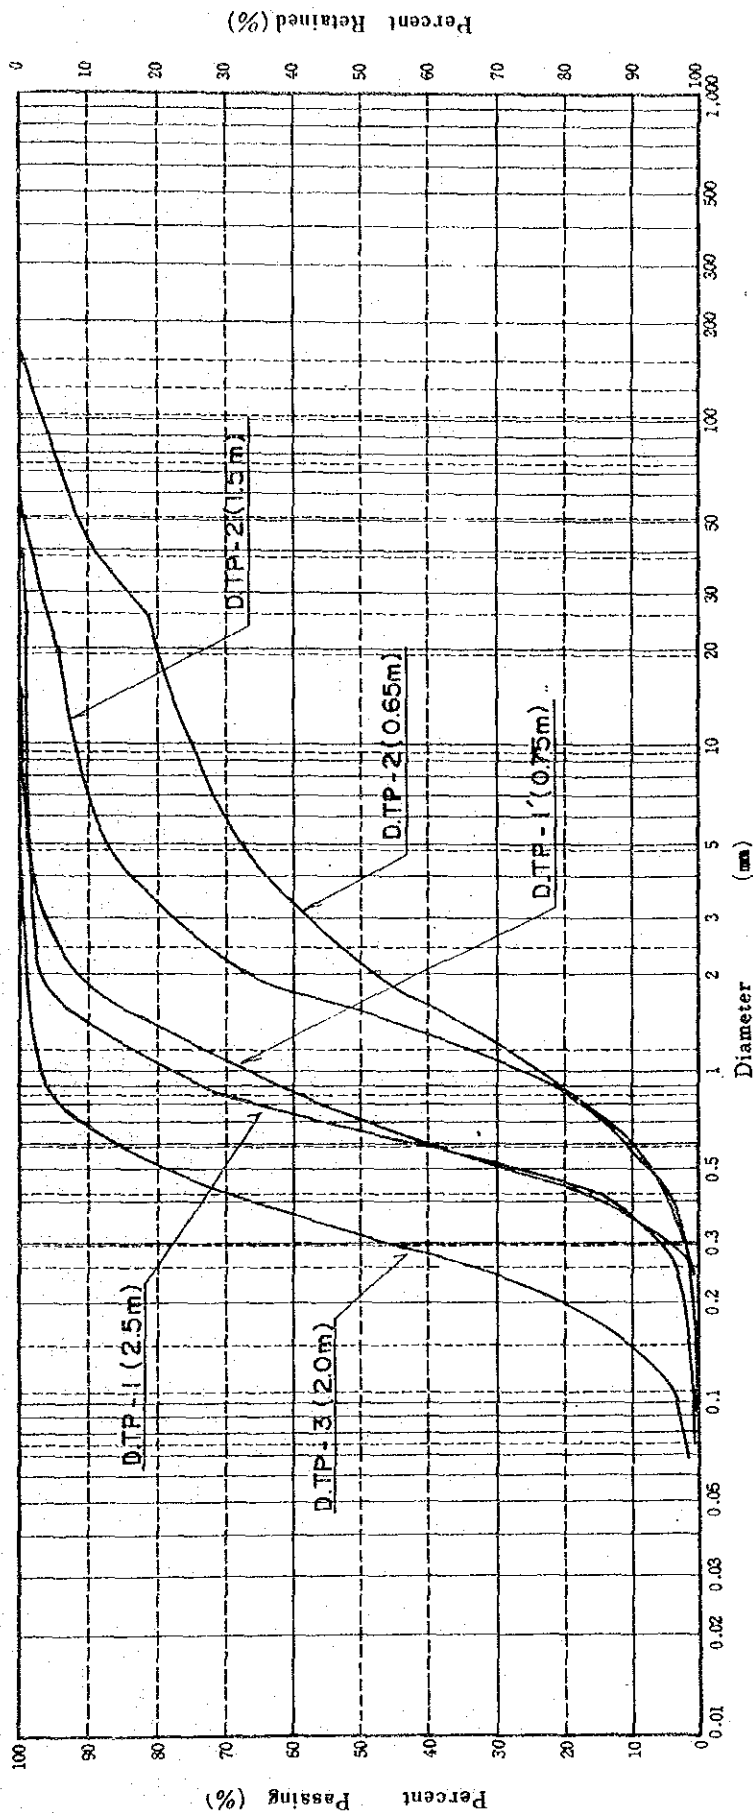
Gradation Curves of Test - pits for Dabong Dam.

Test - pits for Dabong Dam site

Clay to Silt (Fines)	Sand		Gravel		Cobbles	Boulders
	fine	medium	coarse	coarse

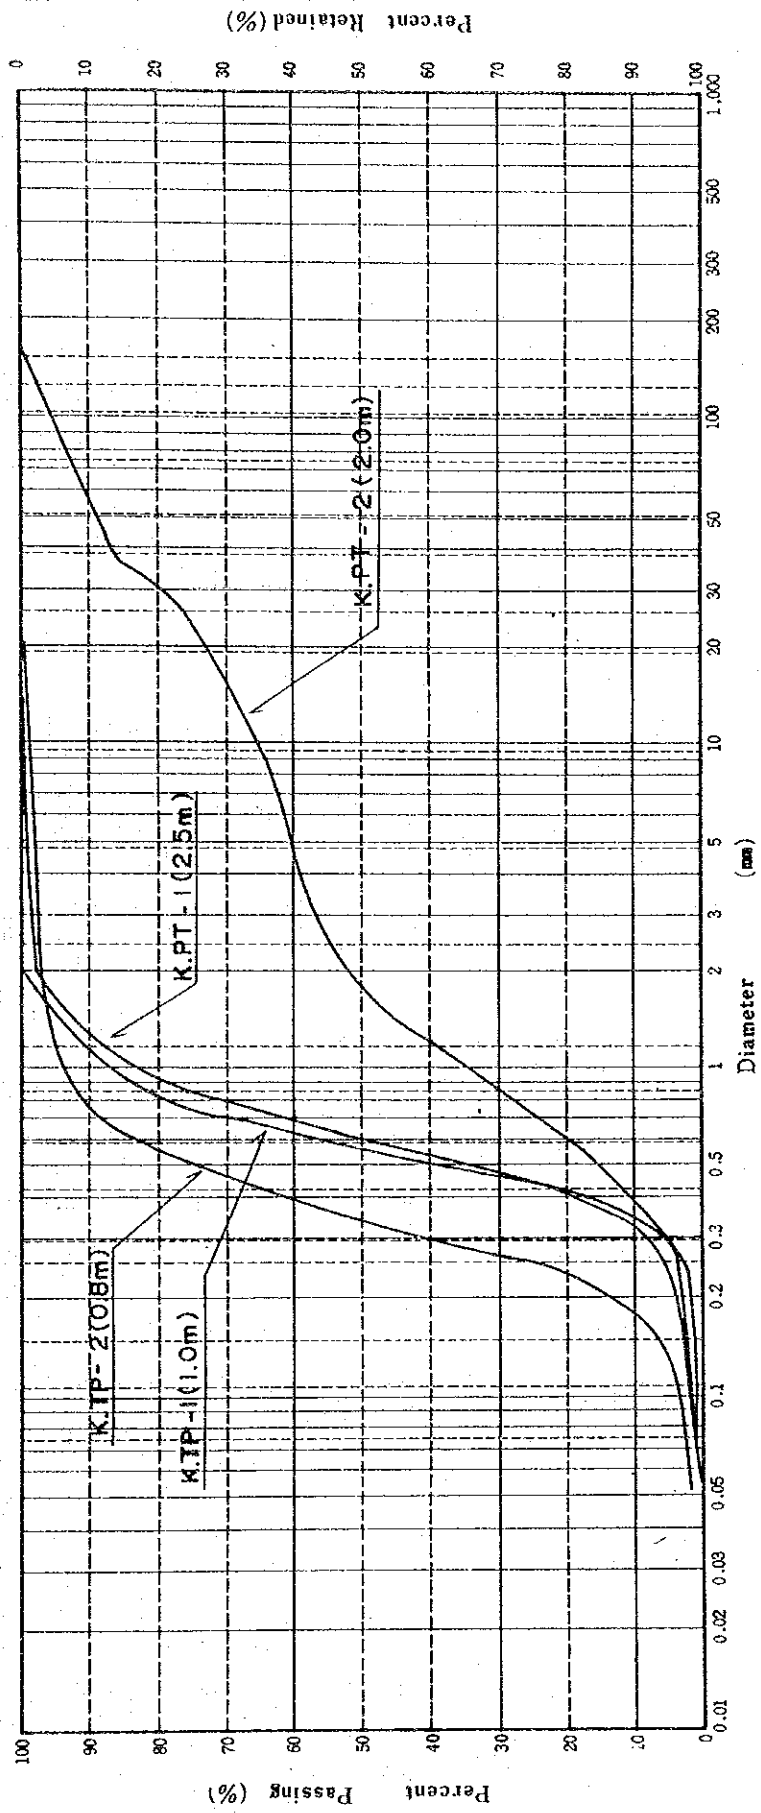
Gradation Curves of Test - pits
for Kemubu Dam

Test - pits for Kemubu Dam site
