PROGRESS REPORT
ON
FEASIBILITY STUDY AND PRELIMINARY DESIGN
OF
SOUTHERN COASTAL LINK ROAD PROJECT

November, 1975

JAPAN INTERNATIONAL COOPERATION AGENCY

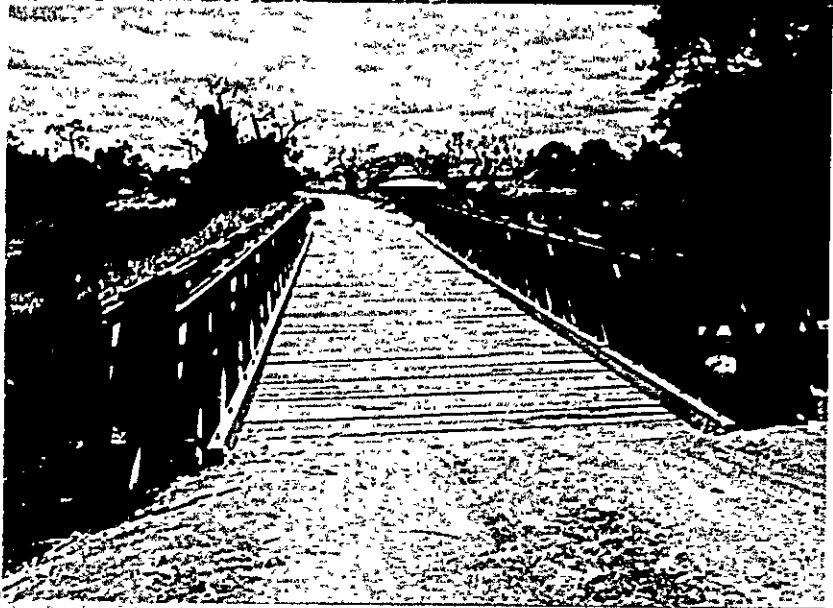
Photo.-2

The heighest Water
Level of the Mavuji
River in the past.

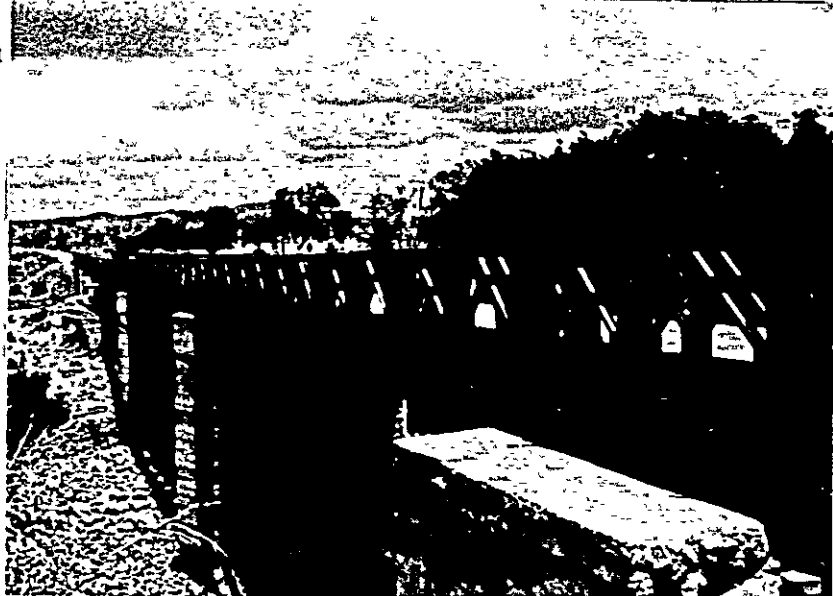
Photo.-3

The heighest Water
Level of the Mbwemkuru
River in the past.

As regards the Mbwemkuru River, stability of river channel and condition of cross-sectional area of river are better than that of other two rivers because movement of river channel stopped at the left side hill and the river bed was scored to give enough cross-sectional area to discharge the flood.
