**BASIC DESIGN STUDY REPORT
ON
THE PROJECT
FOR
RECONSTRUCTION OF BRIDGES
IN
KATHMANDU
THE KINGDOM OF NEPAL**

MARCH 1990

JAPAN INTERNATIONAL COOPERATION AGENCY

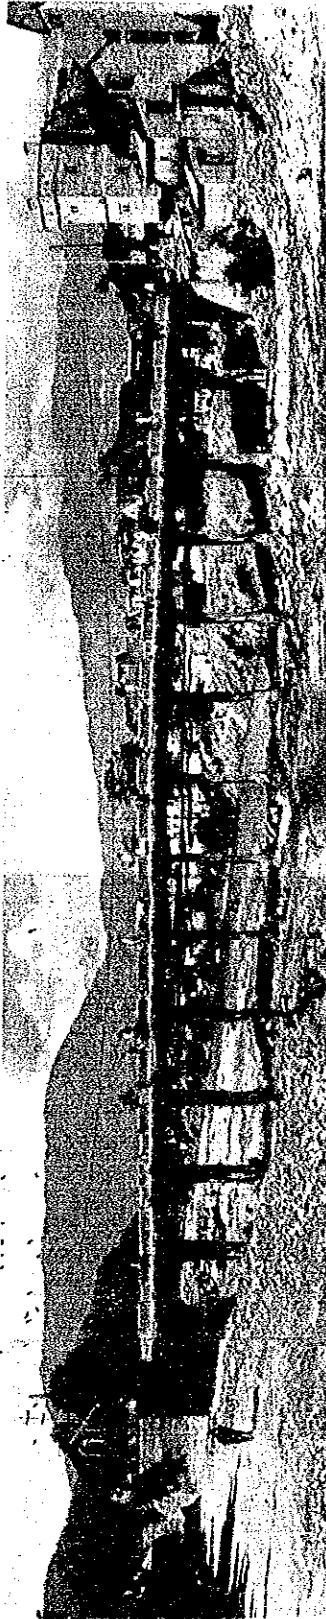
(1) No.2 Bishnumati (Dallu)

Bridge Type : Wooden Bridge Bridge Length : 56m

Bridge Width : 3.0+2X1.5=6.0 m Approach Road Width : 5.5m~8.0m (Right), 4.0m~9.0m (Left)

Circumstances : Not passable to vehicles. Serious disruption during construction is not allowed because of the high number of pedestrians. There are buildings near each existing abutment. There is general progressive scouring of the riverbed in this vicinity.

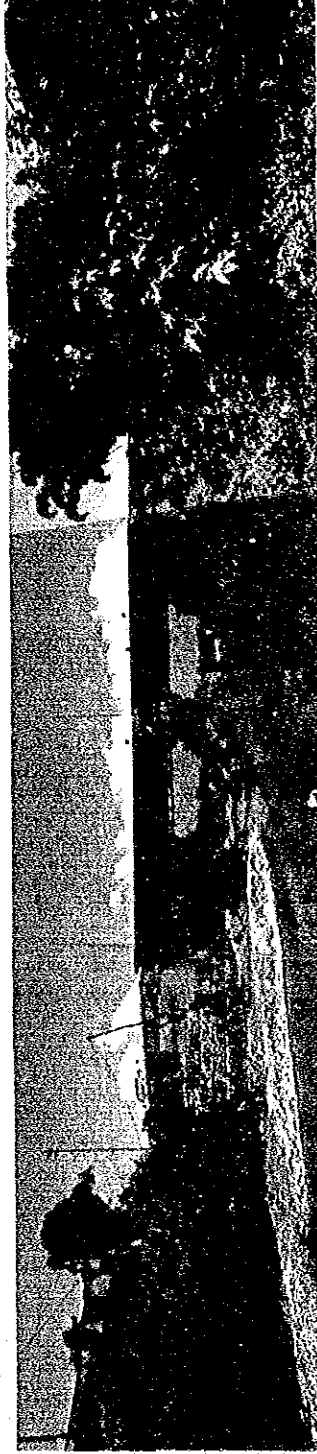
(2) No.4 Dhobi Khola (Kalo Pul)

Bridge Type : Half-Through Steel Plate Girder Bridge

Bridge Length : 44m

Bridge Width : 4.0m

Approach Road Width : 5.1m~8.6m (Right), 7.0m~9.0m (Left)

Circumstances : A lot of vehicles pass over the existing bridge linking the city area and Chabahil. Vehicles cannot pass on the bridge because of the inadequate width. There is progressive local scouring around the existing piers.

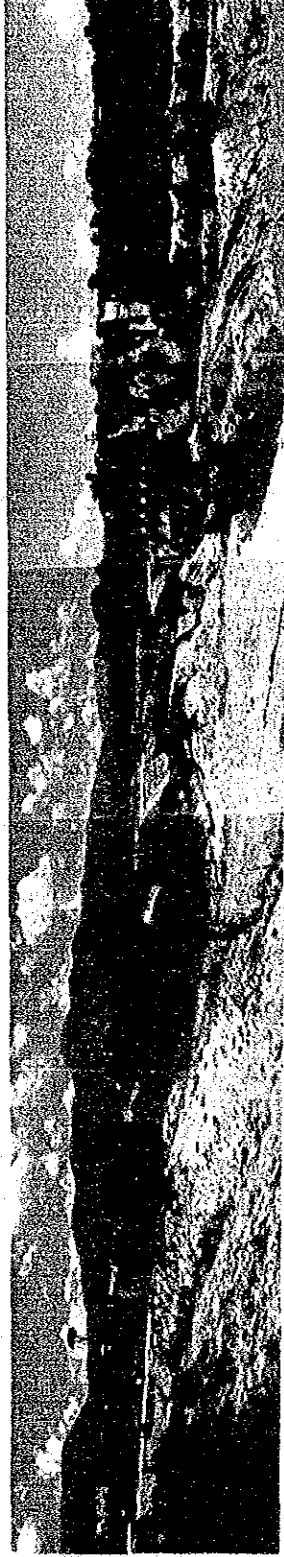
(3) No.6 Dhobi Khola (Handi Gaon)

Bridge Type : The bridge type, width and length cannot be confirmed as it has been washed away.

Approach Road Width : 5.6m~6.7m (Right), 4.2m~6.5m (Left)

Circumstances : The wreckage of the bridge remains at the bridge site. Pedestrians cross the stream by stepping on logs.
The bridge is in an important position linking Handi Gaon and the Chabahil area.

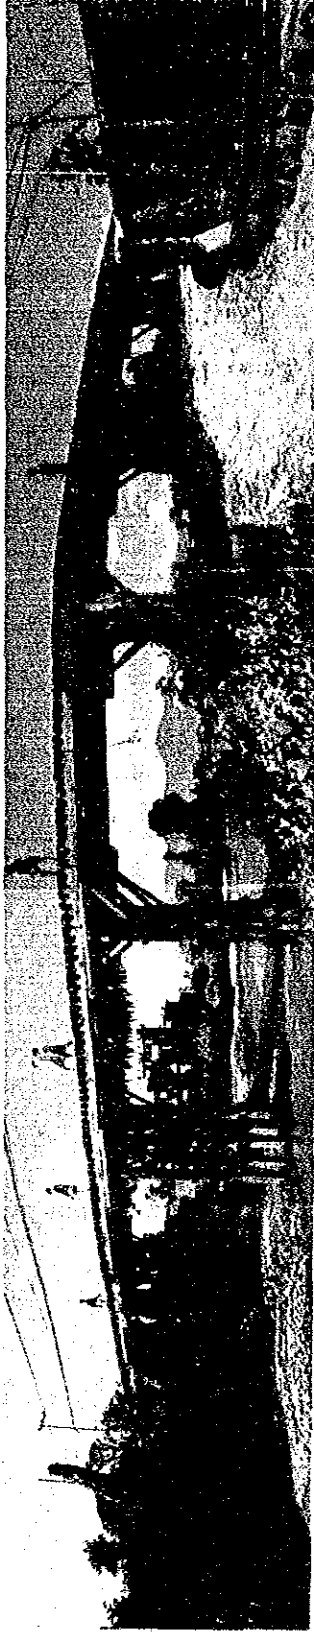
(4) No.7 Dhobi Khola (Babar Mahal)

Bridge Type : Wooden Bridge

Bridge Length : 56m

Bridge Width : 3.5m

Approach Road Width : 4.6m~6.5m (Right), 4.6m~6.5m (Left)

Circumstances : The bridge is mainly used for pedestrians from the surrounding residential area. The wooden structure is badly dilapidated and the piers show signs of severe settlement.

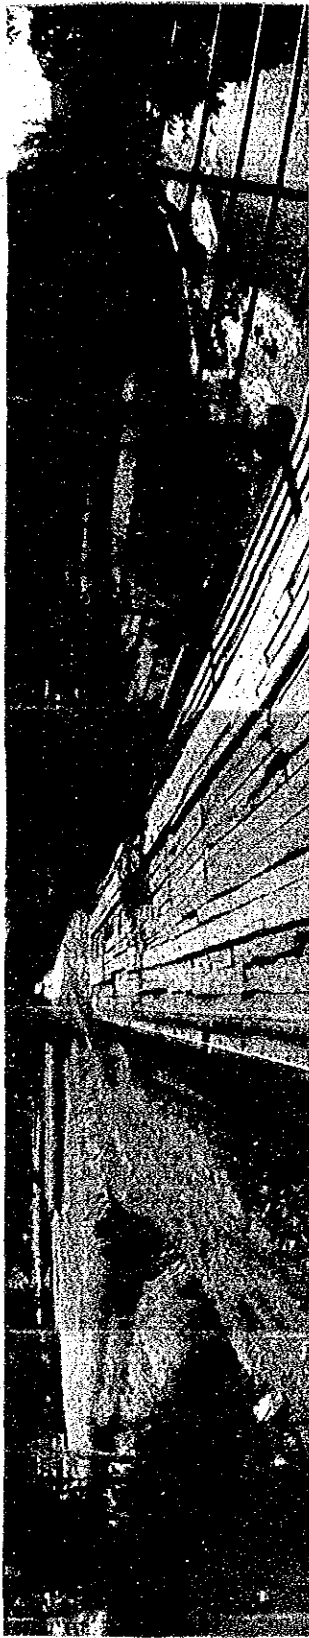
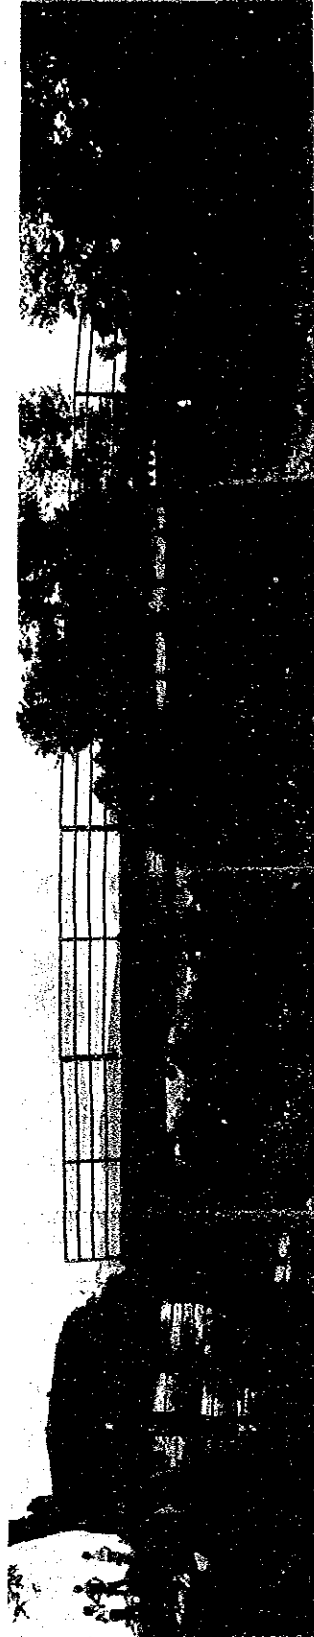
(5) No.8 Mahadev Khola

Bridge Type : Wooden Bridge

Bridge Length : 42m

Bridge Width : 3.9m

Approach Road Width : 5.5m (Right & Left)

Circumstances : The wooden bridge crosses Mahadev Khola river at a rice paddy field. Since the bridge structure is severely dilapidated, it is not usable. There is a temporary detour provided on the upstream side.

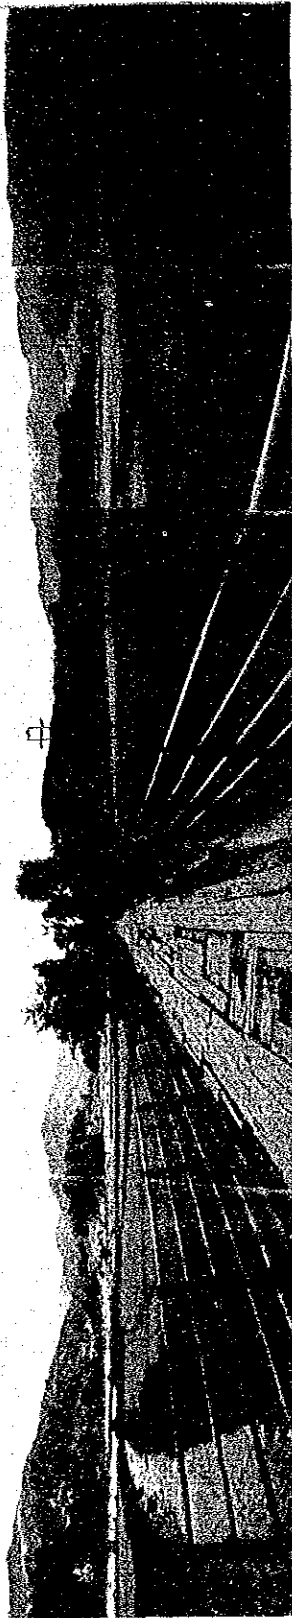
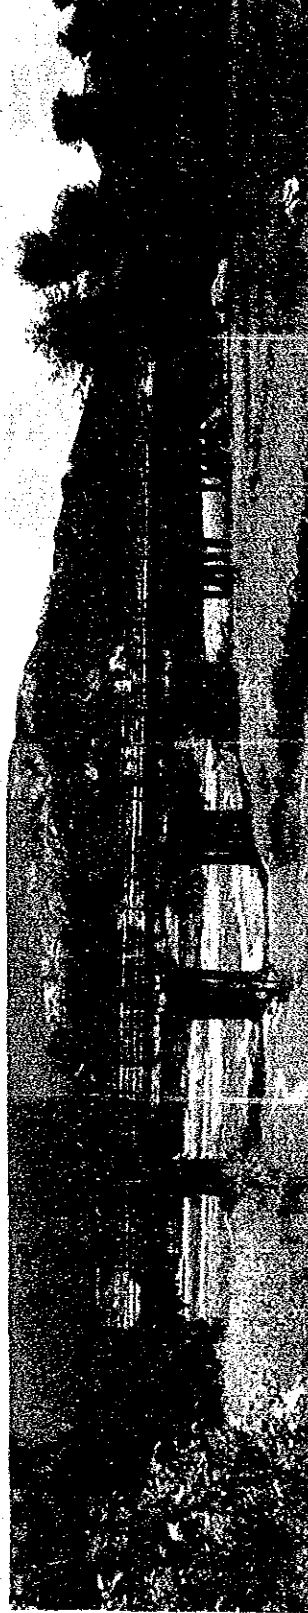
(6) No.9 Manmatta

Bridge Type : Wooden Bridge

Bridge Length : 42m

Bridge Width : 3.9m

Approach Road Width : 5.5m (Right & Left)

Circumstances : The bridge, like the Mahadev Khola bridge, is located on the route connecting Kathmandu city area and Sankhu. It is not usable due to severe dilapidation.
