**FEASIBILITY STUDY
ON
SMALL-SCALE POWER PLANTS
REHABILITATION PROJECT
IN
THE REPUBLIC OF COLOMBIA**

**SILVIA HYDROELECTRIC
POWER PLANT**

MARCH 1990

Japan International Cooperation Agency

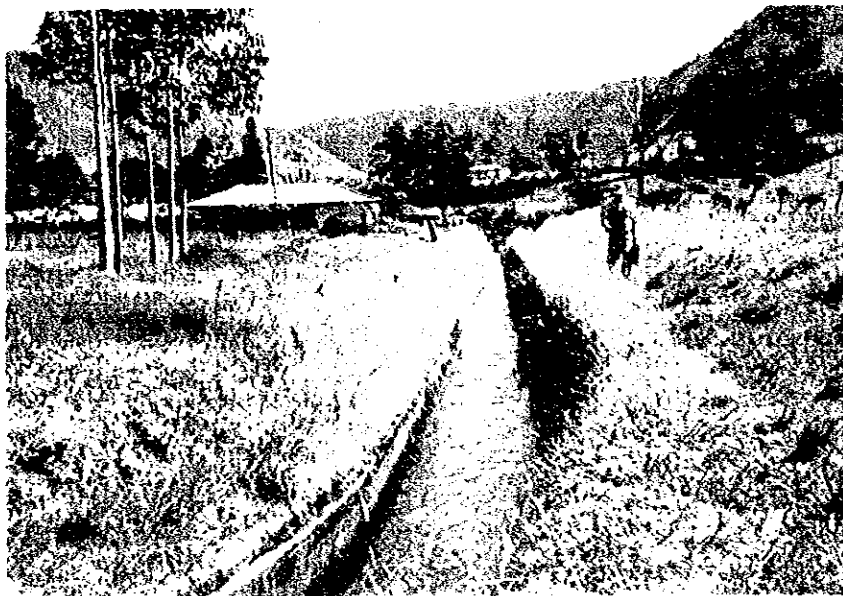
Conduction channel

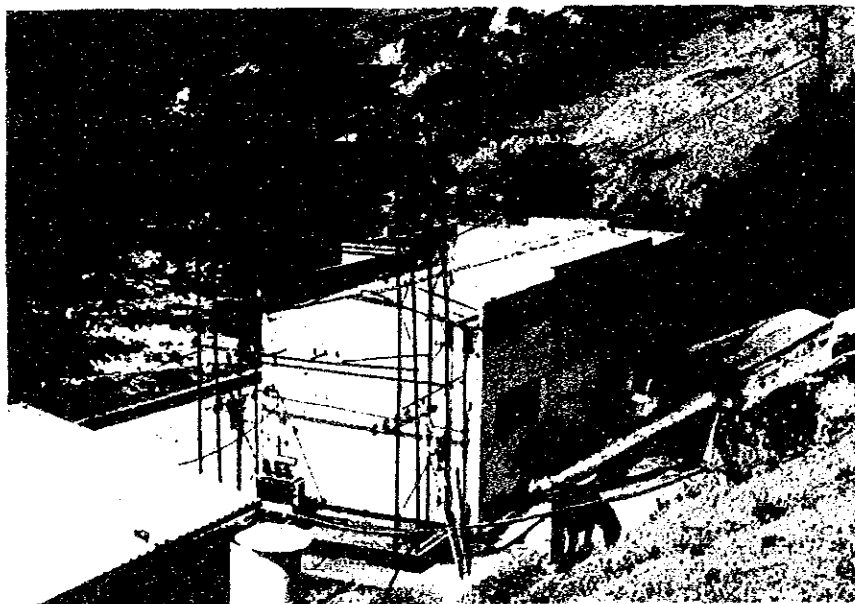
Powerhouse

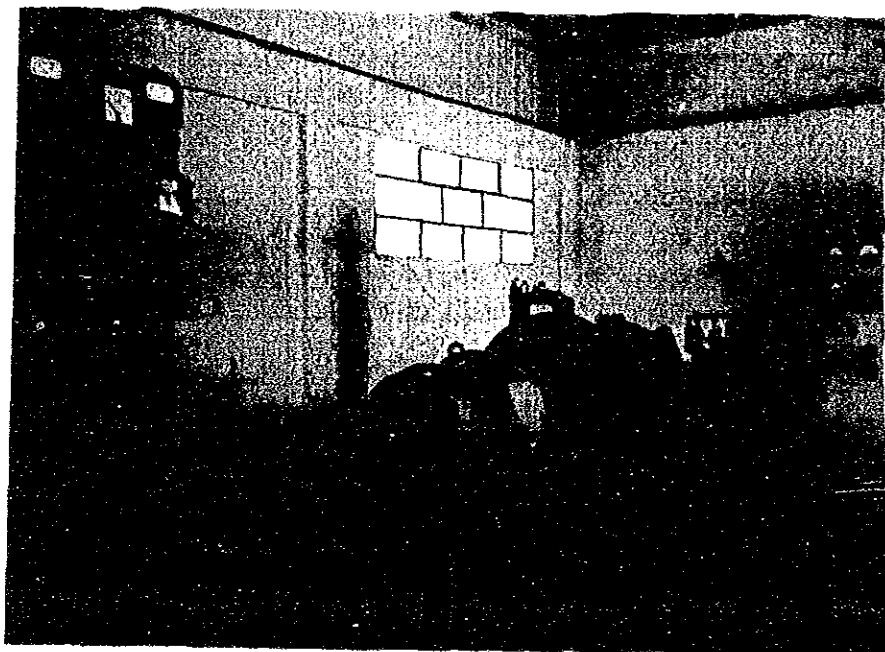
100kW Francis turbine and generator

Since the turbine (104 kW), manufactured in 1960, has been used only for 30 years, the facility utilization factor during the latest five years is 90%, and the operation rate of the facility is 92%. According to a survey conducted by CEDELCA, no defect was found in the turbine and generator. On the other hand, the turbine (500 kW) manufactured in 1954 has not been used and left unattended for 18 years since its breakdown in 1972, it might not be reused.

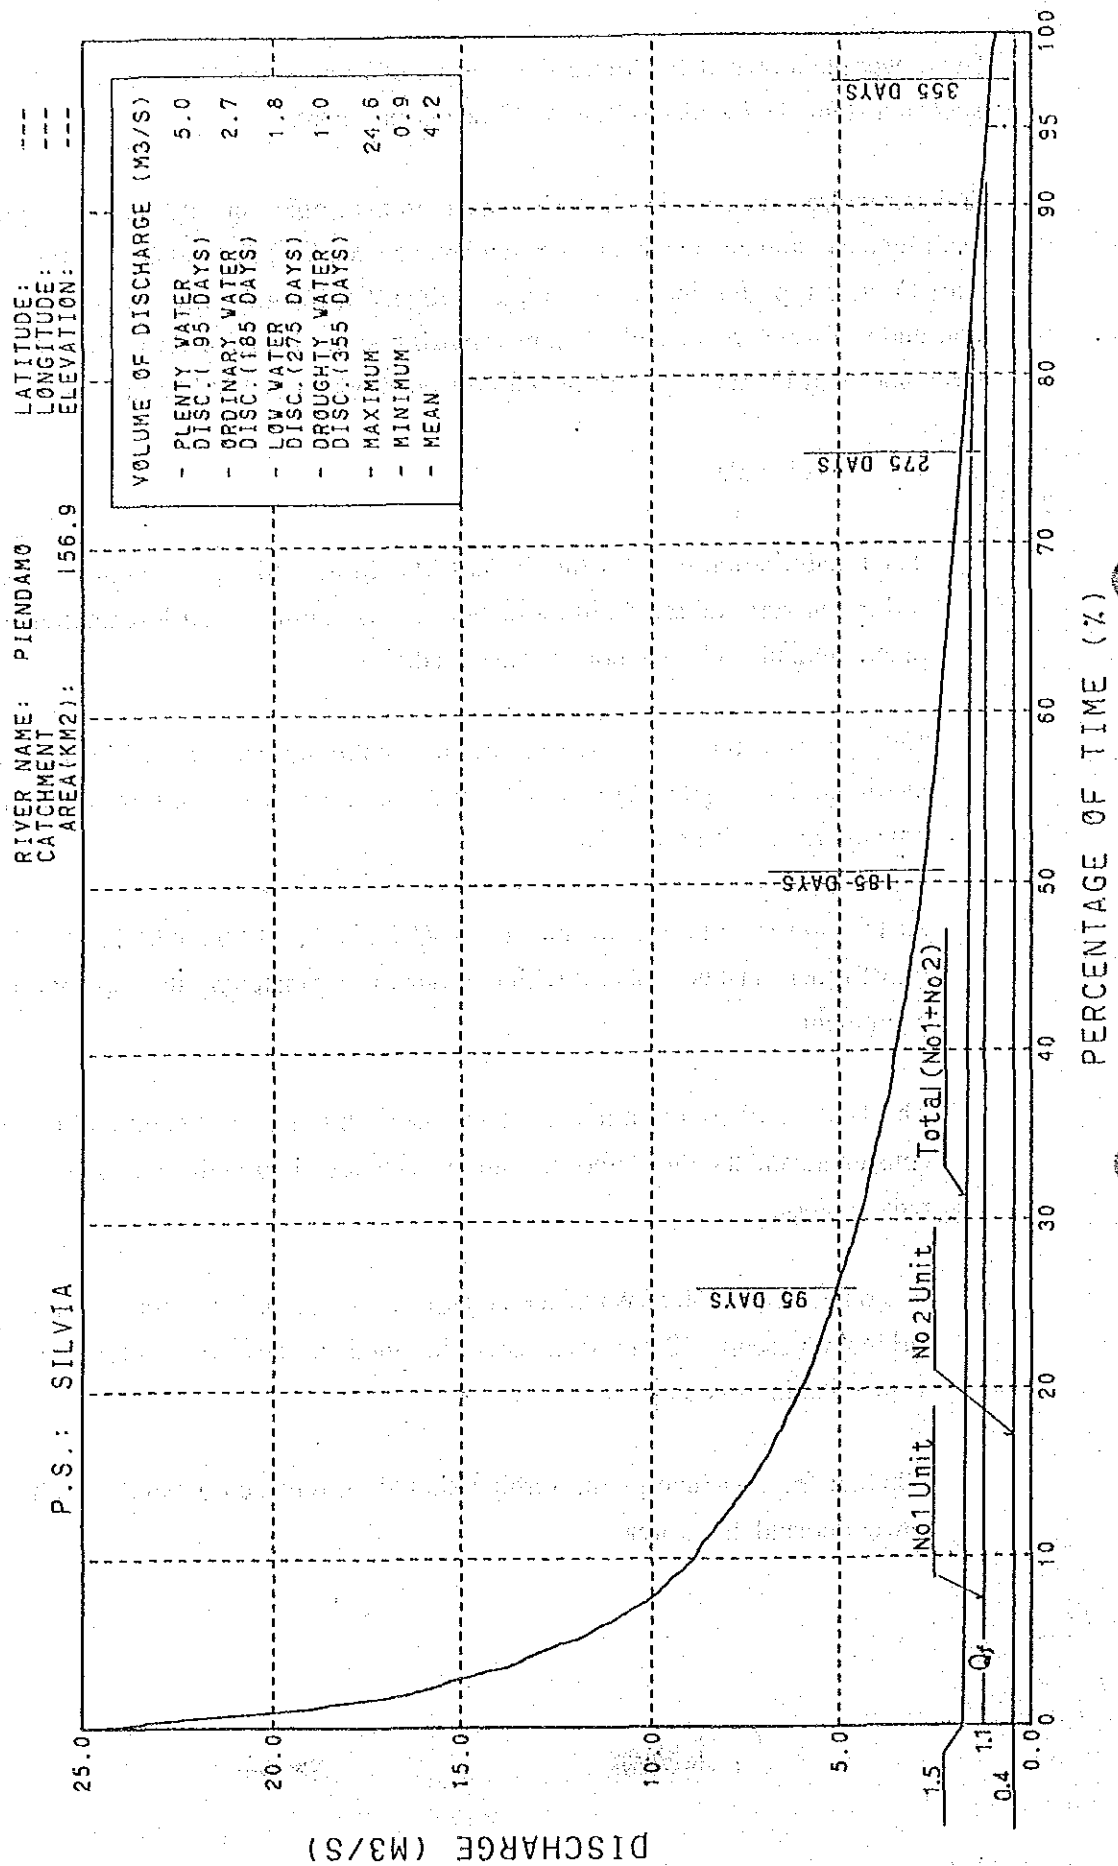
Fig-2.1 TYPICAL FLOW DURATION CURVE AT INTAKE SITE

Judging from the stream regime of the intake site shown in Fig. 2.1, the planned available discharge of $Q=1.5 \text{ m}^3/\text{s}$ might be the appropriate rate for the run-of-river type hydroelectric power plant.

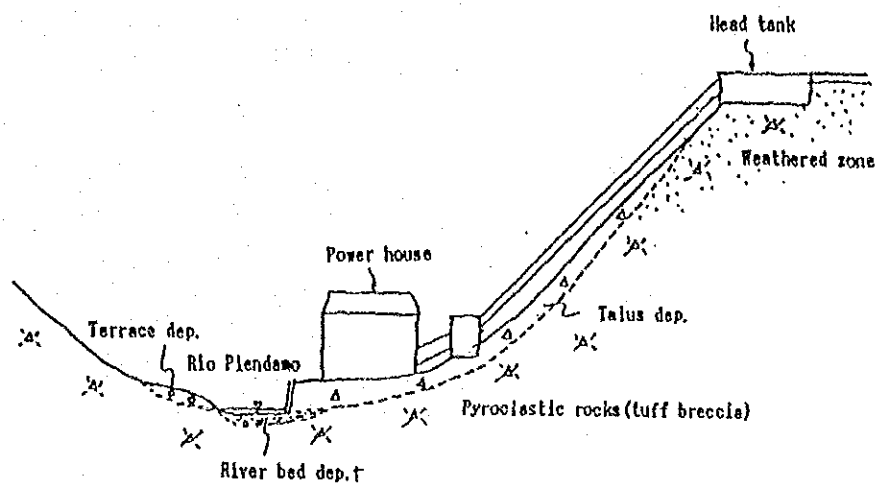
Fig. 6.1 Schematic Geological Profile

The head tank and the desilting basin are built on pyroclastic rocks. The penstocks are built on talus deposit. A small spring was observed at a low elevation area.

Talus deposits are distributed over on the pyroclastic rocks in the vicinity of the powerhouse. The powerhouse building is built on talus deposit and backfilled gravel. The rock surface is presumed to be of the same level as the existing riverbed.

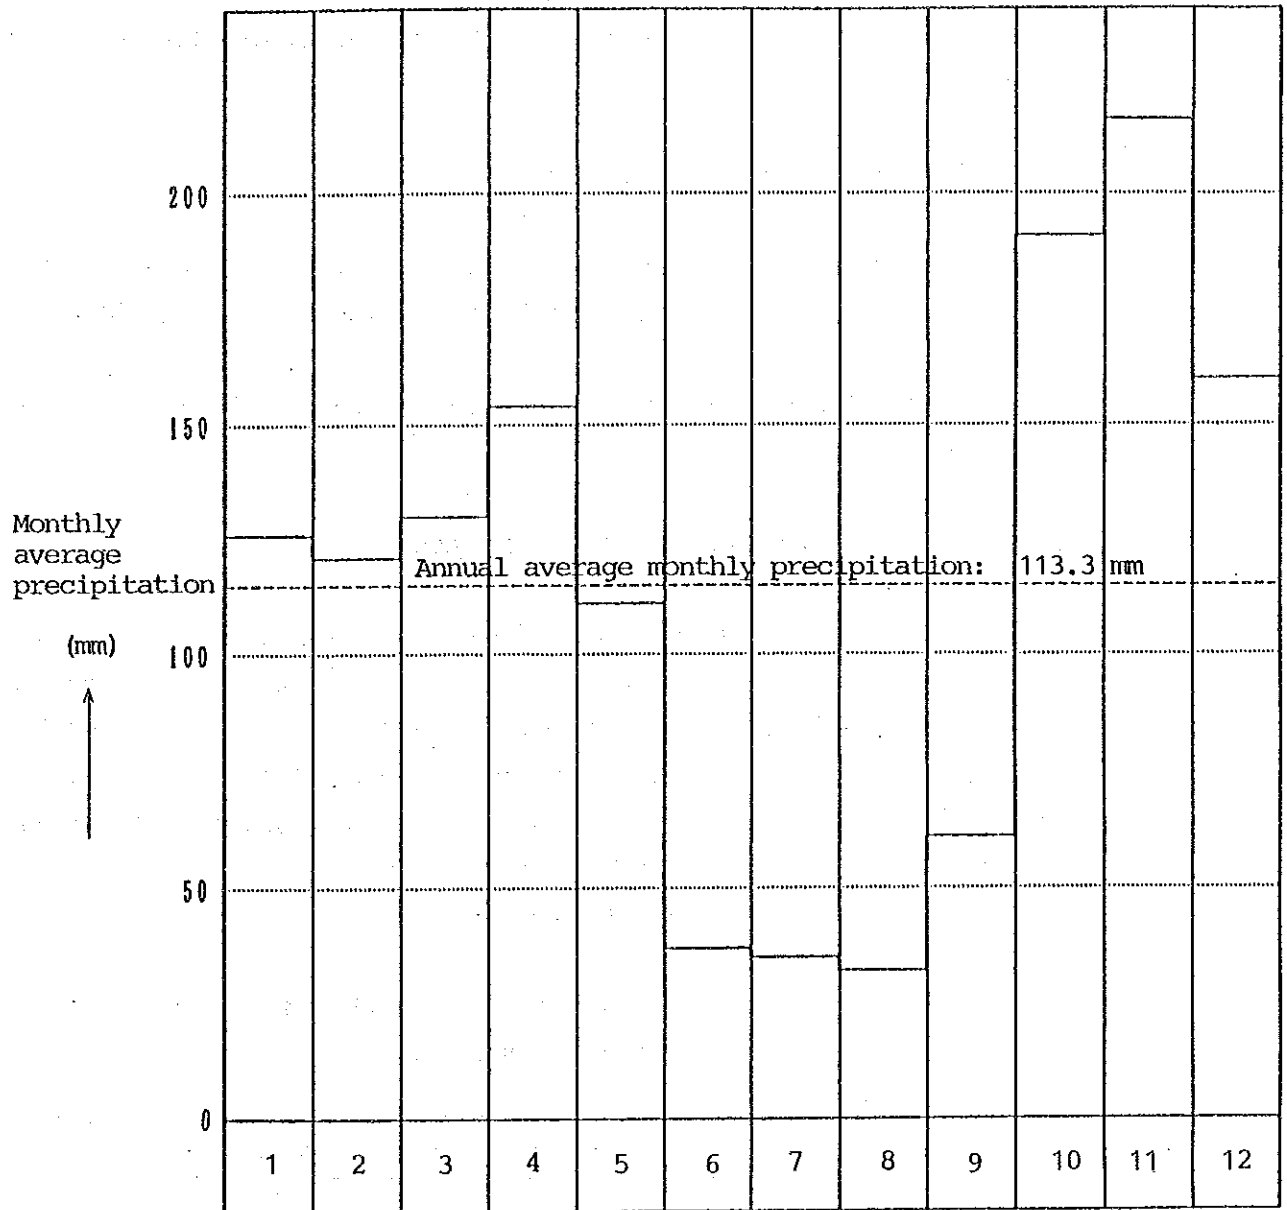
Meteorological station No.2602-002 Silvia pte Electri
 North latitude: 2°37'
 West longitude: 76°22'
 Elevation: 2,560 m
 Annual average precipitation: 1,360.1 mm

Fig.7.2 Monthly Average Precipitation in the Project Site (1970-87)

The project site with the elevation of about 2,600 m above sea level is situated in the northeast of Popayan and lies on the Central Andes Range. The annual precipitation in the project site is 1,000 - 2,000 mm. Though it fluctuates from year to year, rainy and dry seasons are comparatively clear. (Refer to Fig.7.2.)

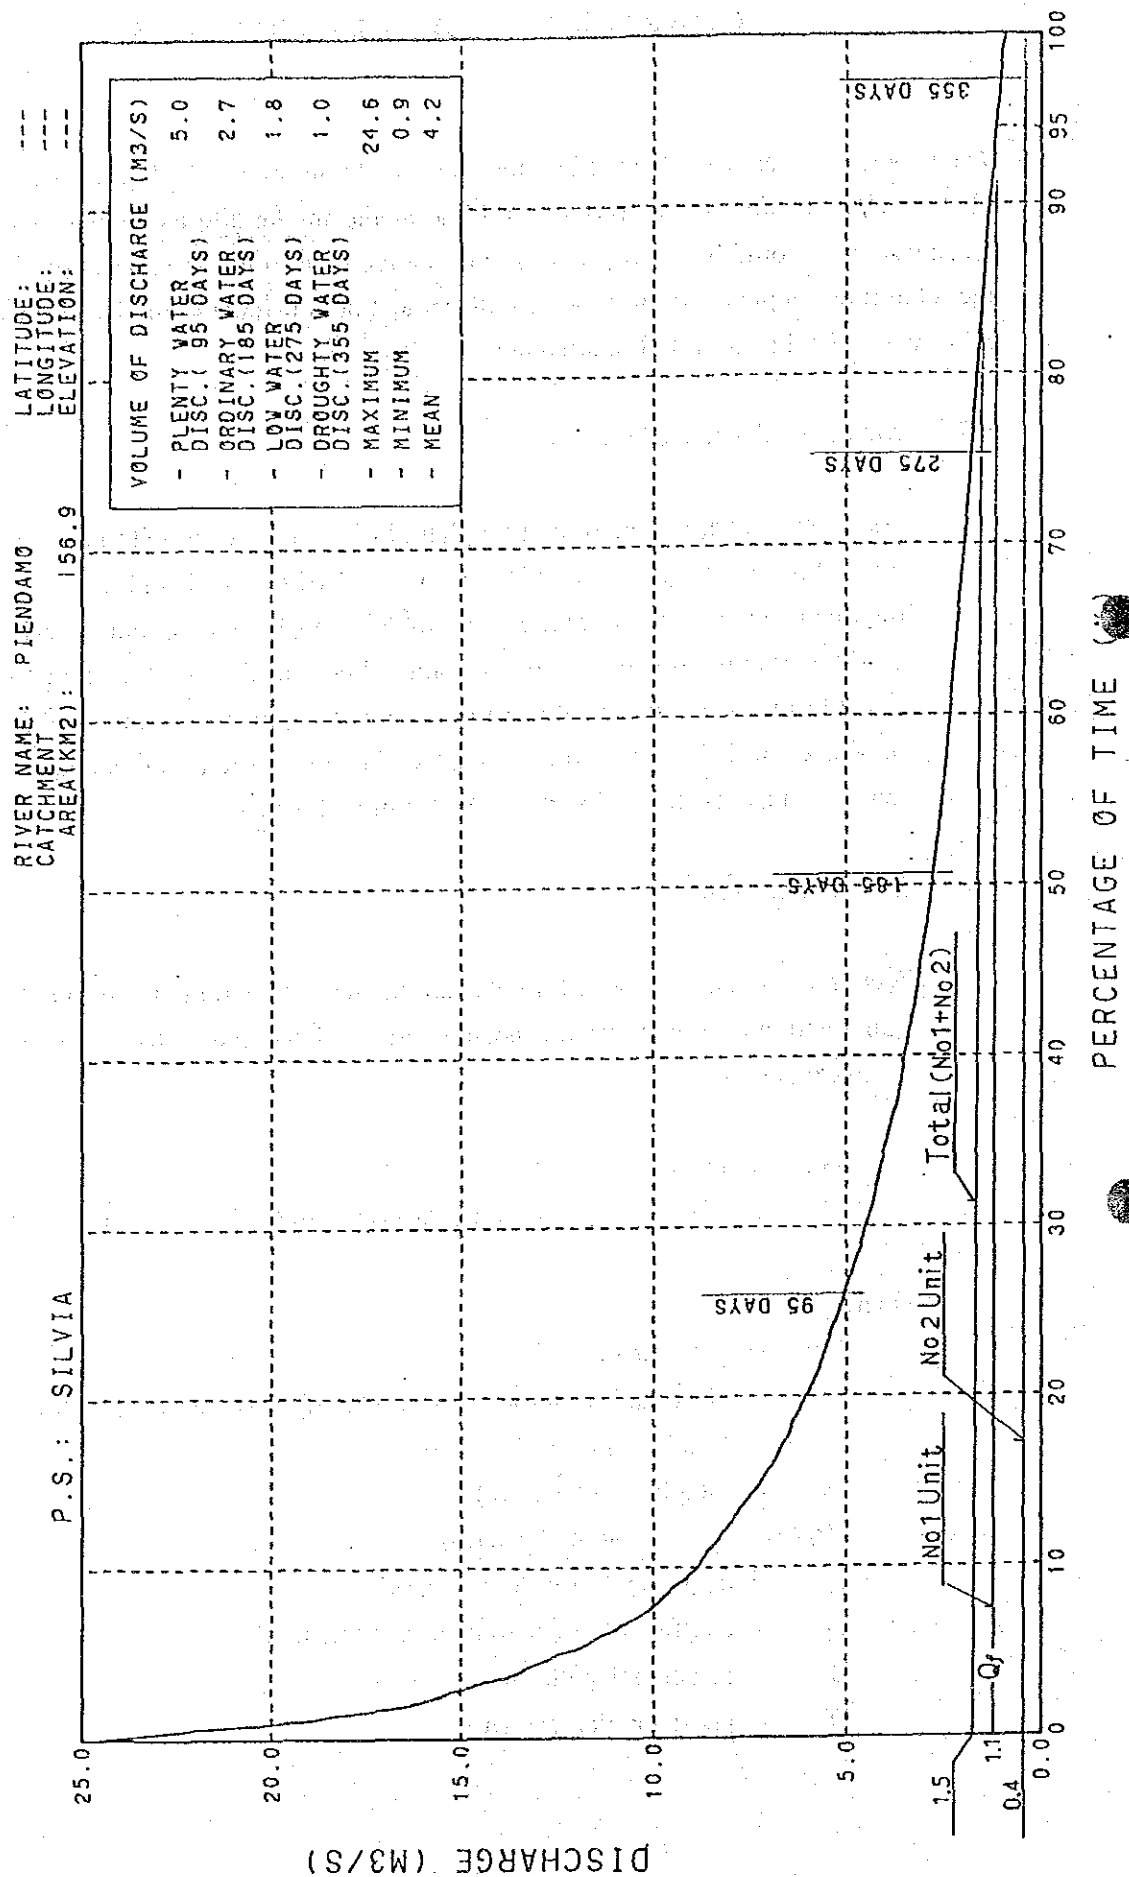
Fig-8.1 TYPICAL FLOW DURATION CURVE AT INTAKE SITE

The generation plan is made based on the planned maximum available discharge at Silvia P/P of 1.5 m³/s. From the hydrological regime at the intake site as shown in Fig. 8.1, this discharge rate would be appropriate, so alternative plans are not considered. Accordingly, the rehabilitation plan is limited to the replacement of non-functioning No. 1 turbine (output: 500 kW) which has been left unattended.

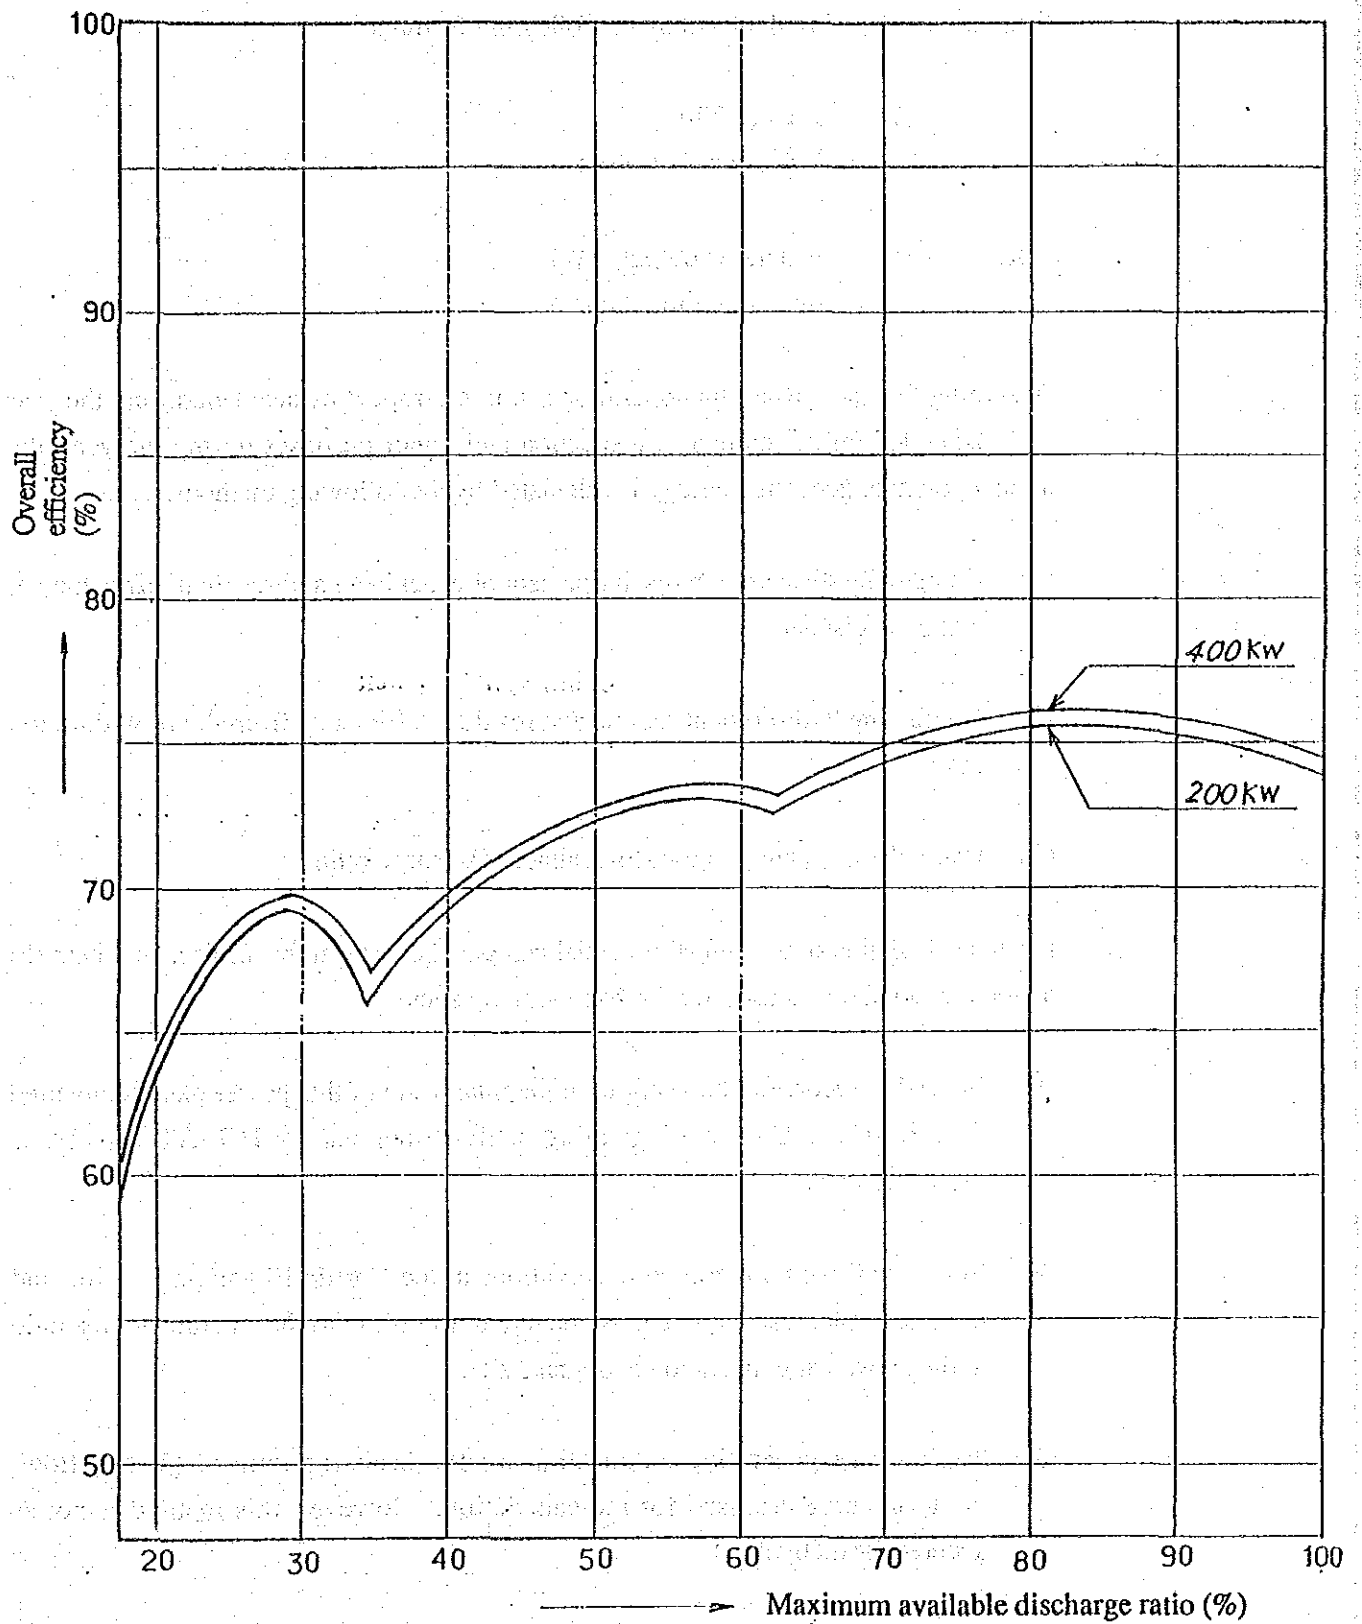
Fig. 8.2 Resultant Efficiency Curve of Cross Flow Turbine and Generator

(Source: The above curves are drawn according to the study standard for mini hydro-power generating plan, Structure Improvement Bureau, Ministry of Agriculture, Forestry and Fishery).

Item Alternative plan	①	②	③	④	⑤
	Available discharge Q (m ³ /s)	Standard net head H _e (m)	9.8 x ① x ② Theoretical output (kW)	Resultant efficiency η	③ x ④ Generated output P (kW)
No. 1 Unit	1.10	31.0	334	0.740	240

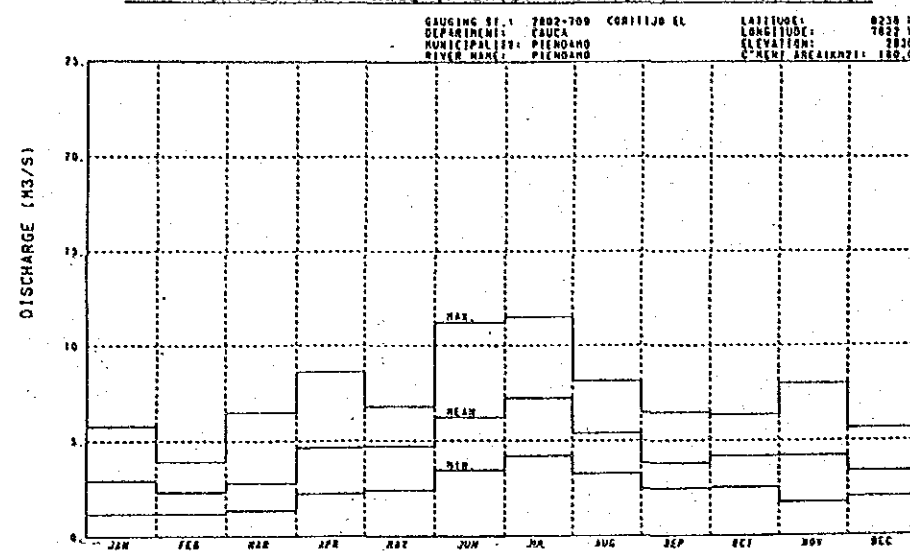
(1)
MONTHLY MEAN VALUE OF DAILY AVERAGE FLOW AT G.S. SITE

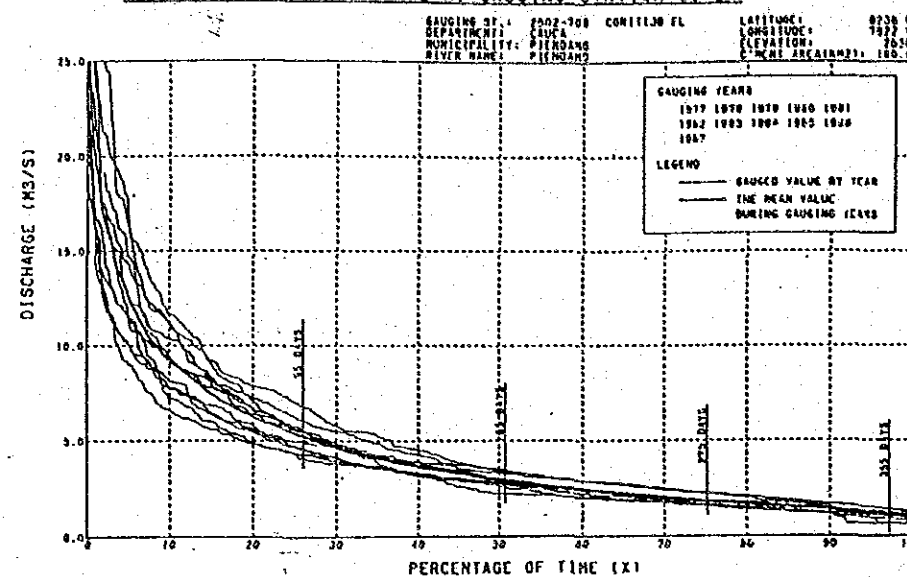
(3)
FLOW DURATION CURVE AT GAUGING STATION SITE

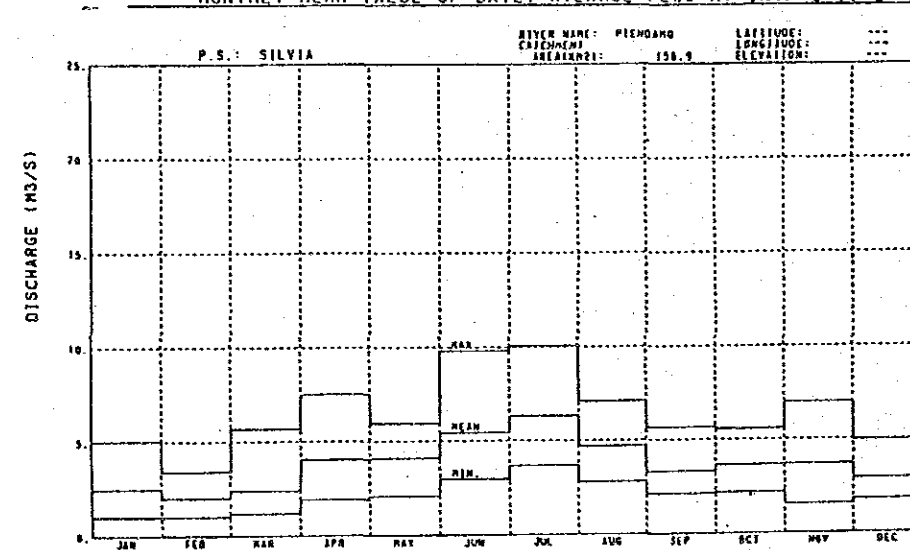
(2)
MONTHLY MEAN VALUE OF DAILY AVERAGE FLOW AT INTAKE SITE

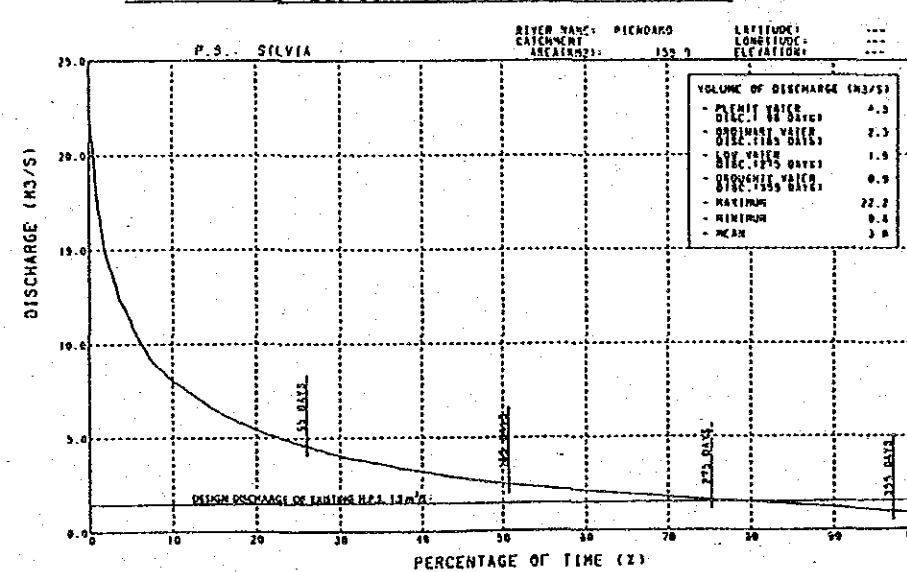
(4)
TYPICAL FLOW DURATION CURVE AT INTAKE SITE

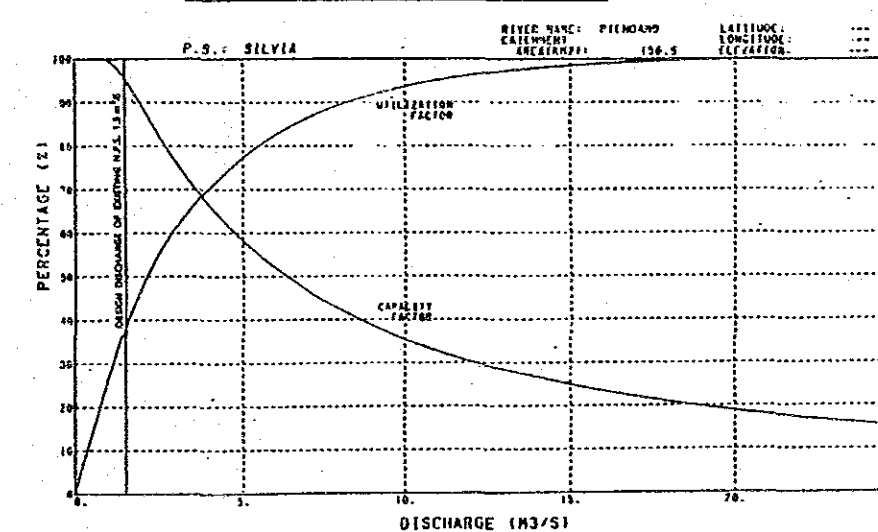
(5)
UTILIZATION & CAPACITY FACTOR
