THE BASIC DESIGN STUDY
ON
THE PROJECT FOR
IMPROVEMENT OF WATER SUPPLY
IN
THE REPUBLIC OF PALAU

FIELD REPORT

JAPAN INTERNATIONAL COOPERATION AGENCY
(JICA)

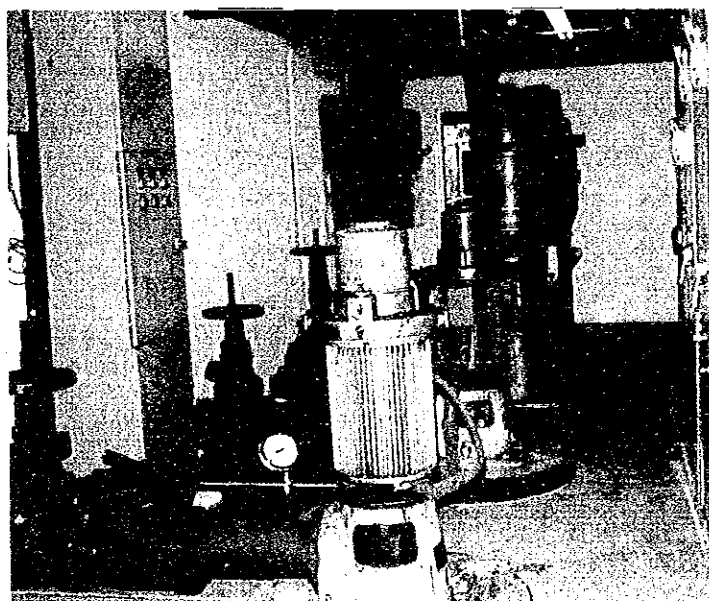
EXISTING WATER TRANSFER PUMPS

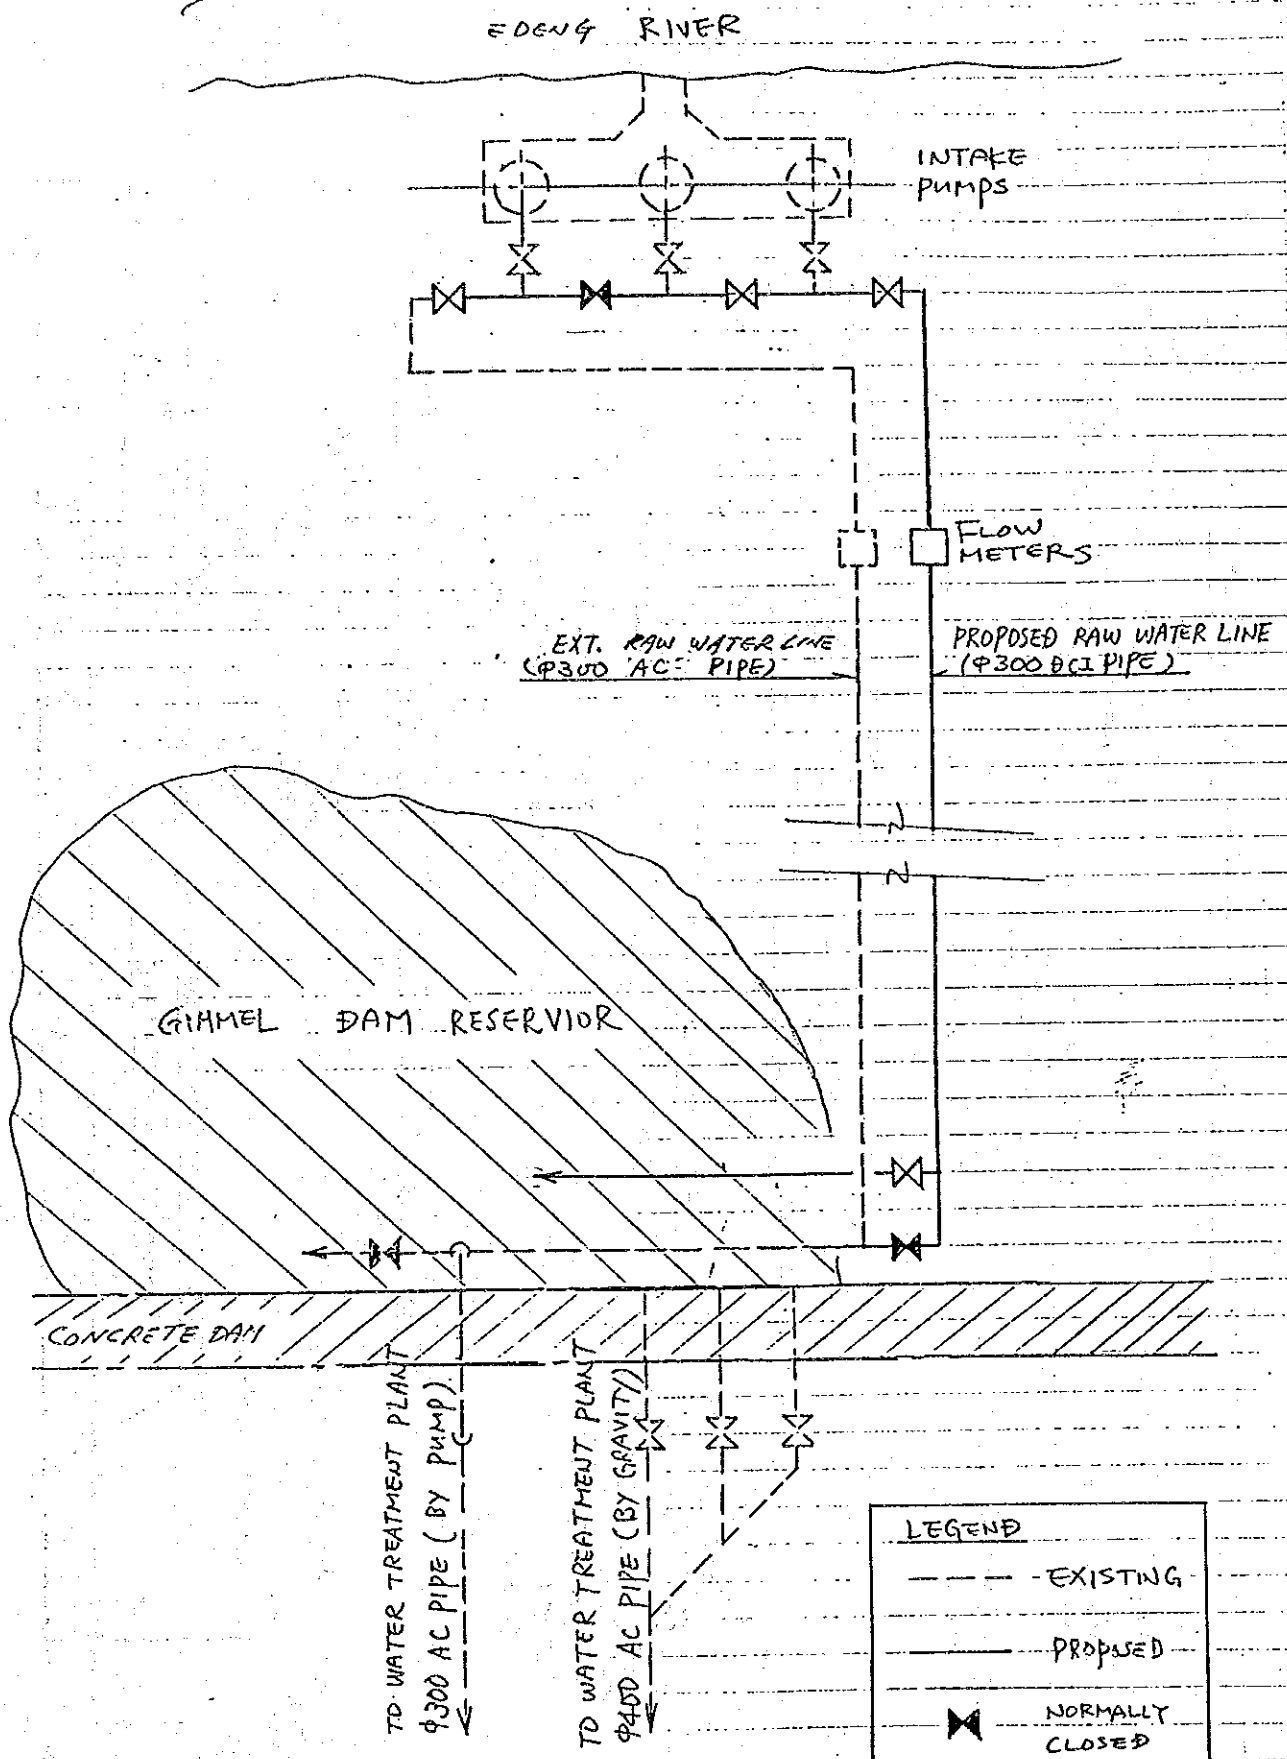
Fig. 1-1 CONCEPTUAL PLAN OF RAW WATER SUPPLY SYSTEM

CONCEPTUAL PLAN OF RAW WATER SUPPLY SYSTEM

- a) One emergency diesel generator set(Approx. 300KVA) and one fuel oil steel tank in the intake pump station.
- b) The raw water transmission line (Approx. 300 mm dia.) from the existing intake pump station to the existing Gihmel dam, the proposed route of the line is as shown on the attached Fig. 1 and Fig. 1-1.

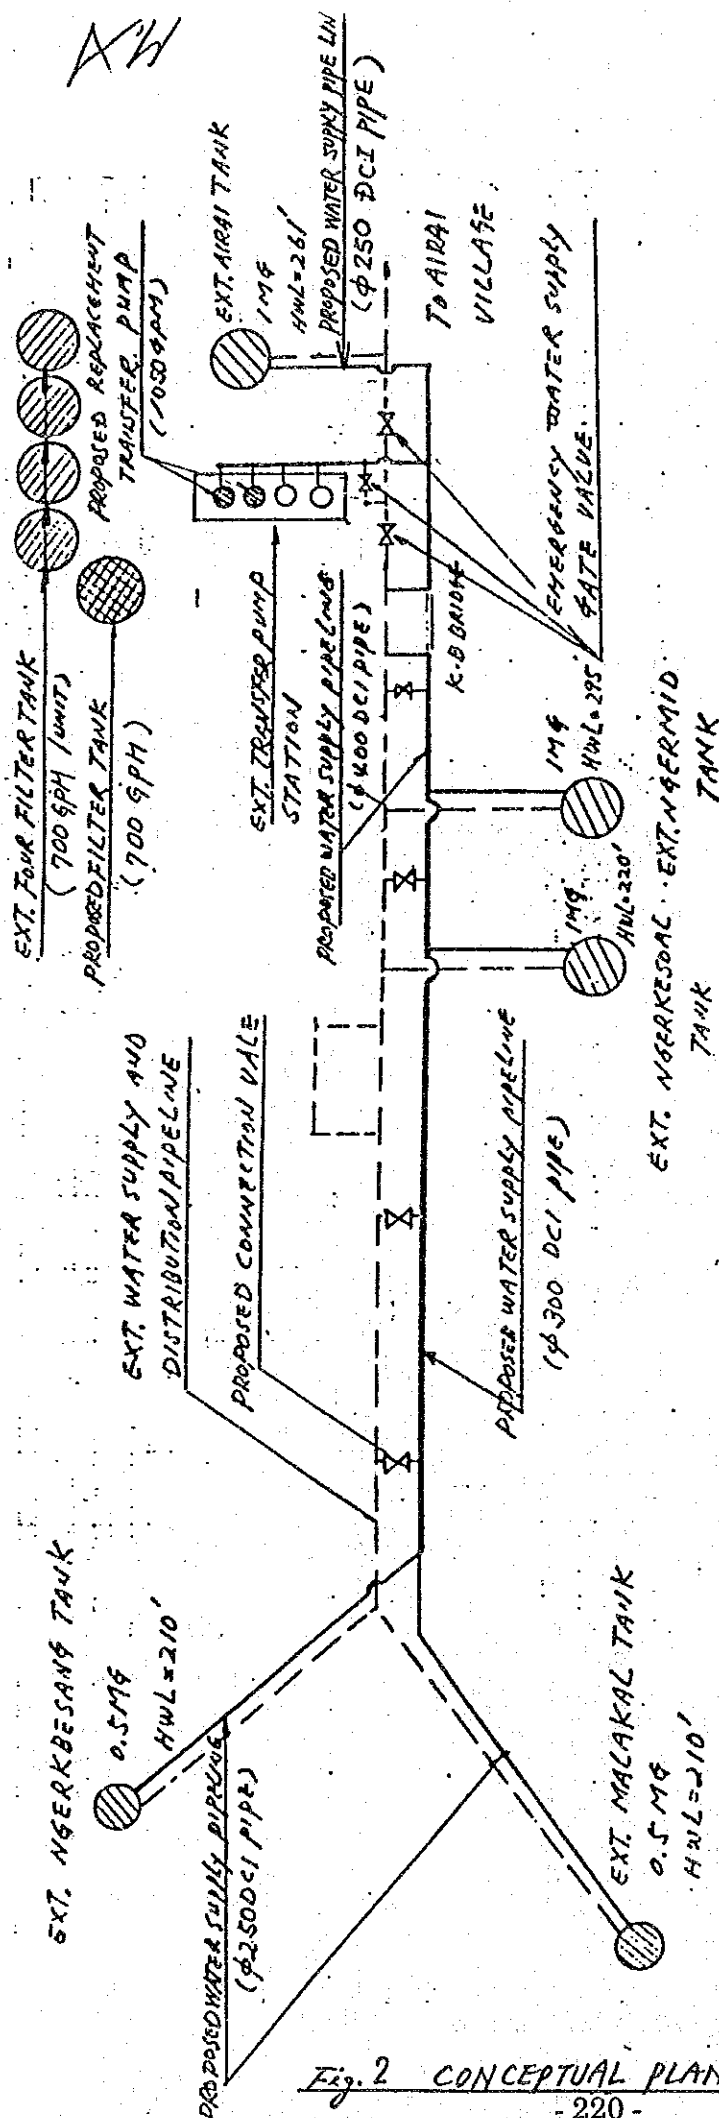
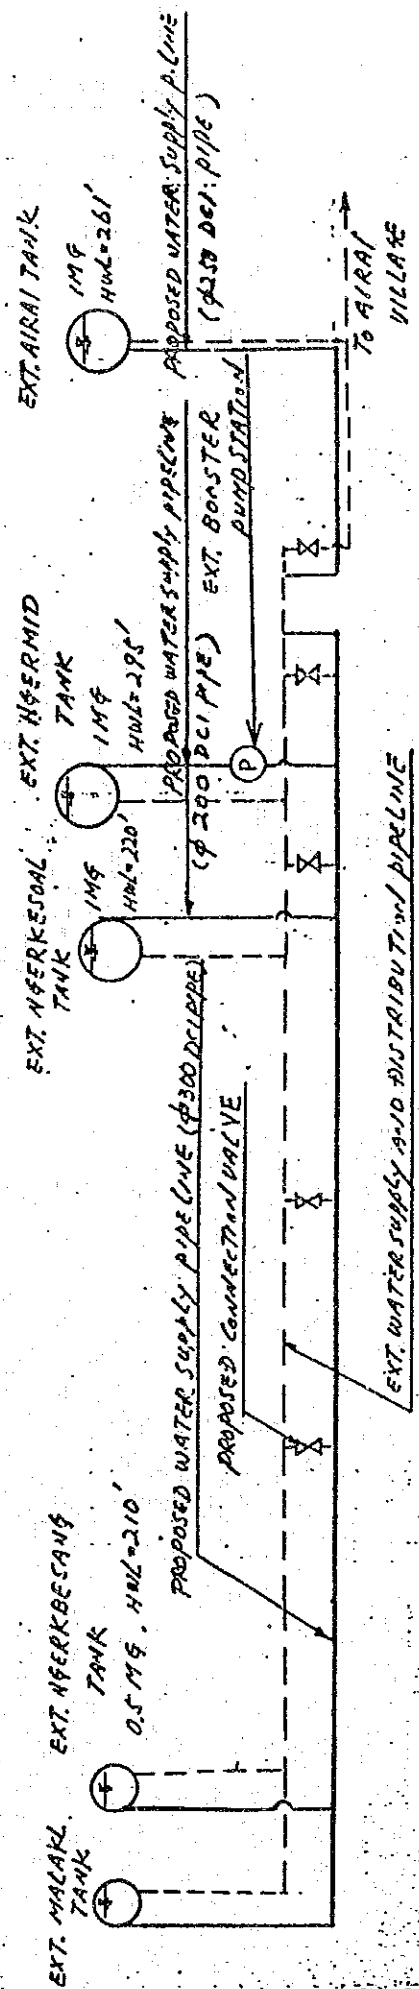
Fig. 2 CONCEPTUAL PLAN OF FRESH WATER SUPPLY SYSTEM

CONCEPTUAL PLAN OF FRESH WATER SUPPLY SYSTEM

CONCEPTUAL ELEVATION OF FRESH WATER SUPPLY SYSTEM

- c) The clean water transmission main line (Approx. 400mm dia.) from the existing Airai water treatment plant(WTP) to the existing Ngermid and Ngerkesoal steel tanks. The proposed route of the line is shown on the attached Fig. 1 and Fig. 2.

- d) The clean water transmission main lines(Approx. 300mm dia. and 250 mm dia.) for Koror city water system. The proposed routes are shown on the attached Fig. 1 and Fig. 2.

- e) The clean water transmission main line (Approx 200 mm dia.) for Airai city water system. The proposed route of the line is shown on the attached Fig. 1 and Fig. 2.

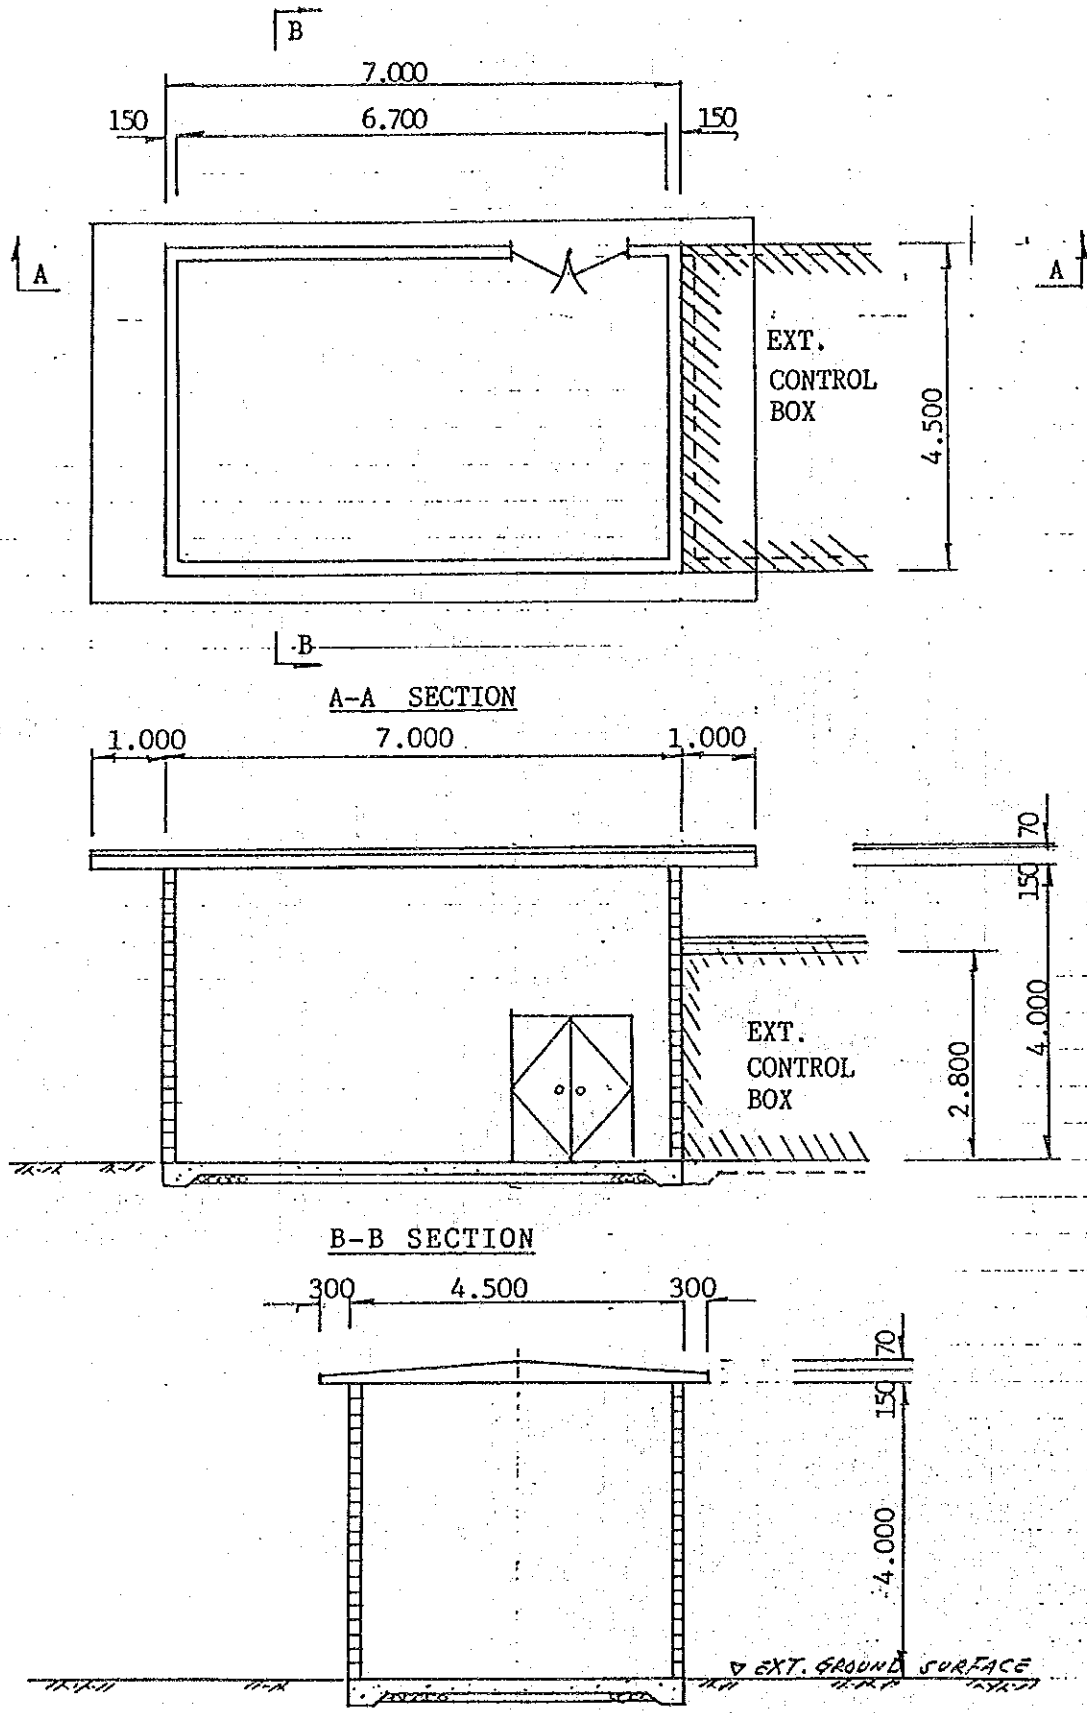
Fig. 3 (1/2) CONCEPTUAL PLAN FOR PROPOSED EMERGENCY DIESEL GENERATOR

EMERGENCY GENERATOR BUILDING

P L A N

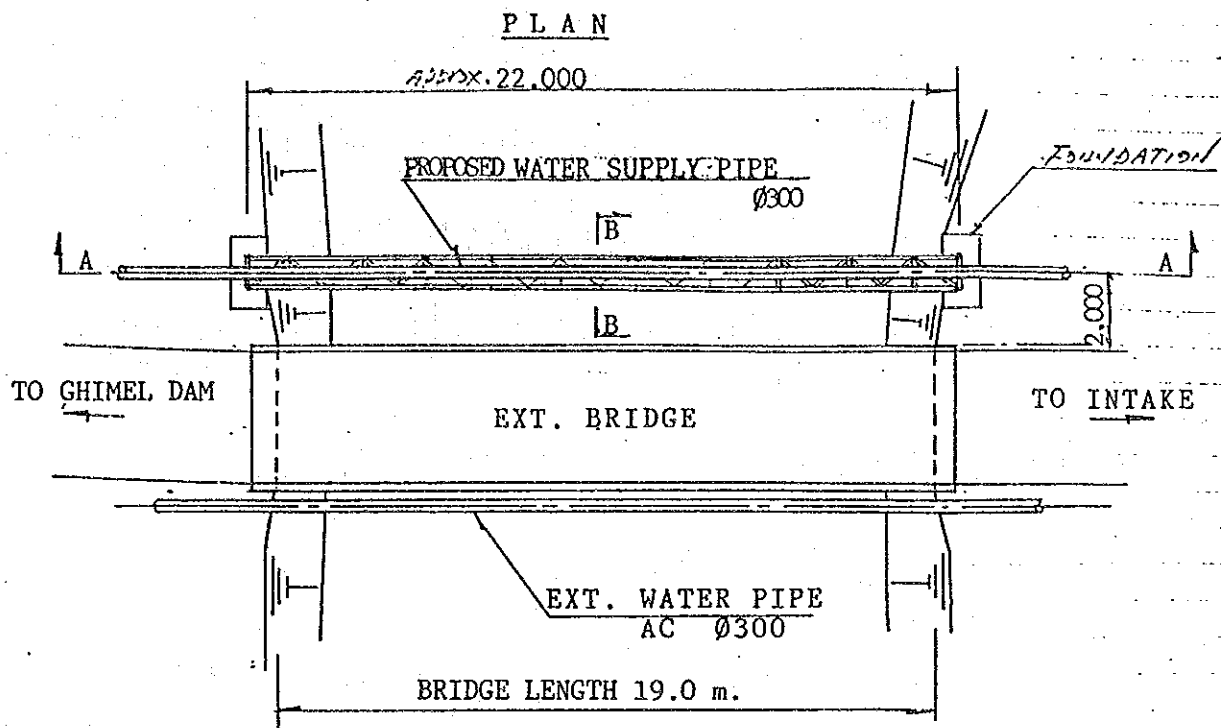
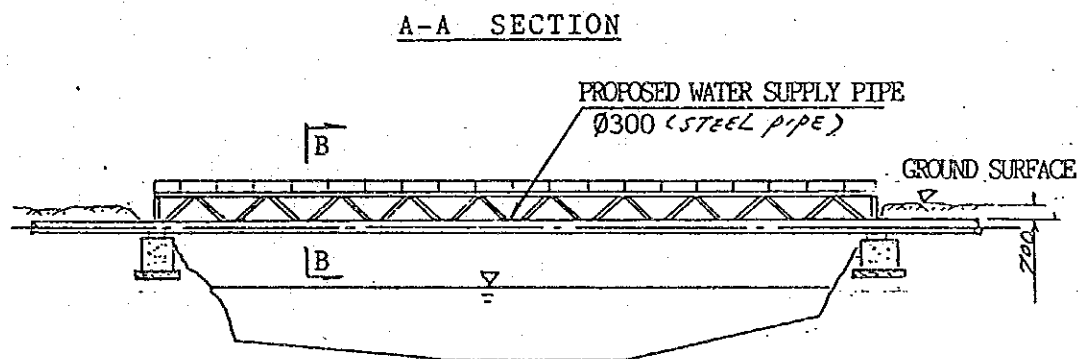
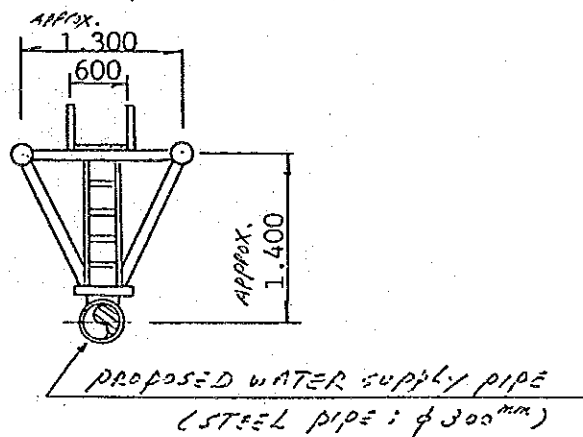
Fig. 6 DETAIL OF WATER PIPE BRIDGE NEAR INTAKE

WATER PIPE BRIDGE

B-B SECTION

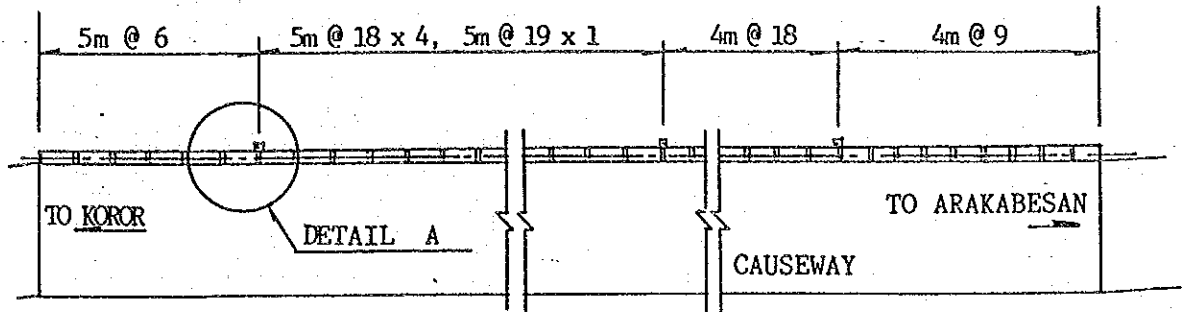
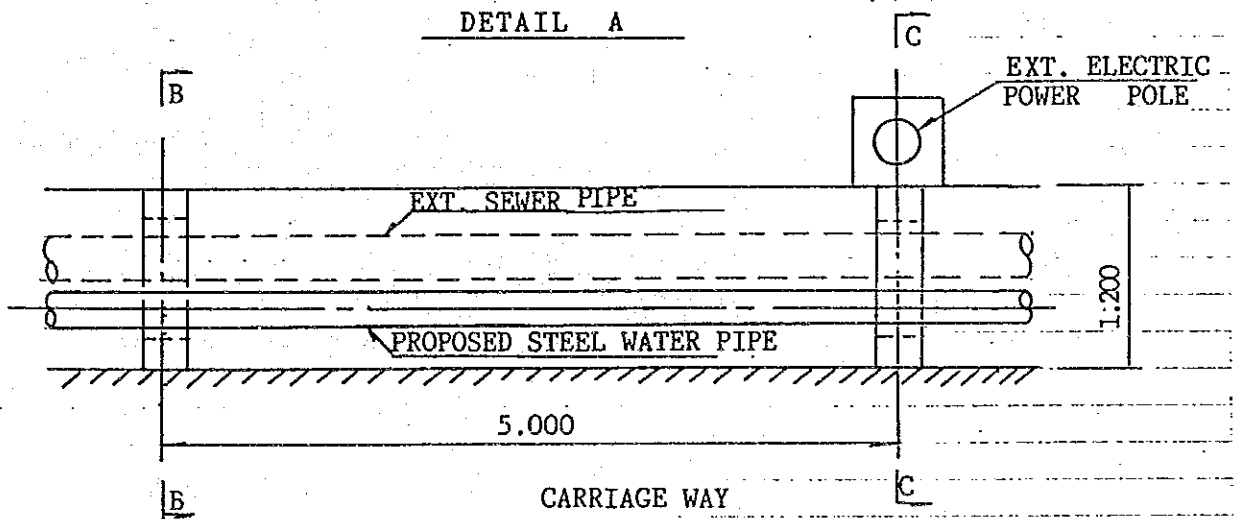
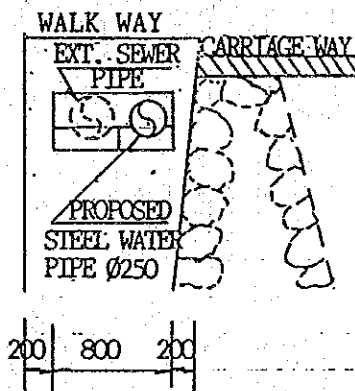
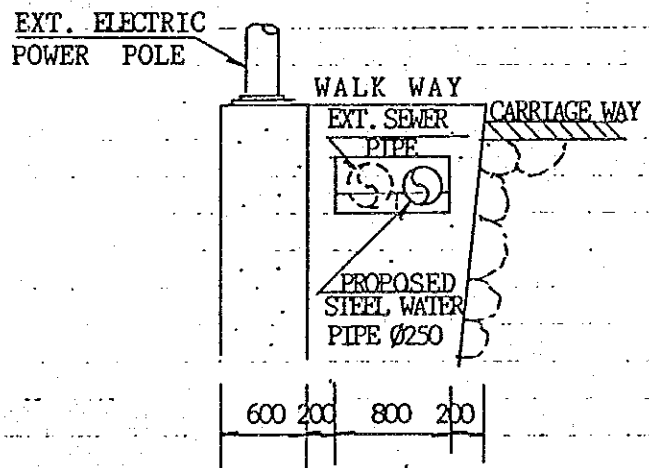
Fig.10 WATER PIPE LINE ALONG CAUSEWAY TO ARAKABESAN IS.

PROPOSED WATER PIPE LINE ALONG CAUSEWAY

B-B SECTION

C-C SECTION

Fig. 10. Water pipe line along causeway to Arakabesan Island

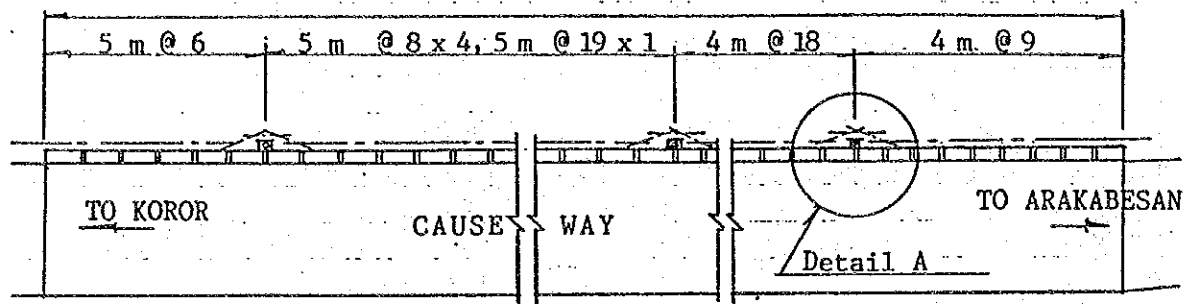
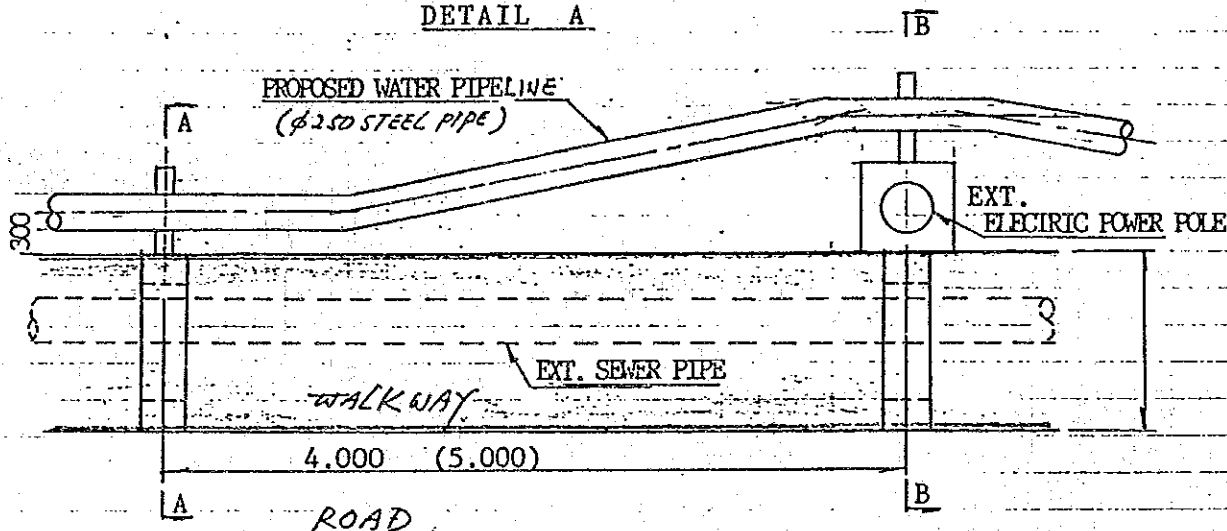
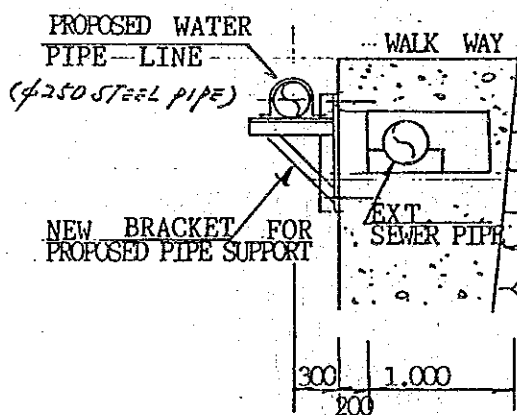
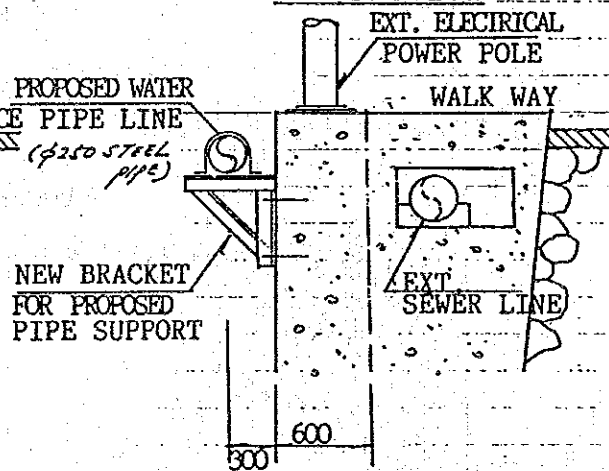
Fig. 11 WATER PIPE LINE ALONG CAUSEWAY TO ARAKABESAN IS.
(ALTERNATIVE)

PROPOSED PIPELINE ALONG CAUSEWAY

DETAIL A

A-A SECTION

B-B SECTION

Fig. 11. Water pipe line along causeway to Arakabesan Island
(Alternative)

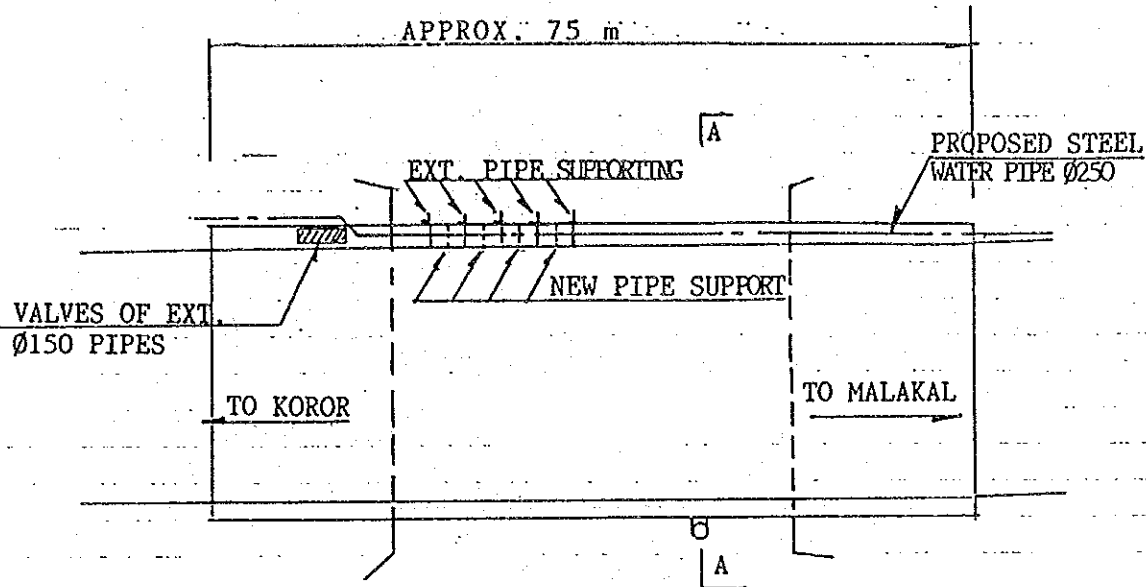
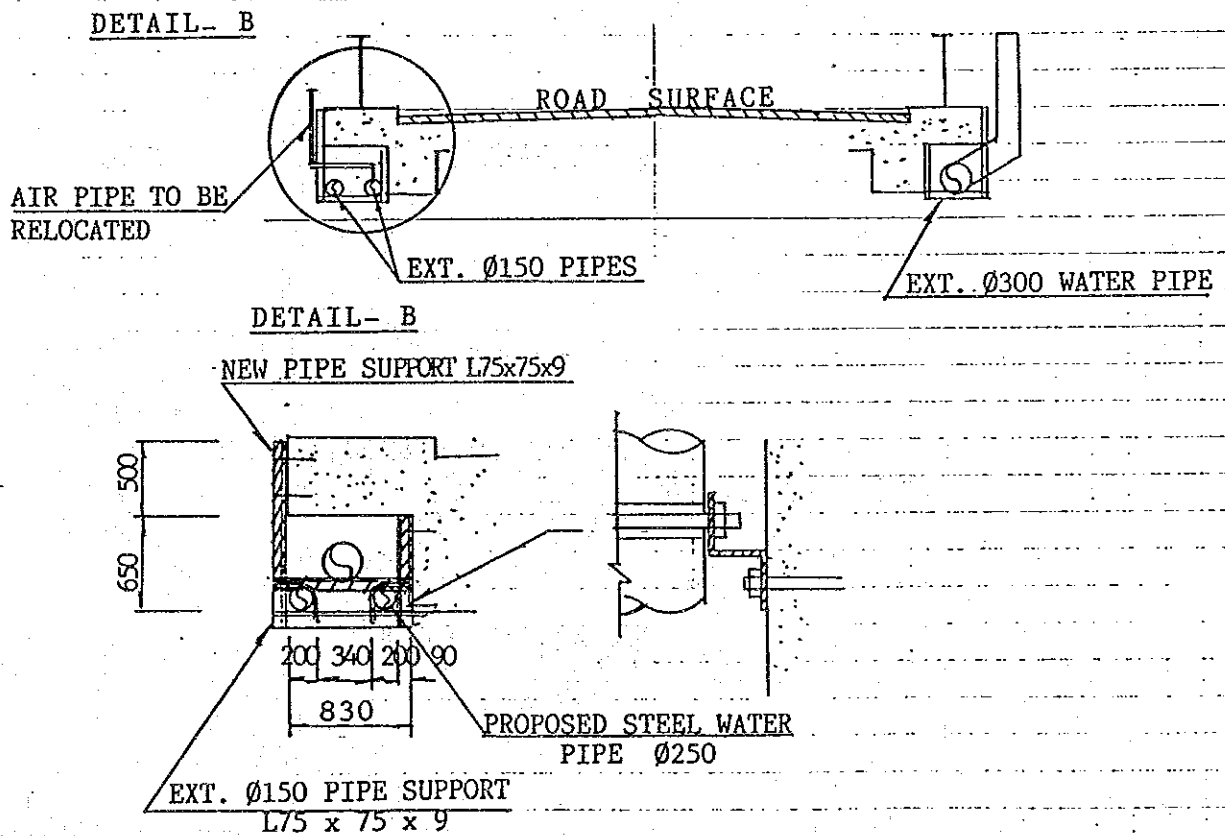
Fig.12 WATER PIPE LINE ALONG MALAKAL BRIDGE

MALAKAL BRIDGE WATER PIPE

A-A SECTION

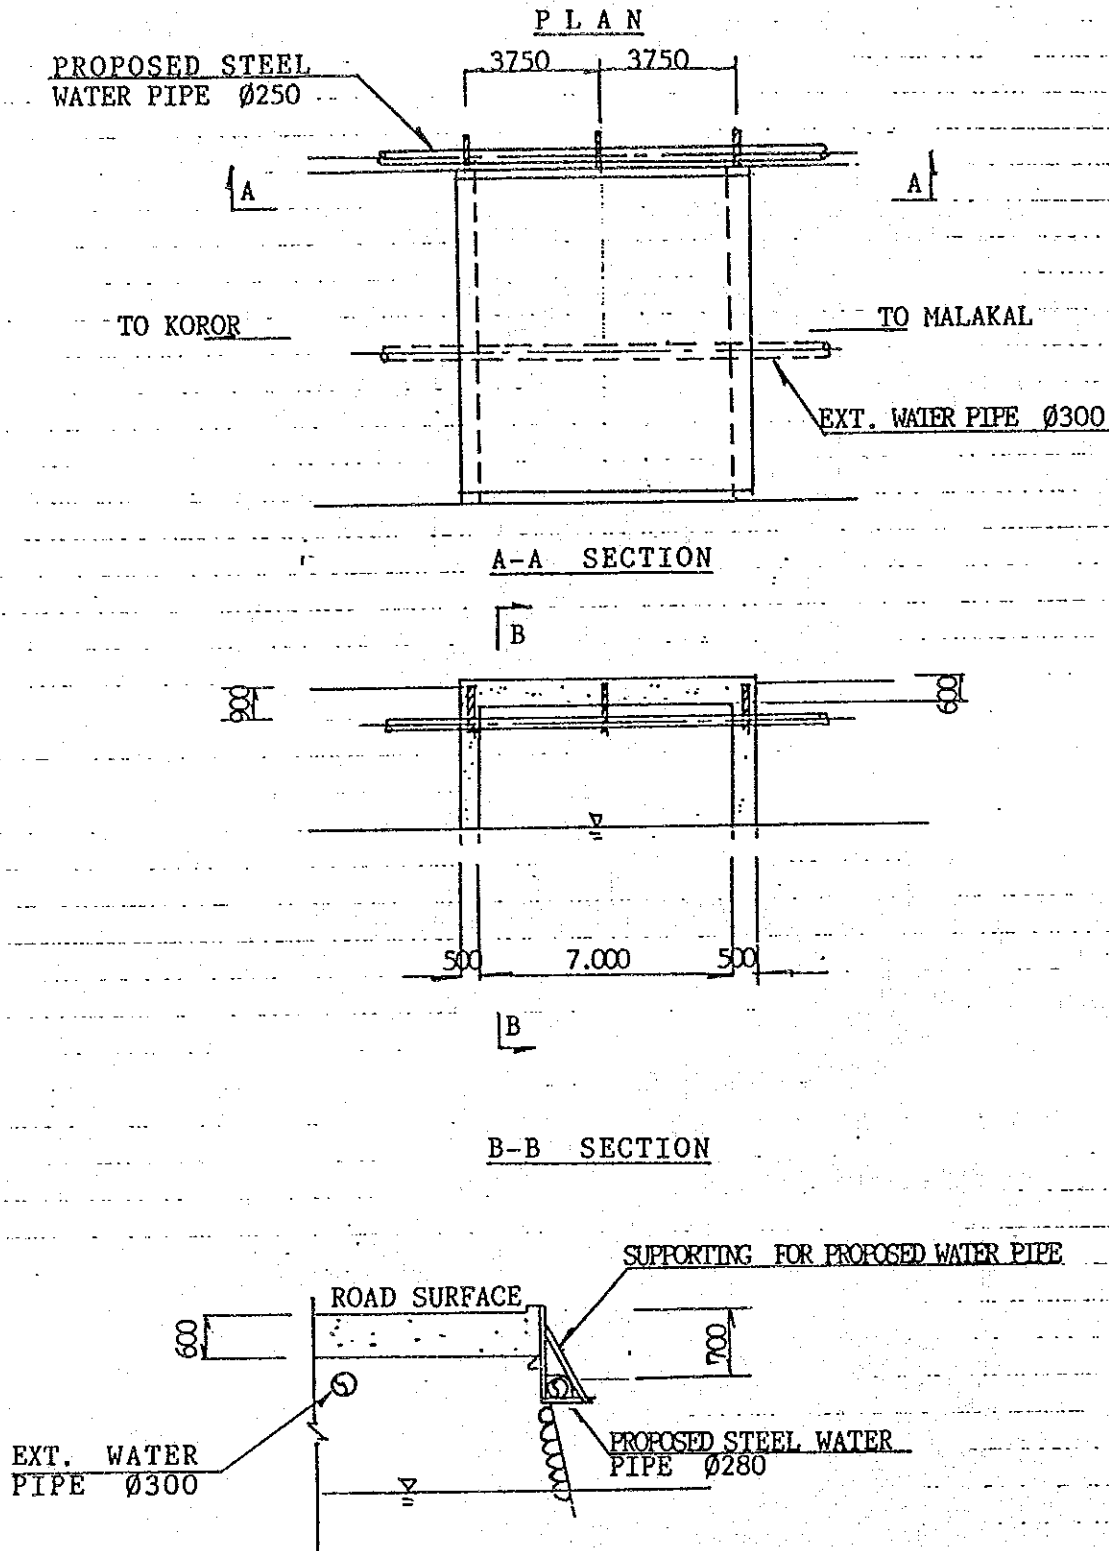
Fig. 13 WATER PIPE LINE BESIDE EXIST. CULVERT AT MALAKAL

PROPOSED WATER PIPE LINE FOR CULVERT BOX AT MALAKAL

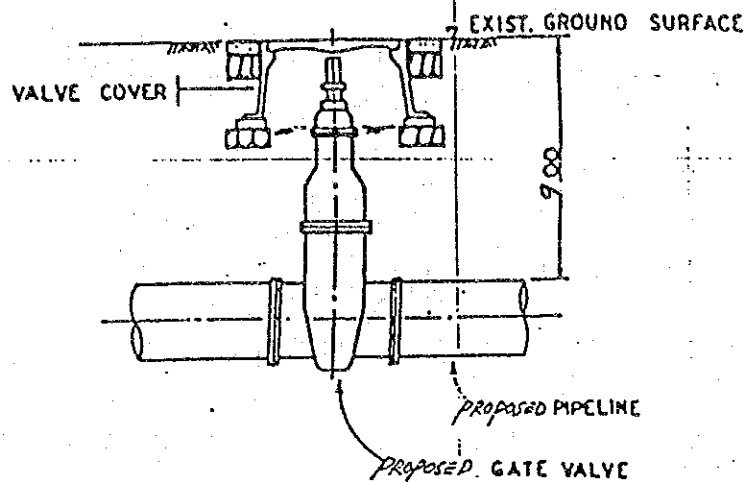
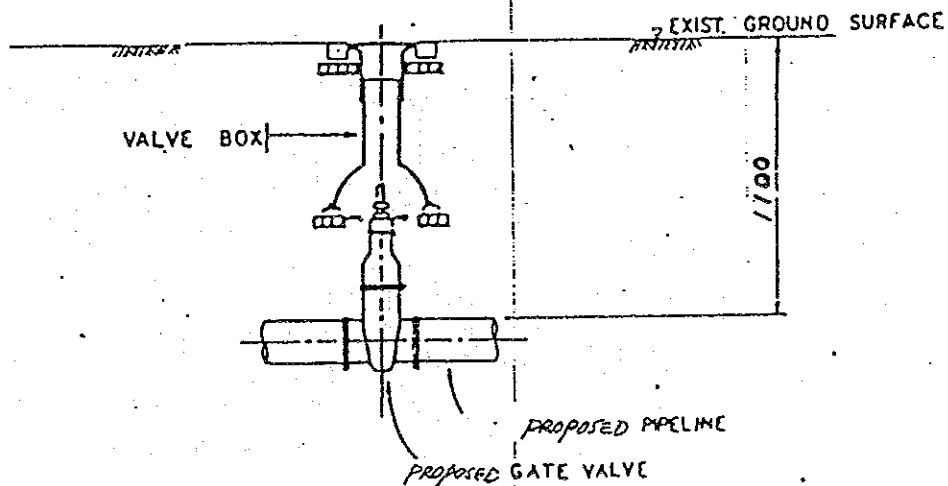
Fig. 14 TYPICAL VALVE COVER & BOX

TYP. VALVE COVER

TYP. VALVE BOX FOR PROPOSED PIPELINE

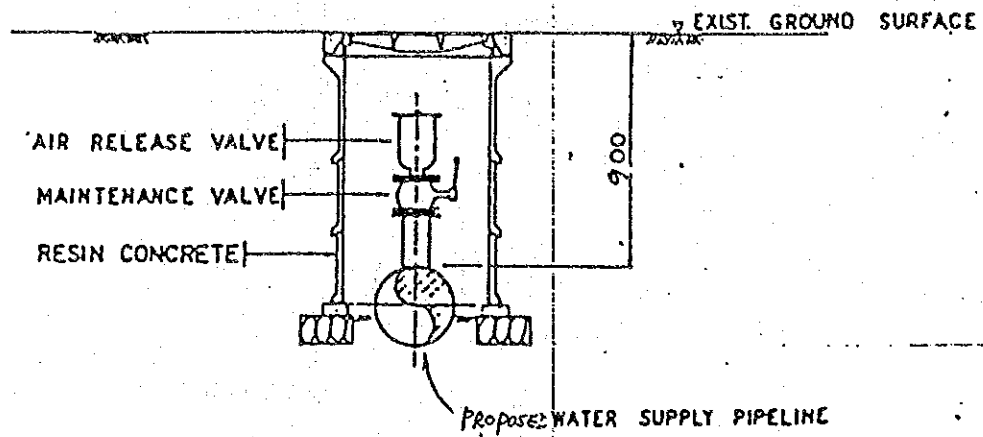
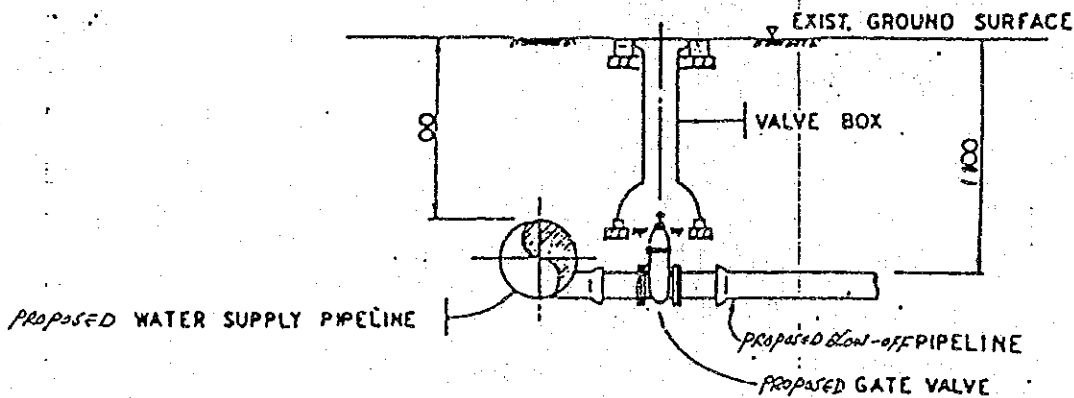
Fig. 15 TYPICAL AIR VALVE BOX & BLOW-OFF

TYP. AIR VALVE BOX

TYP. BLOW-OFF BRANCH

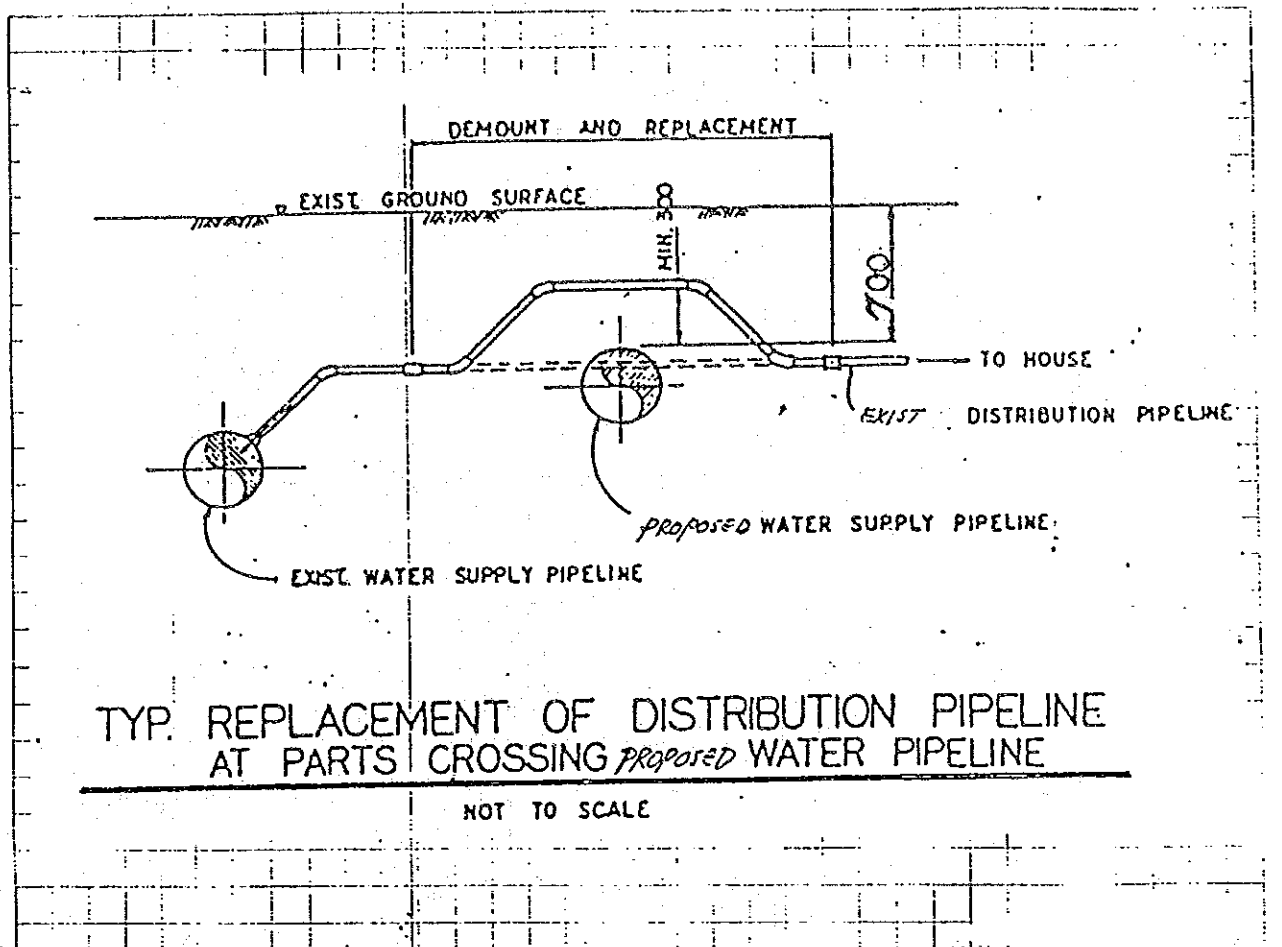
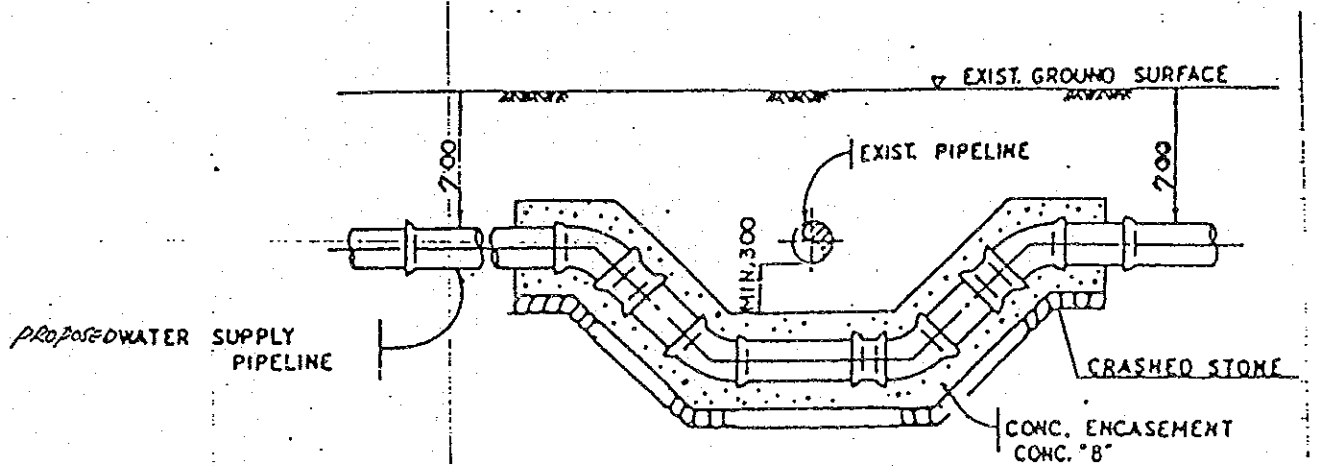
TYP. PIPE CROSSING OF EXIST. WATER MAIN PIPE

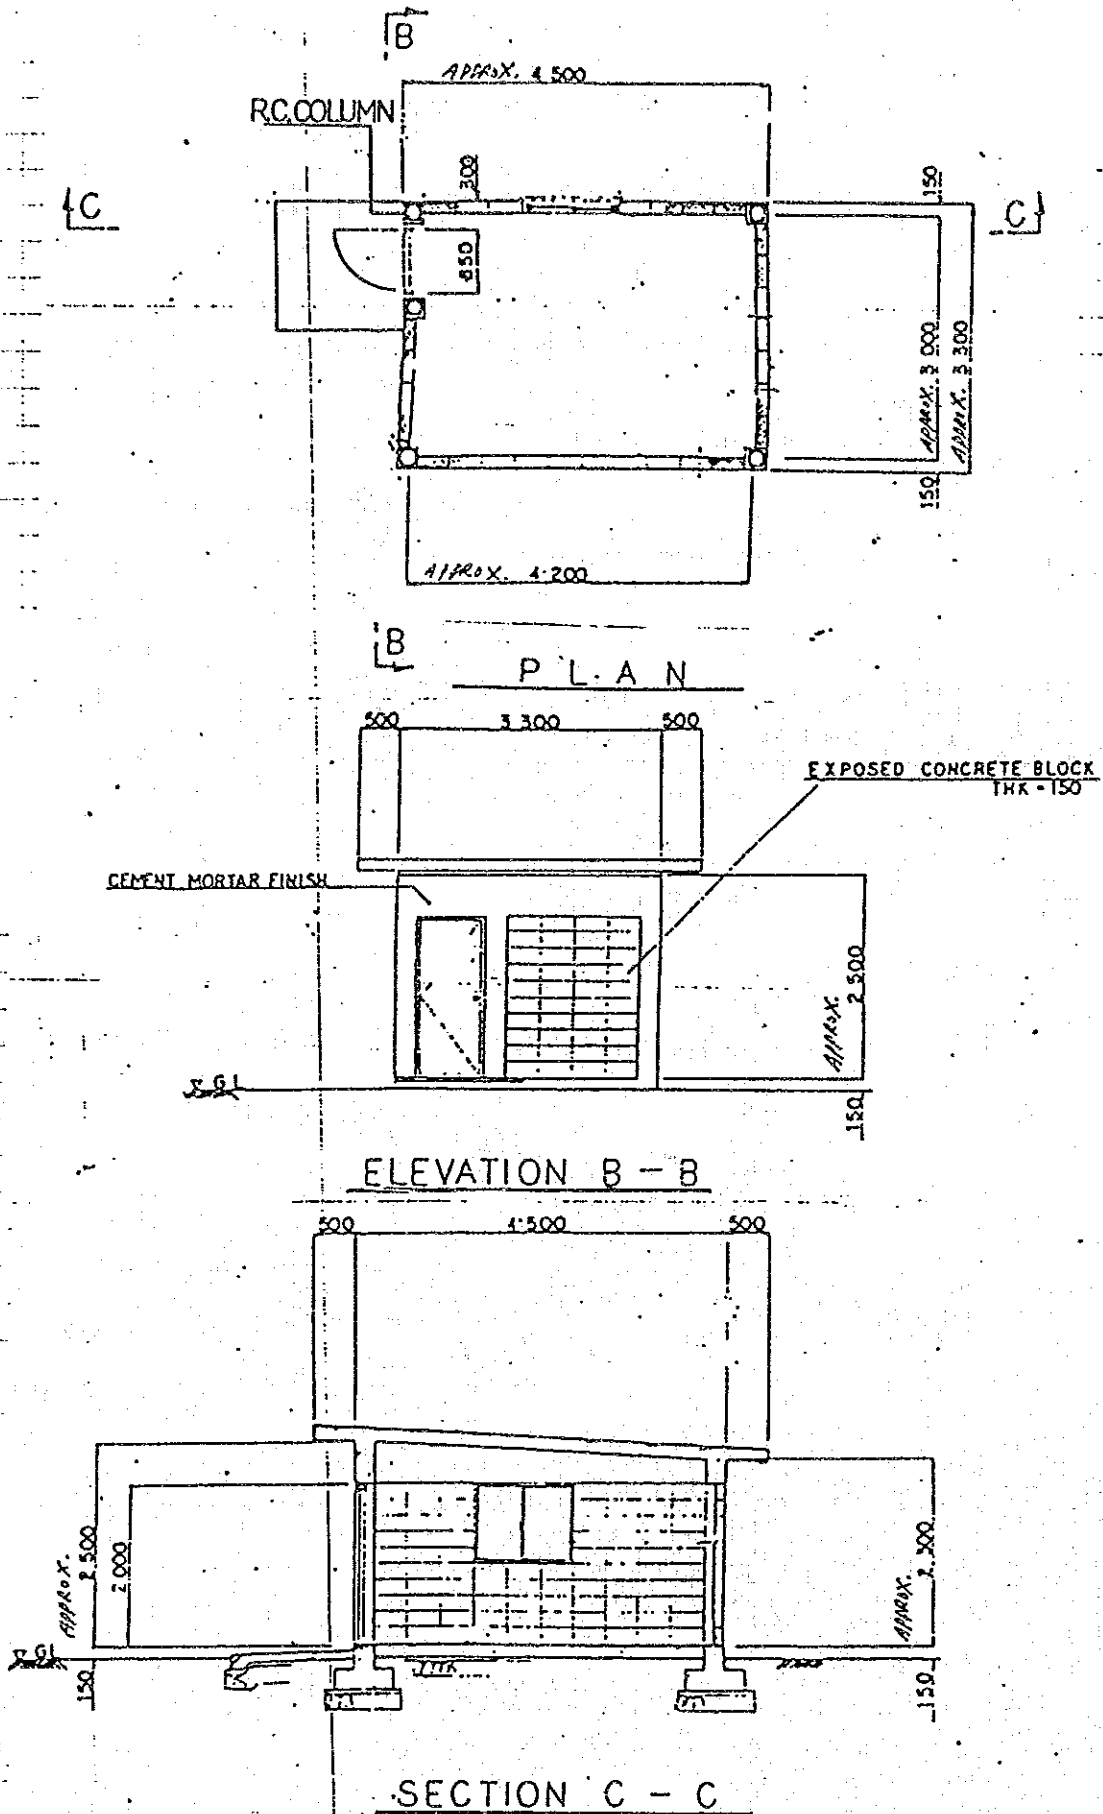
Fig. 17 VALVE HOUSE FOR STEEL WATER TANKS

VALVE HOUSE FOR STEEL WATER TANKS

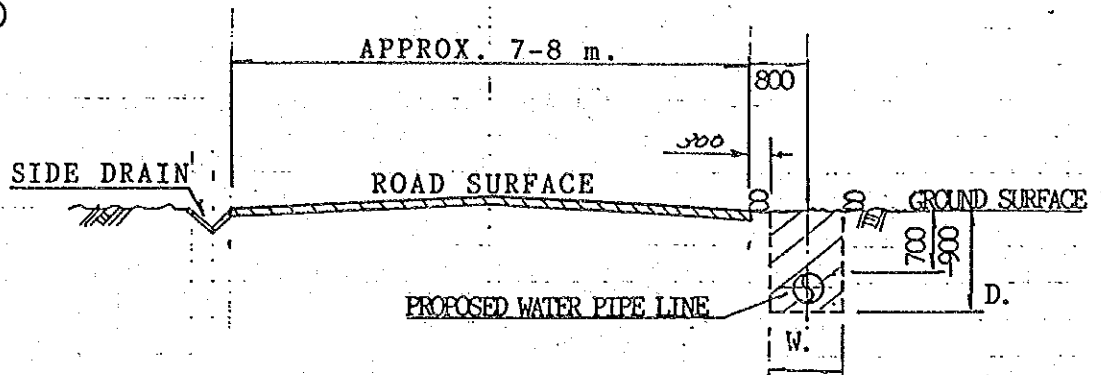
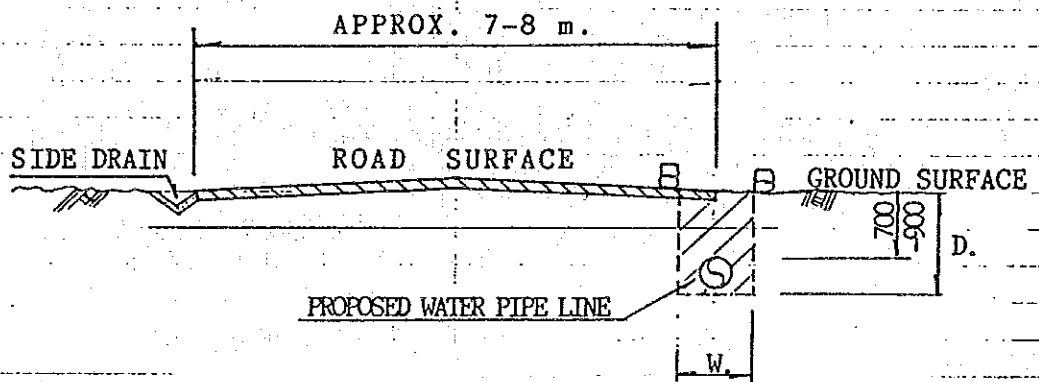
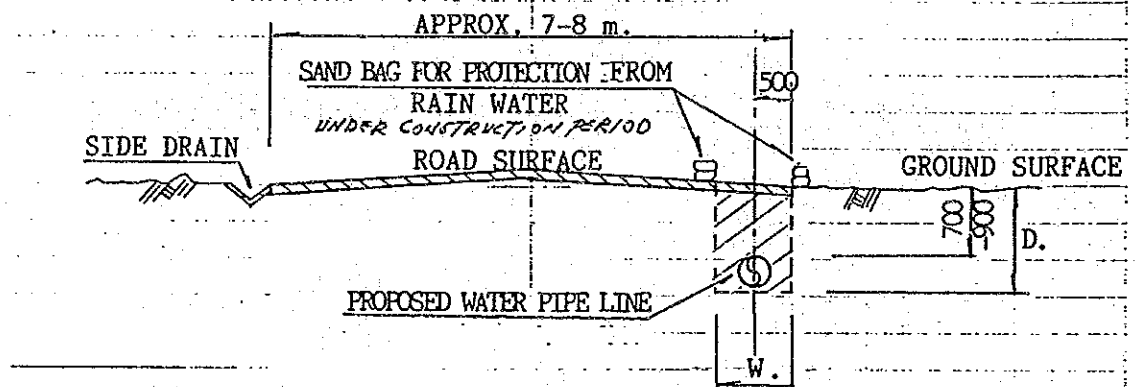
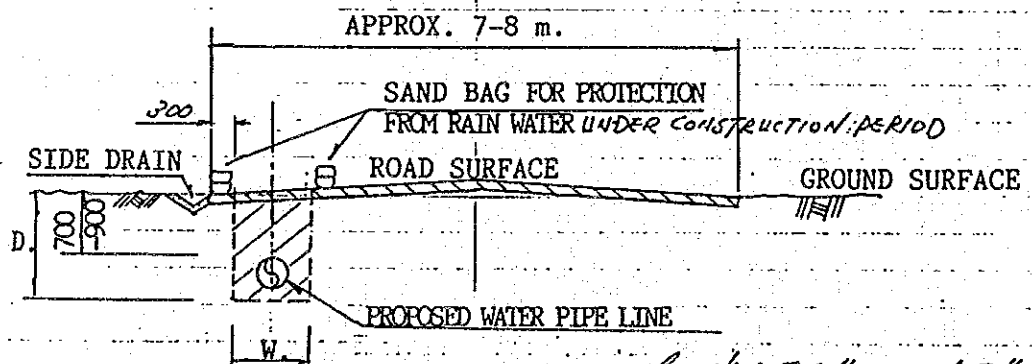
TYPICAL CROSS SECTION OF WATER PIPELINE

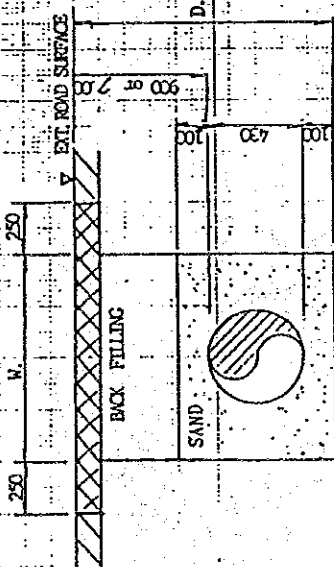
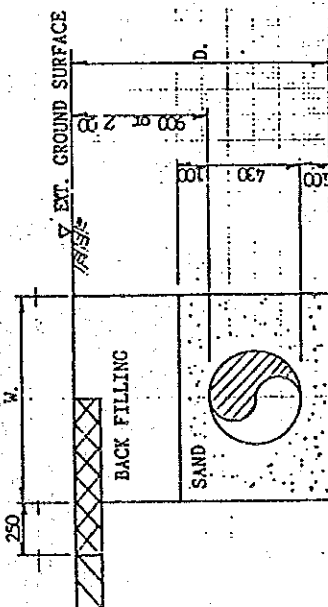
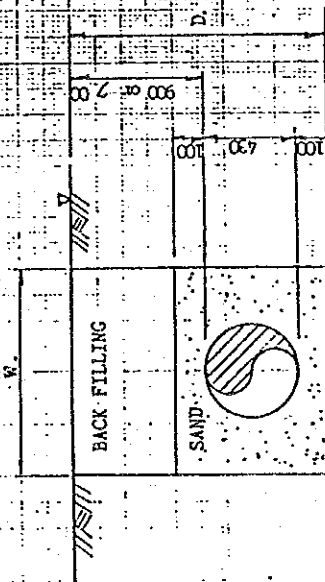
1) PAVED AREA

2) ROAD EDGE

3) UNPAVED AREA

LOCATION	PIPE DIAMETER		400 (mm)		300 (mm)		250 (mm)		200 (mm)	
	COVER(m)		900	700	900	700	900	700	900	700
PAVED AREA	DEPTH (m)		1.43	1.23	1.33	1.13	1.28	1.08	1.22	1.02
	WIDTH (m)		1.00	1.00	0.70	0.70	0.70	0.70	0.70	0.70
ROAD EDGE	DEPTH (m)		1.43	1.23	1.33	1.13	1.28	1.08	1.22	1.02
	WIDTH (m)		1.00	1.00	0.70	0.70	0.70	0.70	0.70	0.70
UNPAVED AREA	DEPTH (m)		1.43	1.23	1.33	1.13	1.28	1.08	1.22	1.02
	WIDTH (m)		1.00	1.00	0.70	0.70	0.70	0.70	0.70	0.70
