THE BASIC DESIGN STUDY
ON
THE PROJECT FOR
IMPROVEMENT OF WATER SUPPLY
IN
THE REPUBLIC OF PALAU

FIELD REPORT

JAPAN INTERNATIONAL COOPERATION AGENCY
(JICA)

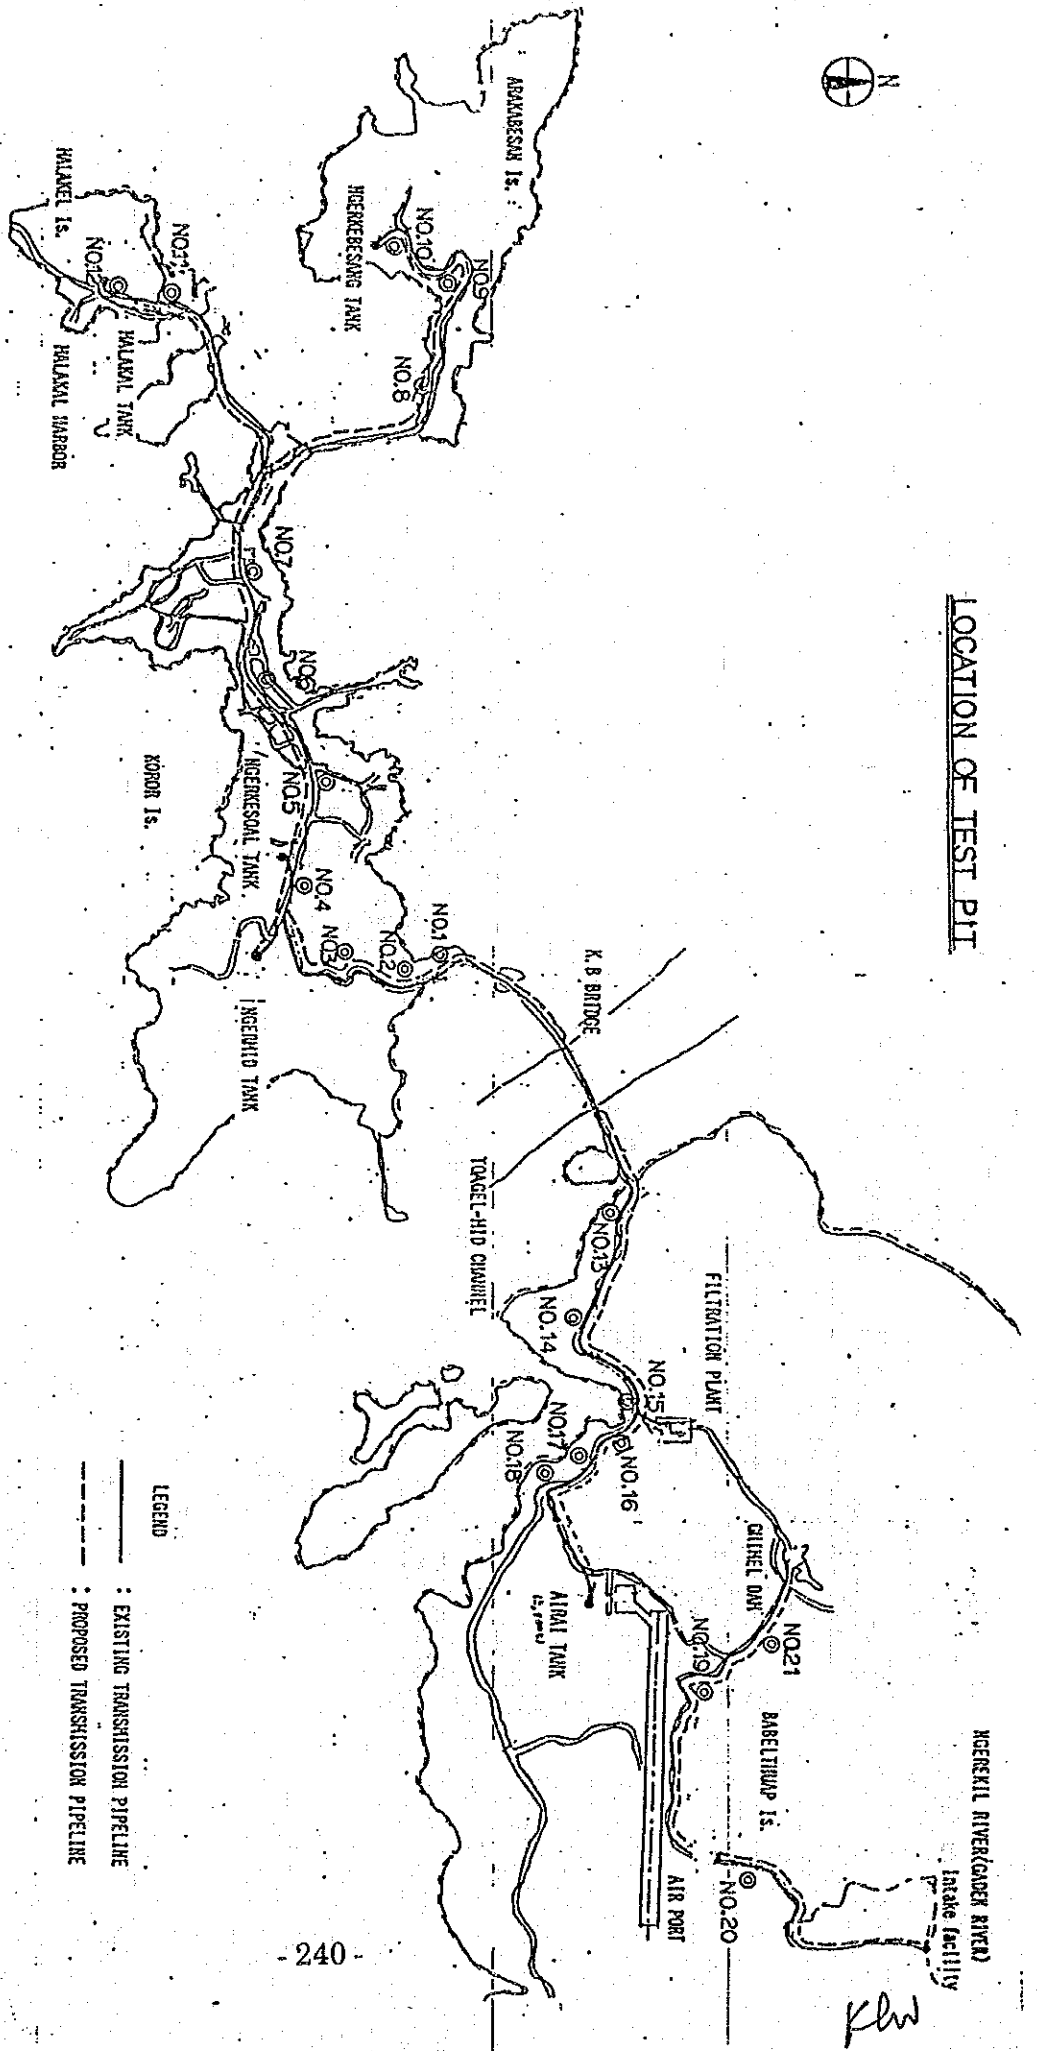
Fig. AII-1-58 Location of Test Pit

LOCATION OF TEST PIT

We surveied the soil investigations of 21 holes along JICA proposed raw water transmission pipeline and clean water transmission pipeline on 14th, Dec. 1989 under the cooperation of GRP. The investigated soil conditions are as shown on the attached Fig. AN-1 (1/3)--(3/3).

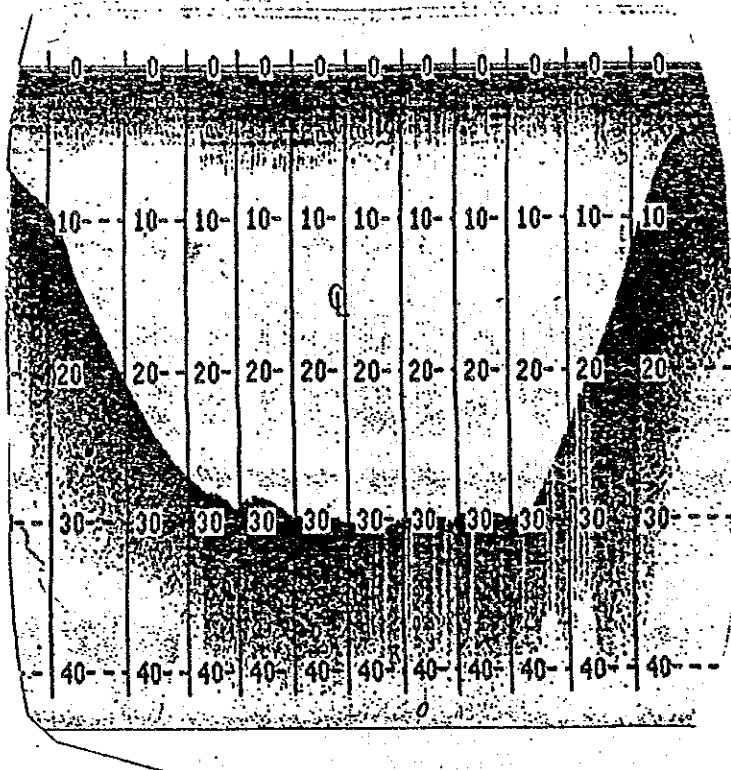
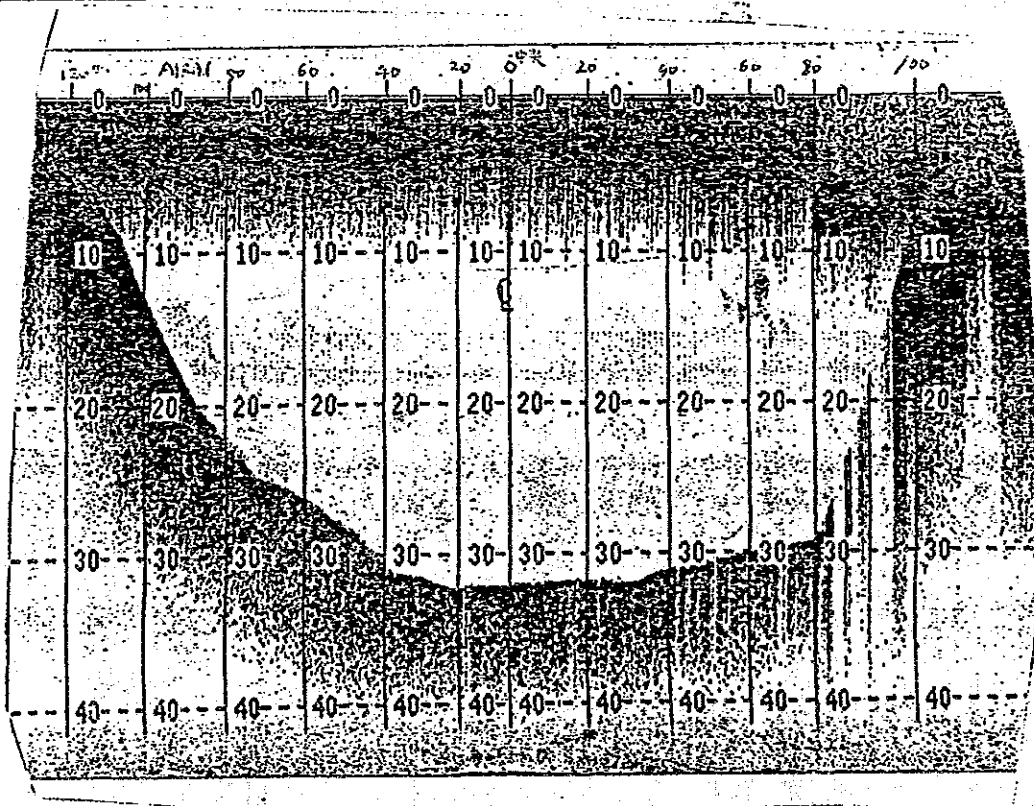
Fig. AN-2 - (2/3) GEOGRAPHICAL SURVEY RESULT

SECTION ①-①

SECTION ②-②

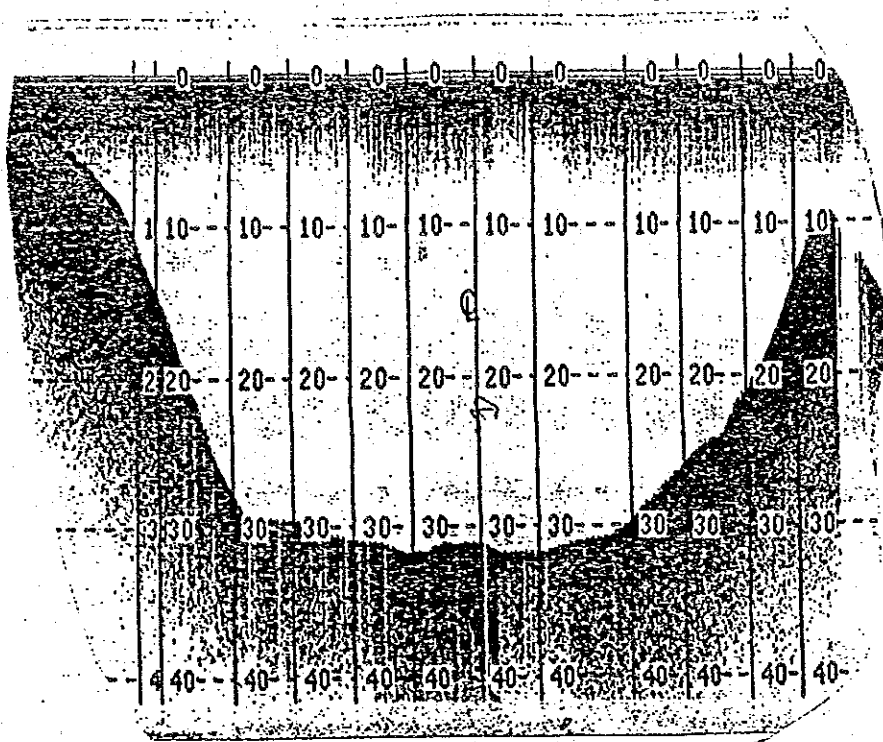
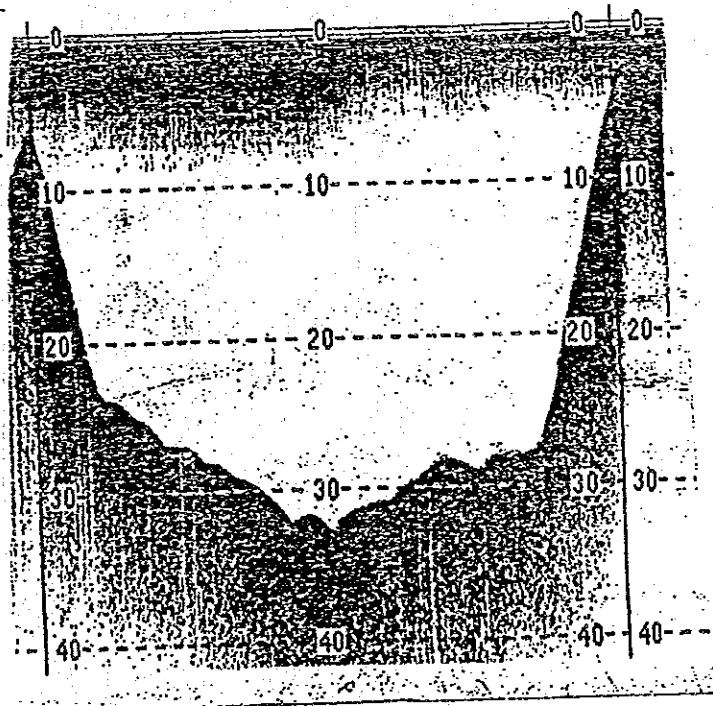
Fig. AN-2- (3/3) GEOGRAPHICAL SURVEY RESULT

SECTION ③ - ③

SECTION ④ - ④

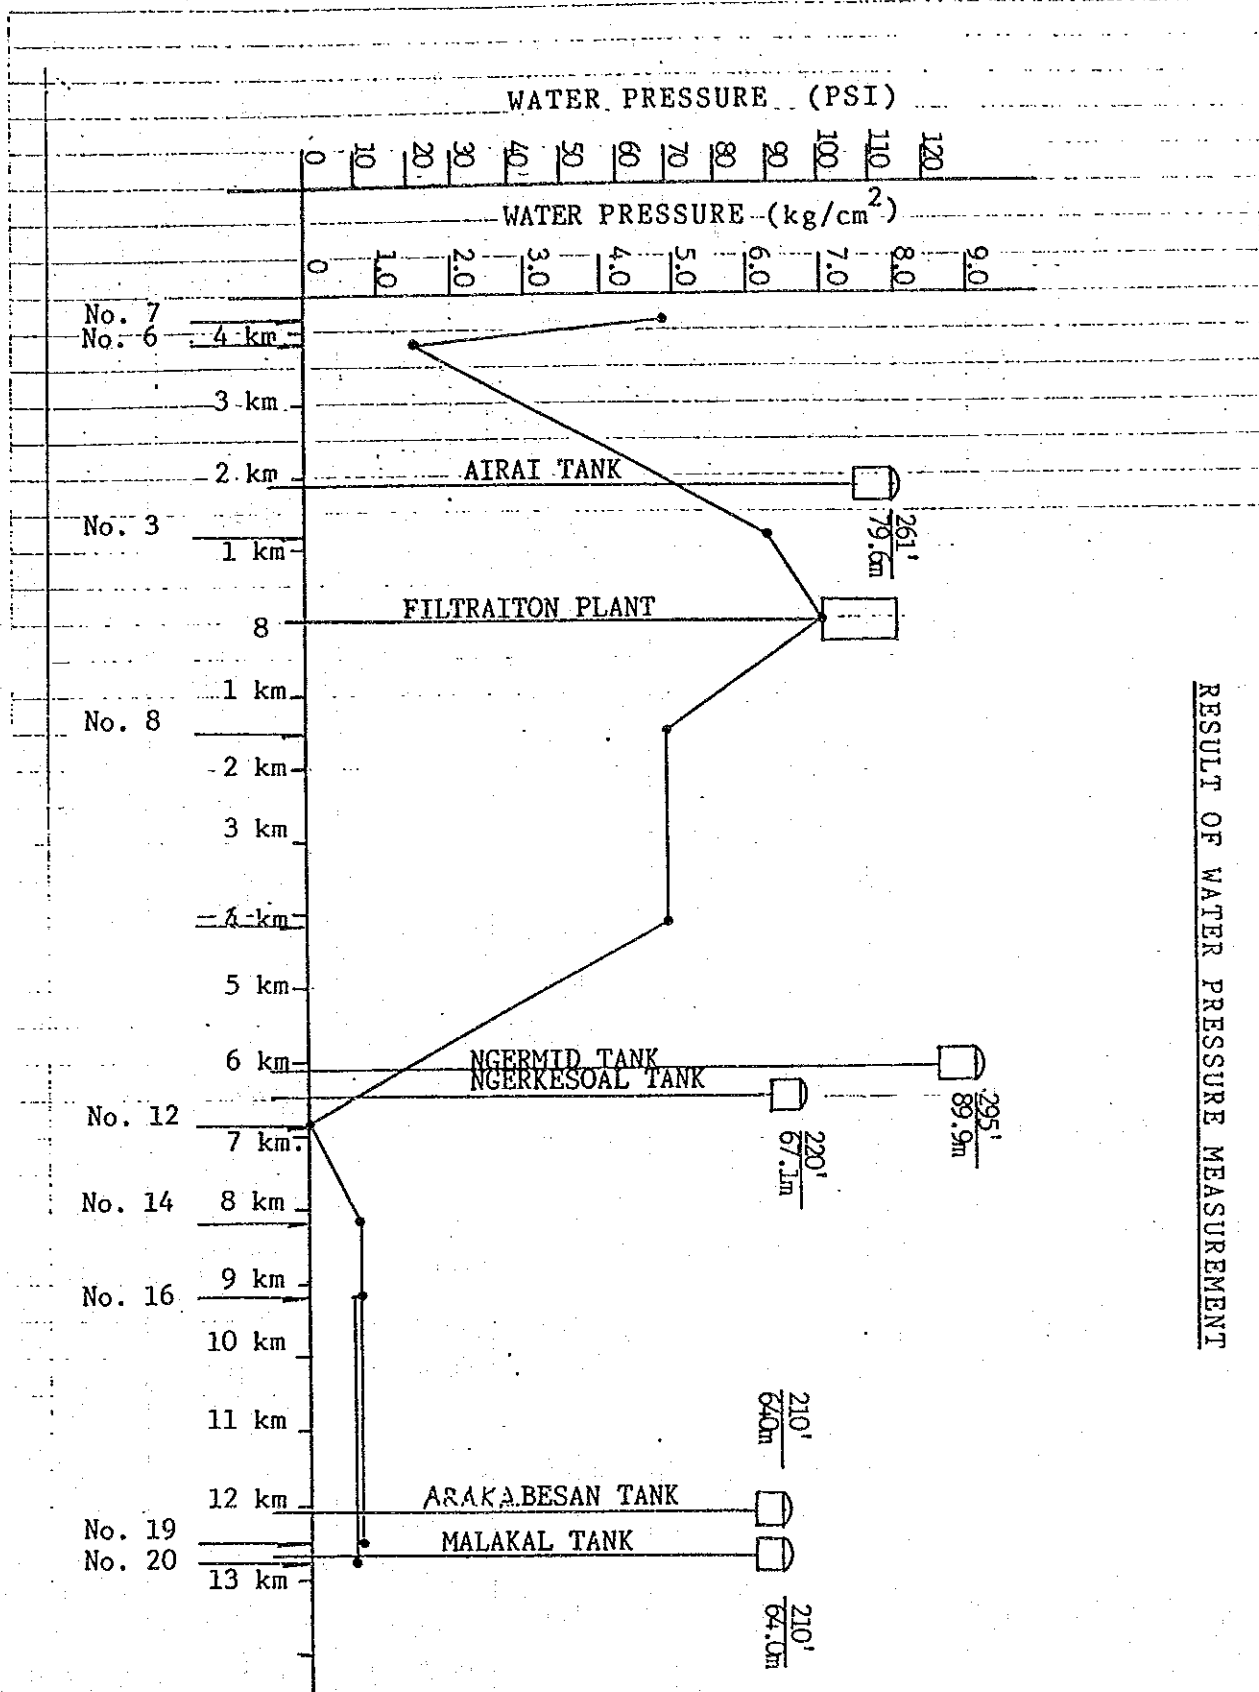
Fig AN-3-(1/2) RESULT OF WATER PRESSURE MEASUREMENT

③ LOCATION OF WATER PRESSURE MEASUREMENT

RESULT OF WATER PRESSURE MEASUREMENT

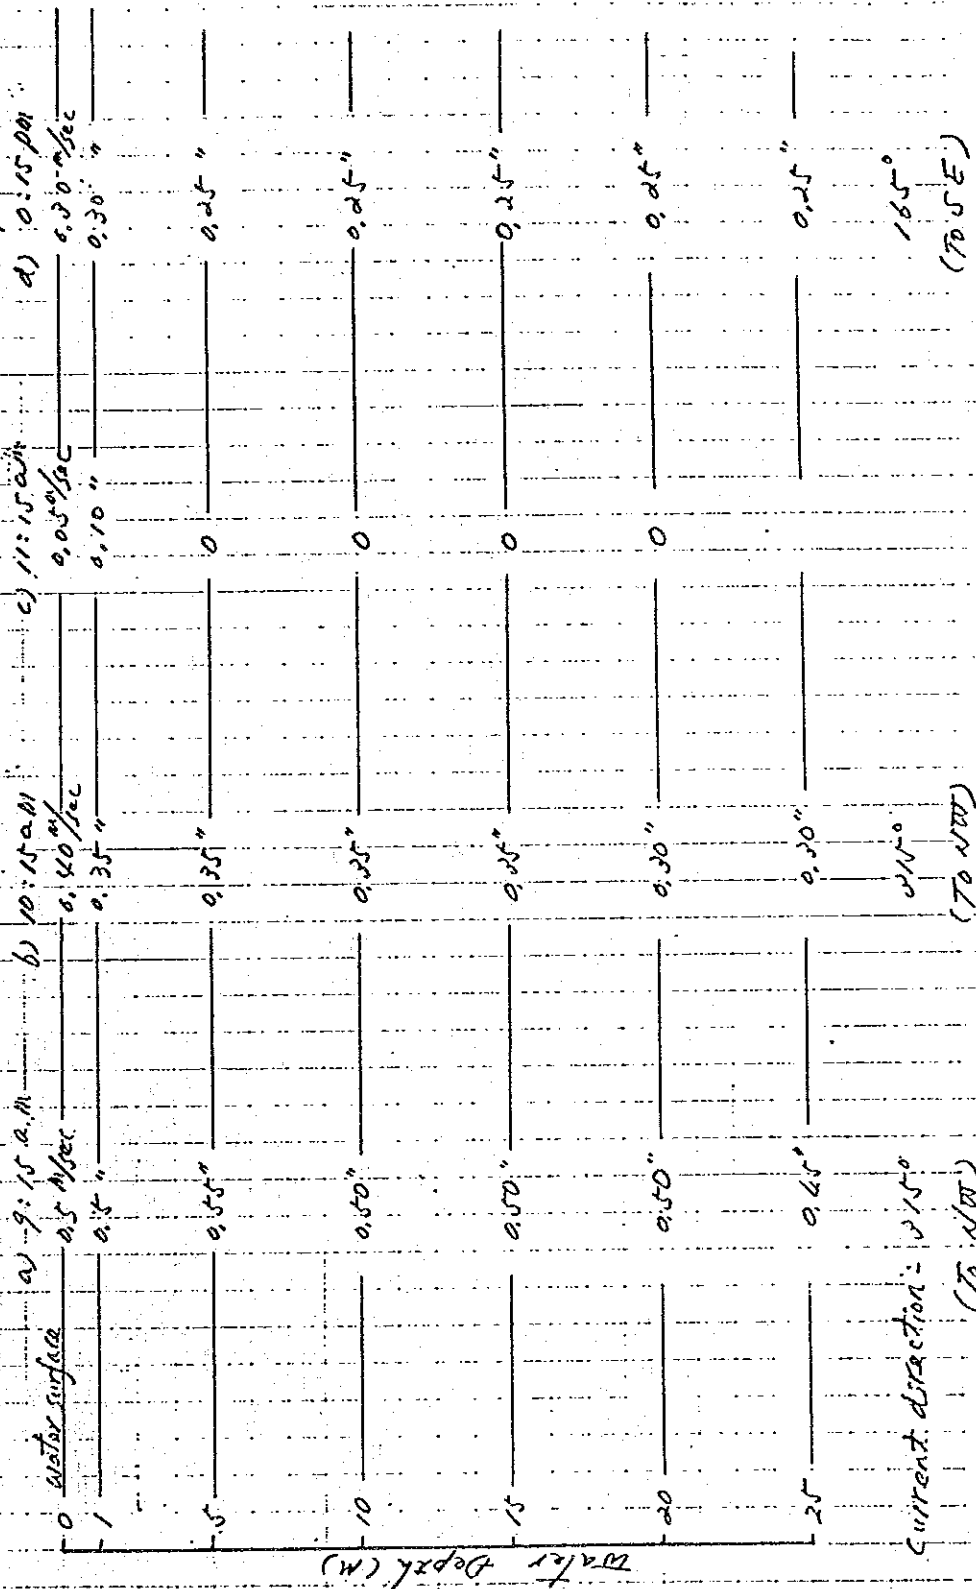
Fig. AN-4. TIDAL CURRENT VELOCITY AND DIRECTION

Remarks 1) Measurement: Dec. 15th 1989

2) Measurement point: At Center of K.B. Bridge
