**THE GOVERNMENT OF MAURITIUS**

**THE STUDY ON  
LANDSLIDE PROTECTION PROJECT  
IN PORT LOUIS**

**FINAL REPORT**

**MAIN REPORT**

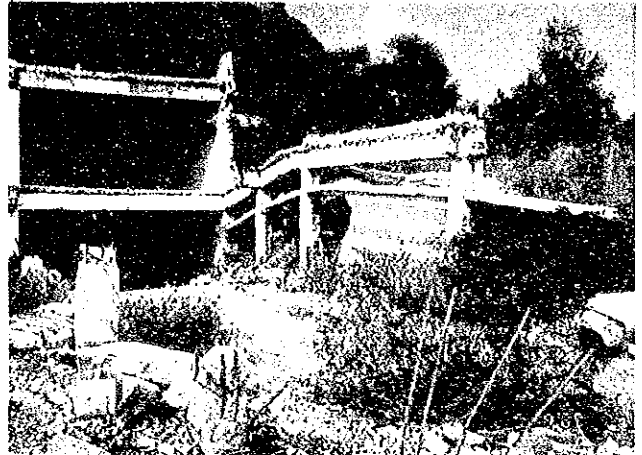
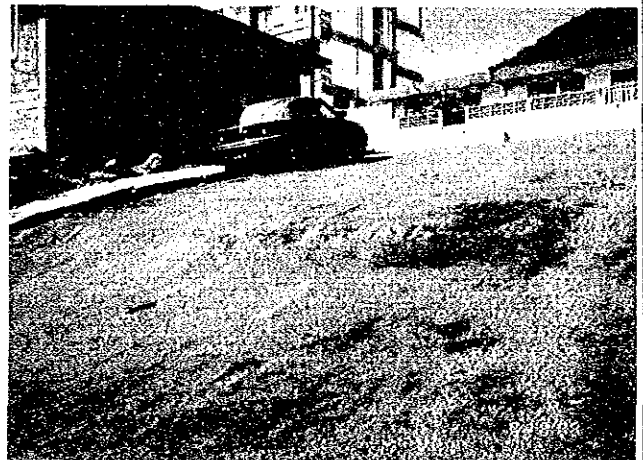
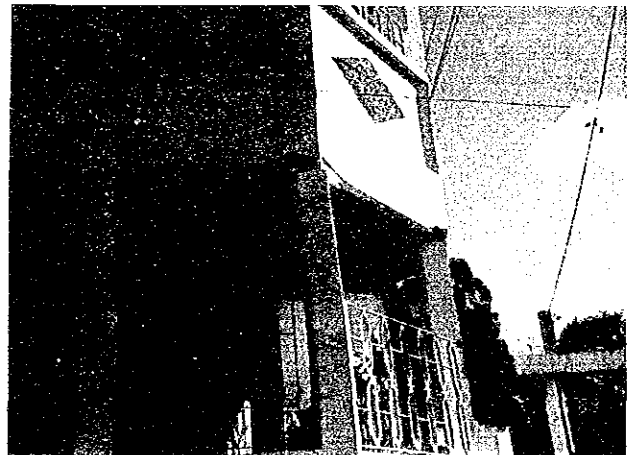
PHOTOGRAPHS OF DAMAGES BY THE LANDSLIDE

Photo 1.  
Slip scarps and open cracks at crown part of the landslide

Photo 2.  
Demolished building in the landslide

Photo 3.  
Demolished mosque in the landslide

Photo 4.  
Upheavals crossing a road at northern toe portion of the landslide

Photo 5.  
Damaged structures in the landslide area

Photo 6.  
Damaged house in the landslide area

The Government of Mauritius designated the district of about 12.5 ha as a high risk area for landslide damages. In the restricted area, 327 houses are packed and 479 families are living. Anticipated potentially endanger area is assumed in the outside lower parts of the landslide area. Total population of the high risk area and the anticipated potentially endanger area is about 3700. More than 50 buildings or houses were demolished because of their serious damages by landslide movements. A mosque built more than 120 years ago and Ecole de la Montagne with 550 students, which is now closed, are included in these demolished buildings. About 1 m differences in level, which cause traffic interference, were created on main roads in the landslide area. Damages caused by landslide movements are shown in the attached photographs of Fig.1.1-2.
