THE STUDY OF ROAD IMPROVEMENT
BETWEEN SANTA BARBARA AND BELLA VISTA
IN
THE REPUBLIC OF BOLIVIA

FINAL REPORT

SUMMARY

JAPAN INTERNATIONAL COOPERATION AGENCY

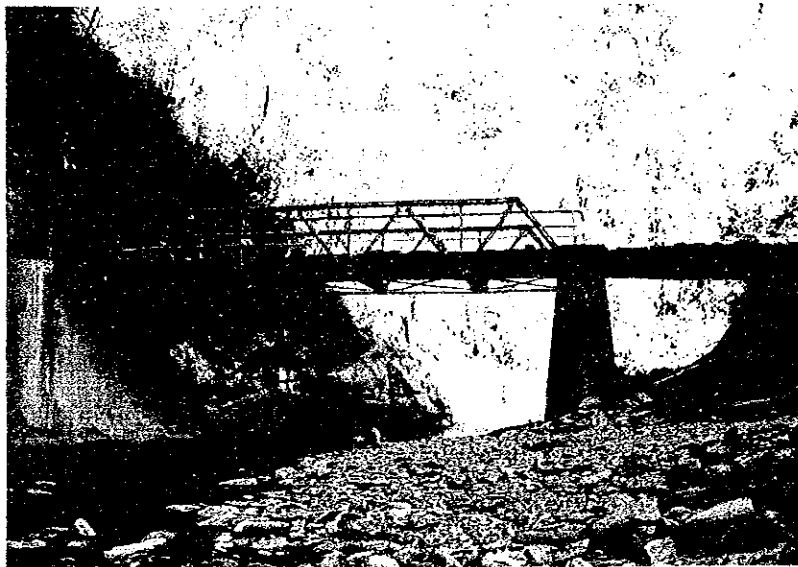
Photo-6
Scene of the present truss bridge near Puerto León. The bridge is old and rotten and wooden slabs have been used in temporary treatment.

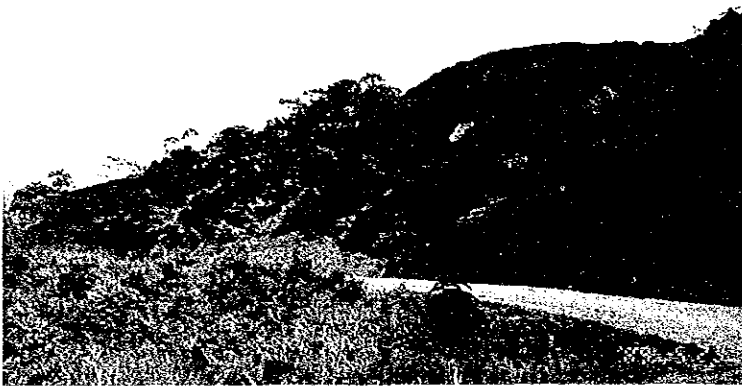
Photo-11
Scene of the location 116 km from the point of origin, where landslides occur now and then.

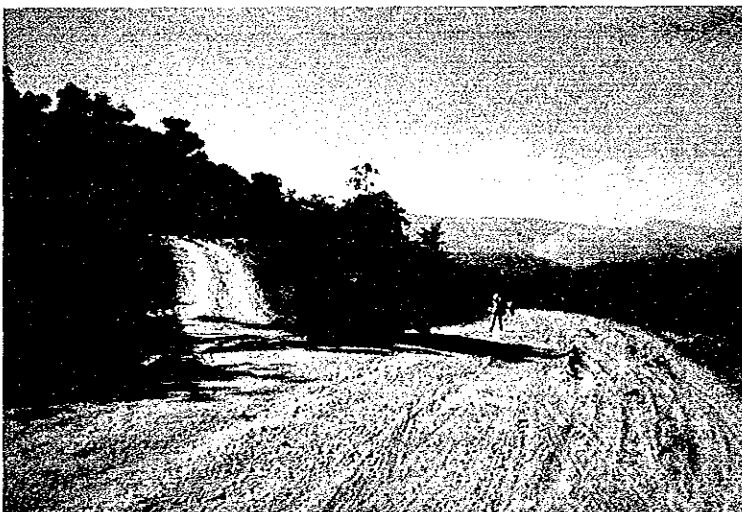
Photo-12
Scene of the present road condition at Bella Vista (terminal point of the Study Road). The road in the foreground of this photo has been already improved by the SNC.
