附 属 資 料

APPLICATION
BY
THE GOVERNMENT OF THE REPUBLIC OF MALDIVES
FOR
THE DEVELOPMENT STUDY
ON
THE SEAWALL CONSTRUCTION PROJECT IN MALE ISLAND
TO
THE GOVERNMENT OF JAPAN

SCOPE OF WORK
FOR
THE DEVELOPMENT STUDY ON
THE SEAWALL CONSTRUCTION PROJECT FOR MALE ISLAND
IN
THE REPUBLIC OF MALDIVES

附属資料7. モルディブにおける高潮災害

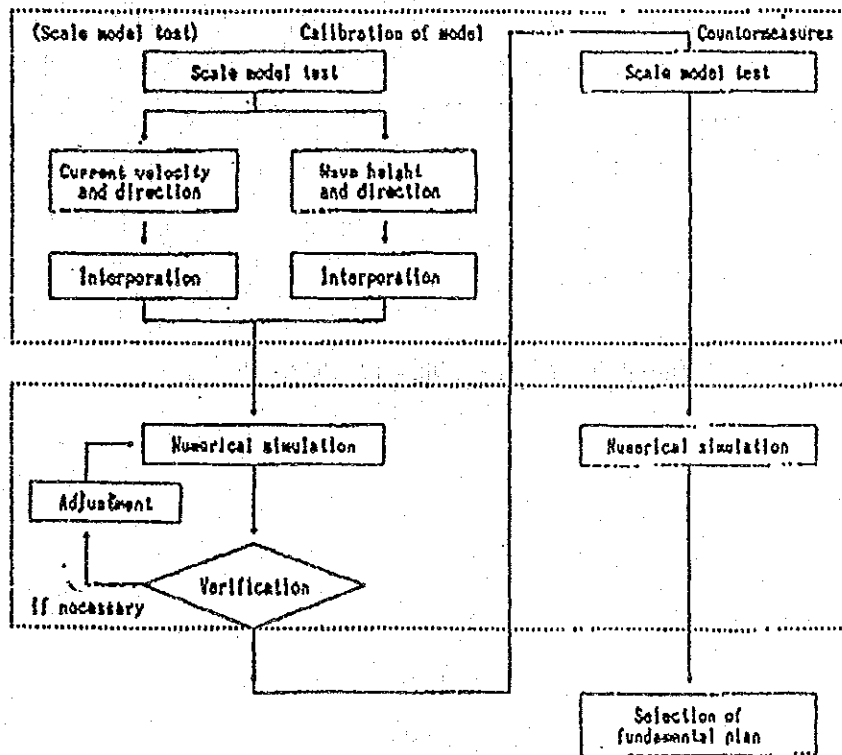
Fig 2.1 Flowchart of Hydraulic Model Test

The flowchart of hydraulic model test is shown in Fig.2.1.

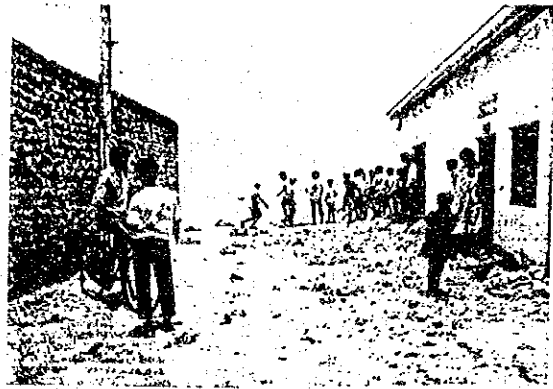
次に、高潮状況を写真をもとに調べる。島の東側で撮影した写真-1によると、水位が上昇するとともに高波がリーフ上で砕破しているのが明らかである。家屋の前の道路にはサンゴ塊が多数散乱している。この付近の護岸状況を写真-2に示す。護岸の地盤面から

写真-1 マレ島東部における高潮米襲状況 (撮影地点と撮影方向は図-4の①→により示す。)

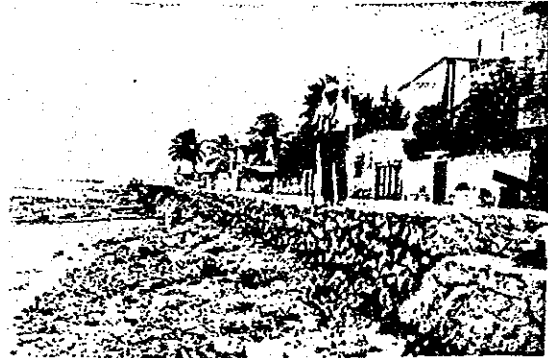
写真-2 マレ島東岸の護岸状況

の高さは約1.4mであり、サンゴ塊をモルタルで固めた構造となっている。これらのサンゴ塊は強度試験によると、単位体積重量が約 $2.34\text{g}/\text{cm}^3$ 、1軸圧縮強度が約 $400\text{kg}/\text{cm}^2$ であった。道路とリーフ面との地盤高の差は約1.2mである。高波によりこの段差を越えて海水が侵入し、サンゴ塊が散乱した。写真-3、4は島の南部の状況を示す。内陸側を向いて撮影したものである。道路が浸水するとともに、島の南部にあったゴミ処理場より大量のゴミが散乱している。このような浸水により下水が逆流し、併せて高温が続いたため衛生状態は大変悪くなり、飲料水等も汚染され、コレラの発生を見た。コレラは4月20日頃から始まり、2名が死亡、28名の患者が出た。

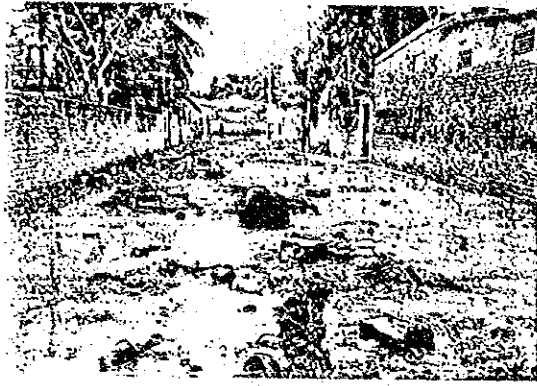
写真-3 マレ島南部における浸水状況（撮影地点と撮影方向は図-4の②→により示す。）

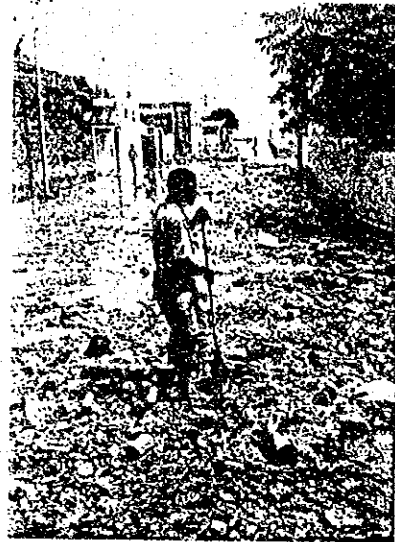
写真-4 マレ島南部における浸水およびゴミの散乱状況（撮影地点と撮影方向は図-4の③→により示す。）

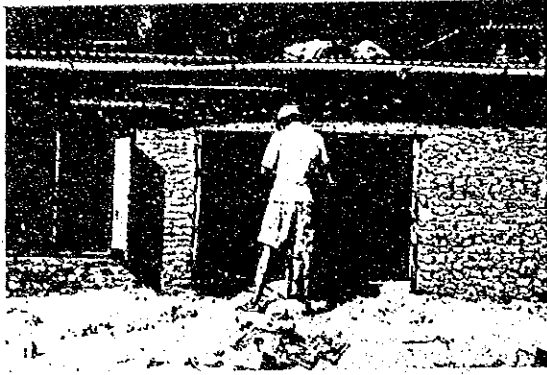
写真-7 家屋内に侵入したサンゴ塊

ギーロスを伴うことなしに島に到達した。写真-6は同島の南側を撮影したものである。被災前にあった砂浜は消失し、大量のサンゴ塊が前浜に打ち上げられた。島にはリゾート客用のコテージが汀線に沿って並んでいるが、その家屋内には大量のサンゴ砂やサンゴ塊が侵入し、家屋は大きく被災した。写真-7は、家屋の被災状況を示す。入口の戸が流失しており、土砂の堆積によりその位置での地盤高が高くなっていることが明らかである。
