FEASIBILITY STUDY
ON
MAGWAGWA HYDROELECTRIC POWER
DEVELOPMENT PROJECT

FINAL REPORT
DATA BOOK (2)

II.1 Seismic Exploration

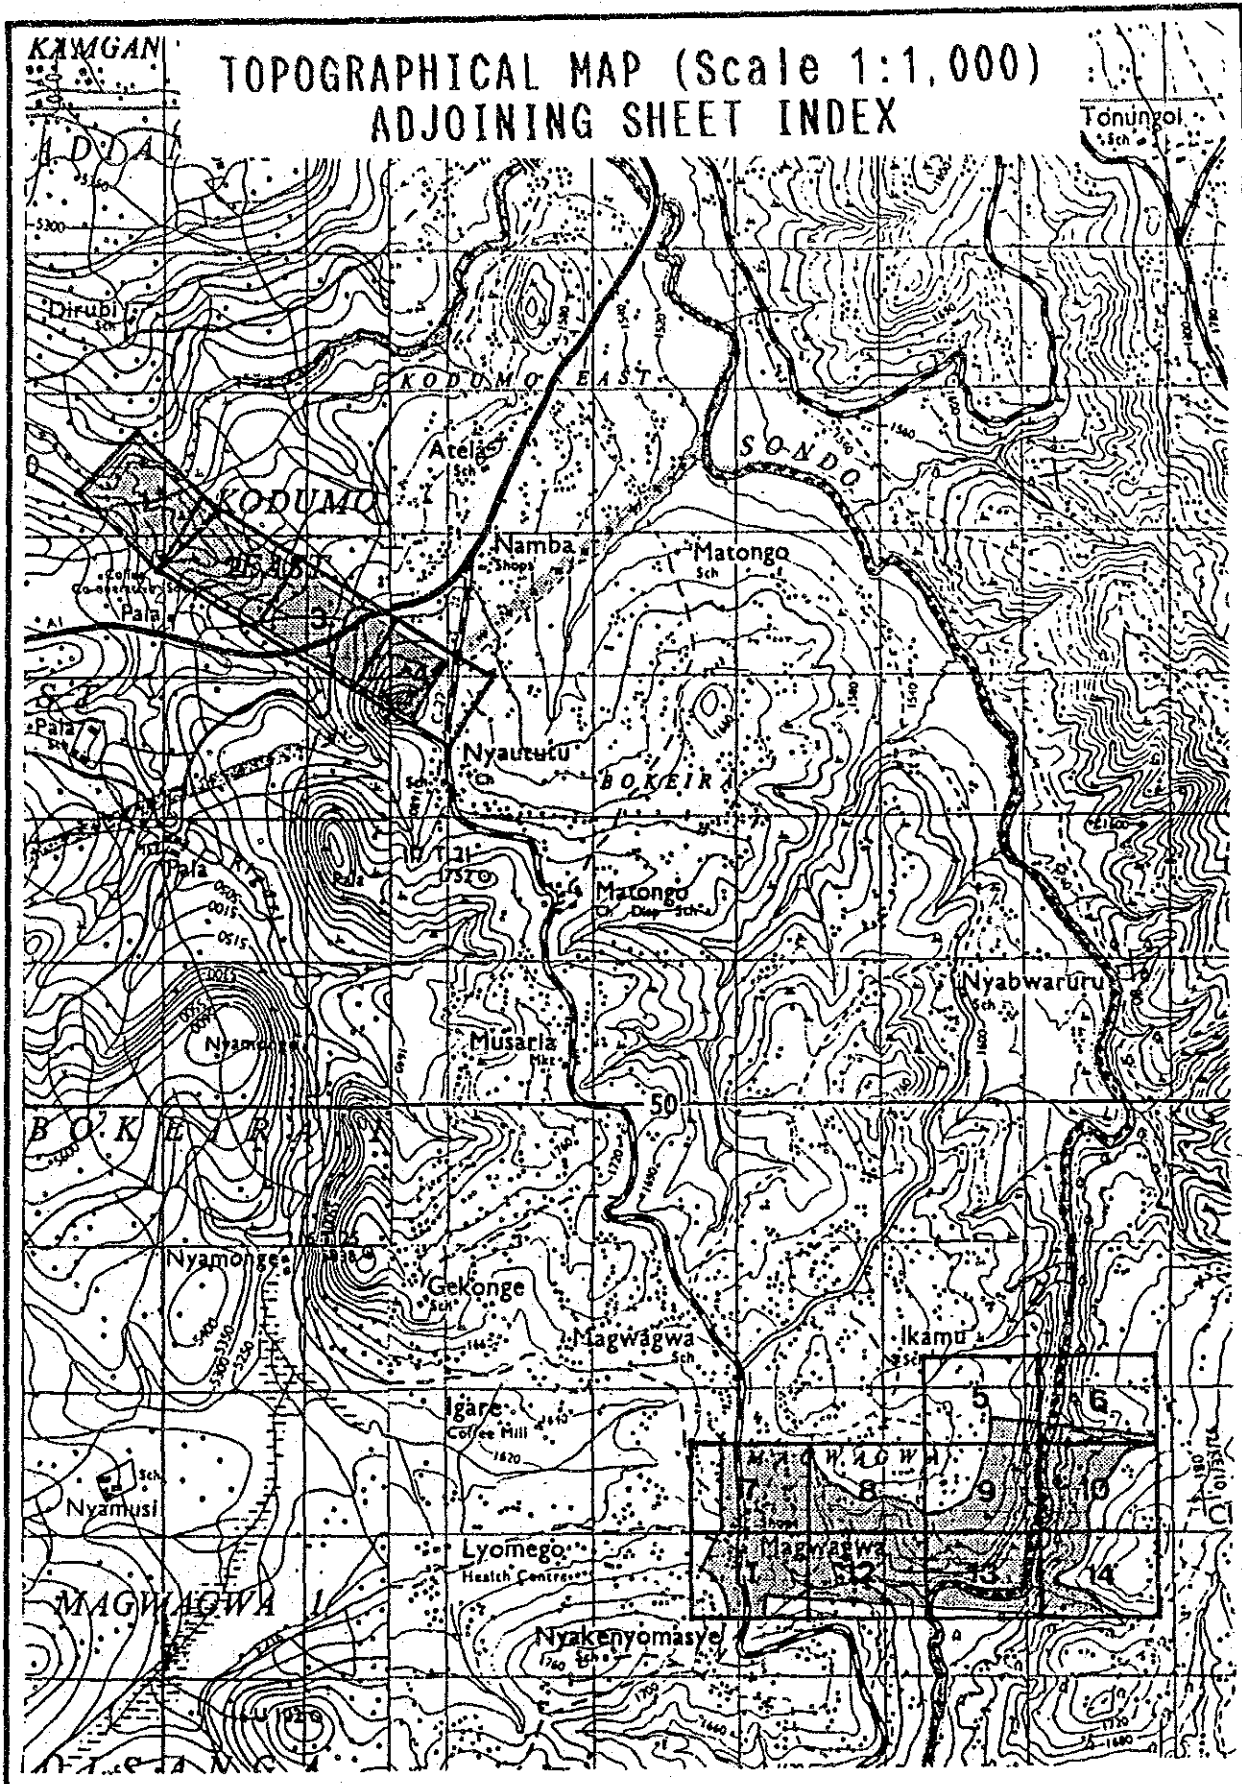
Figure 3.3 Sheet Number Index of Topographic Maps on a Scale of 1 to 1,000

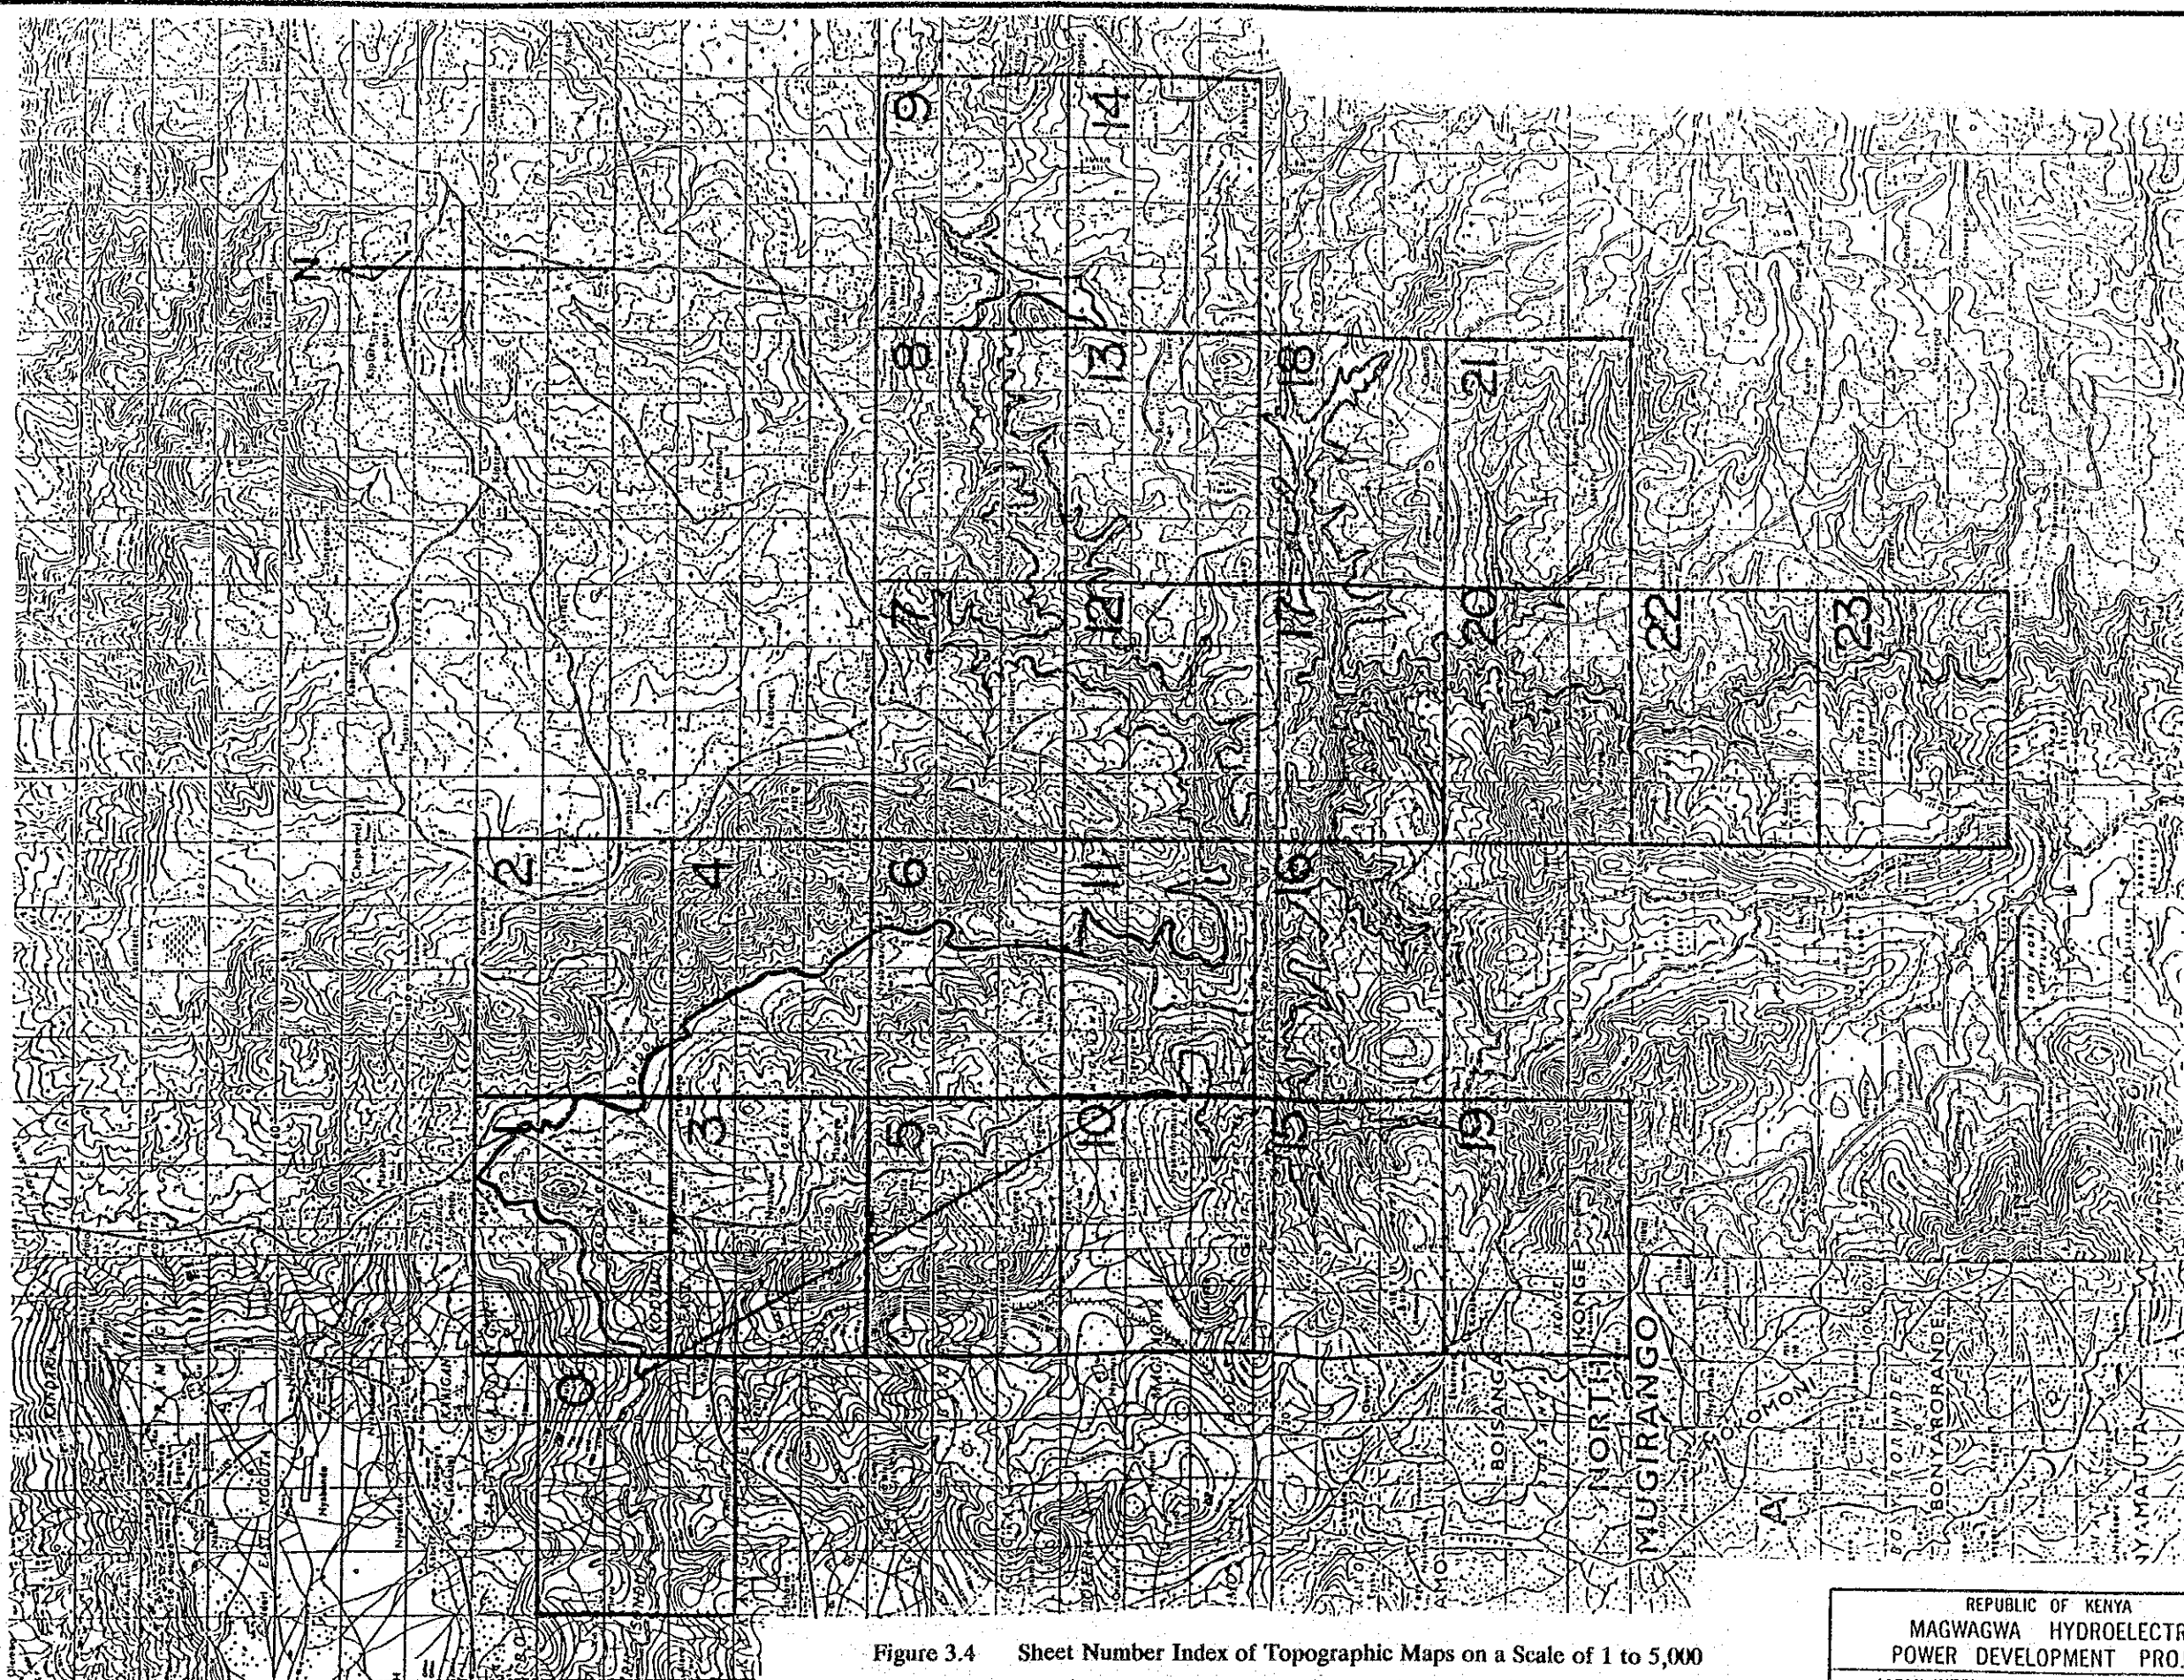
Figure 3.4 Sheet Number Index of Topographic Maps on a Scale of 1 to 5,000
