4.2 SELECTION OF PRELIMINARY DESIGN SECTIONS

4.3 SUPPLEMENTAL TOPOGRAPHIC SURVEY

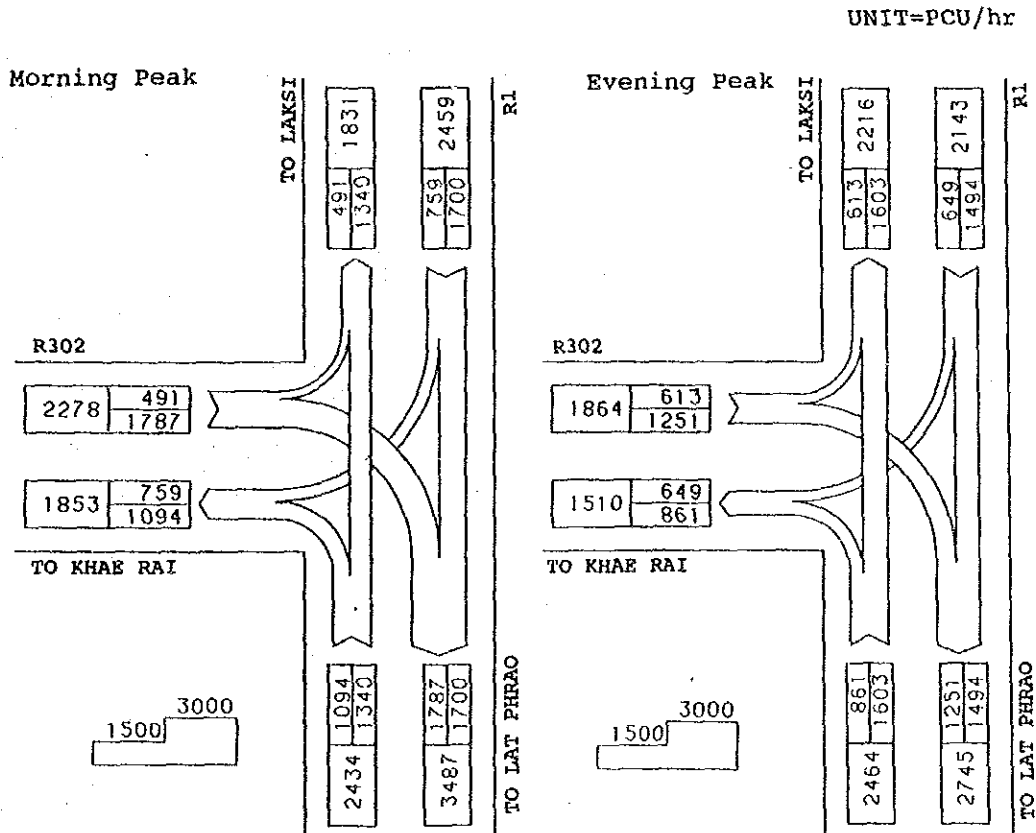
Figure 4.7 TURNING MOVEMENT AT THE INTERSECTION OF S-18

The supplemental traffic survey recorded the peak-hour traffic volume which passed through the intersection under over-saturated conditions. If it were not for the over-saturated conditions the volume of traffic would have been higher for the same period of time.

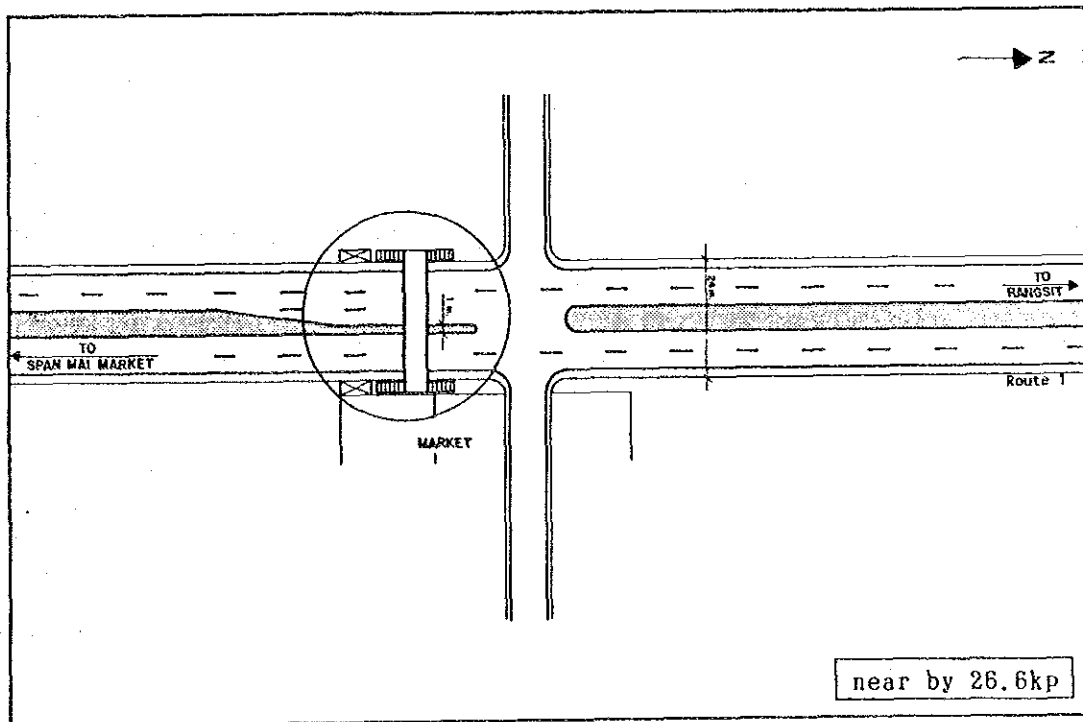
ILLUSTRATION OF TRAFFIC SAFETY / OPERATION PLAN

Installation of pedestrian overpass: Satisfies criteria for improvement.
