**FINAL REPORT  
ON  
THE AGRICULTURAL VERIFICATION STUDY**

**MAIN REPORT**

MARCH 1993

JAPAN INTERNATIONAL COOPERATION AGENCY

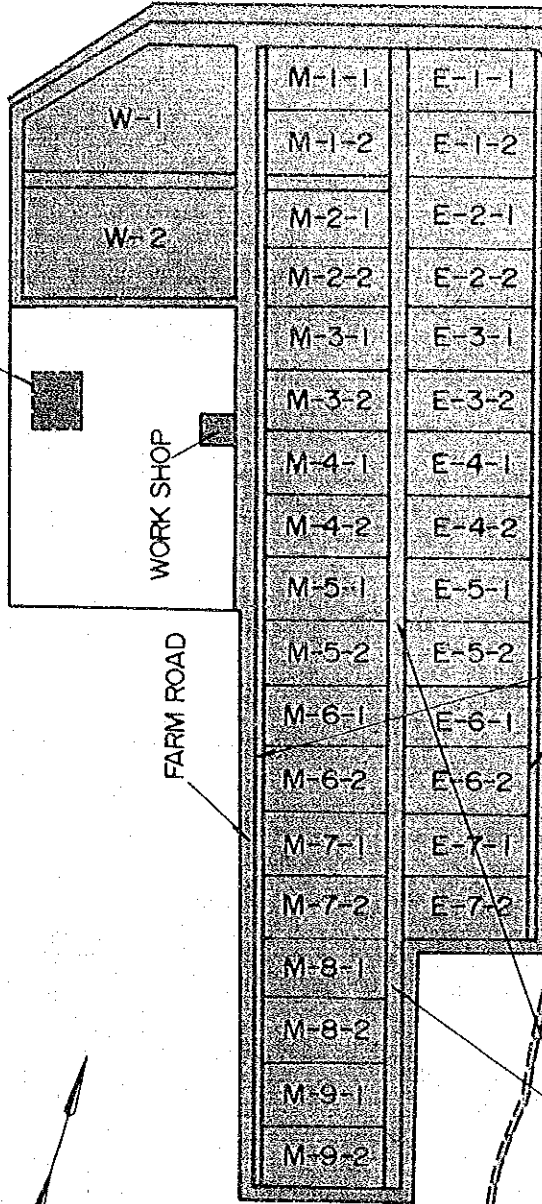
PLAN OF AVS FARM (NAMUSHAKENDE)

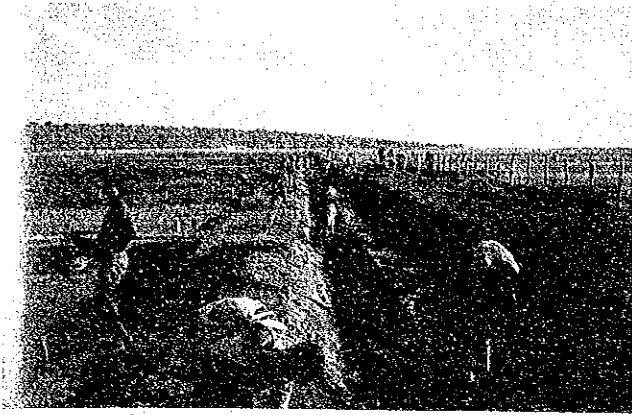
Construction of an irrigation canal

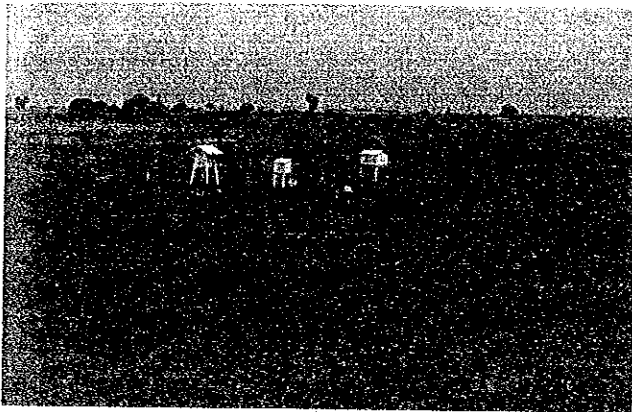
Field agro-meteorological station

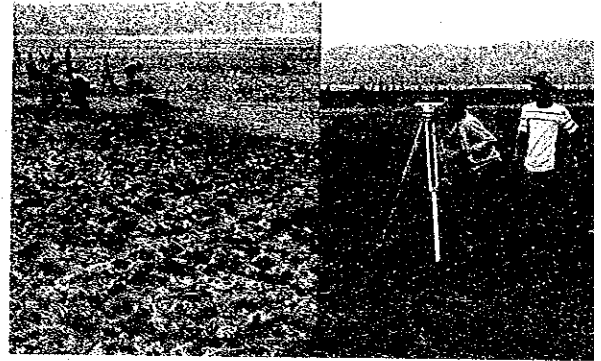
Farm levelling work

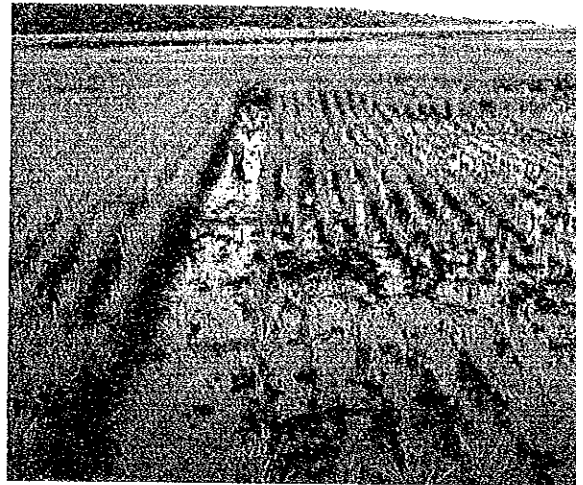
Lime application trial for rice (Namushakende, (right : no lime)

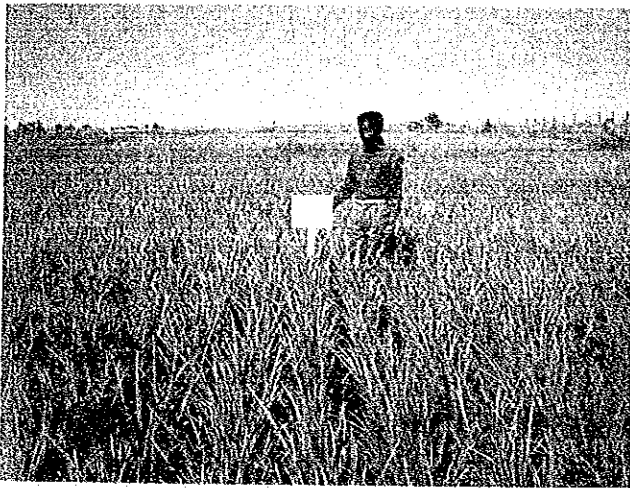
Rice straw incorporated plot in the soil improvement trial (Namushakende) (The spaces between crop stands are not seen because of vigorous growth)

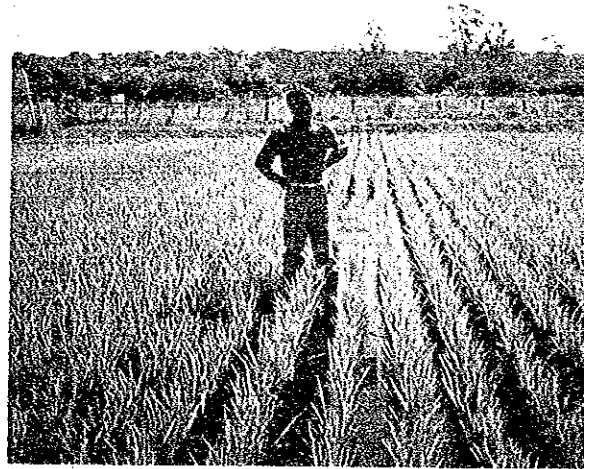
Rice straw-free plot in the soil improvement trial (Namushakende) (The spaces between crop stands are easily seen because of poor growth)

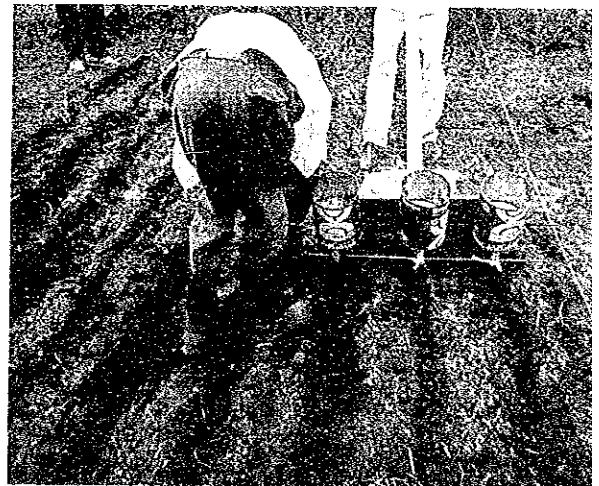
Sowing test using the 3-line drill seeder manufactured by the AVS team

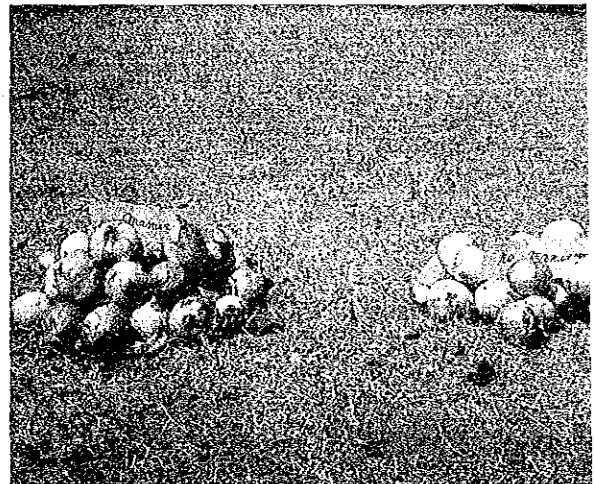
Onion (Namushakende)  
left : Cattle manure applied      right : No manure

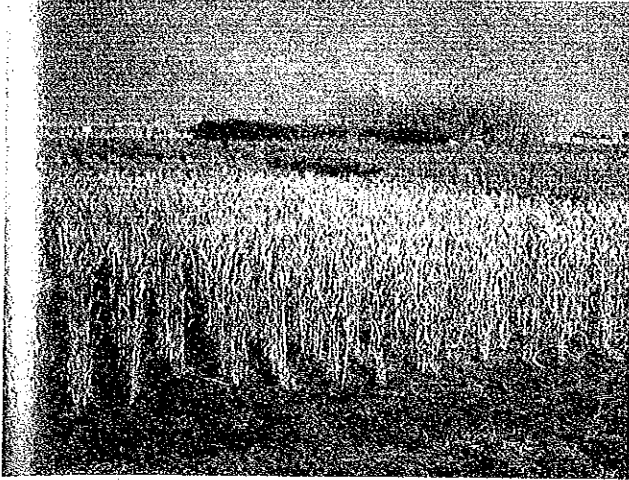
Wheat on the field (Namushakende)  
left: No manure right: Cattle manure applied  
(earlier maturation)

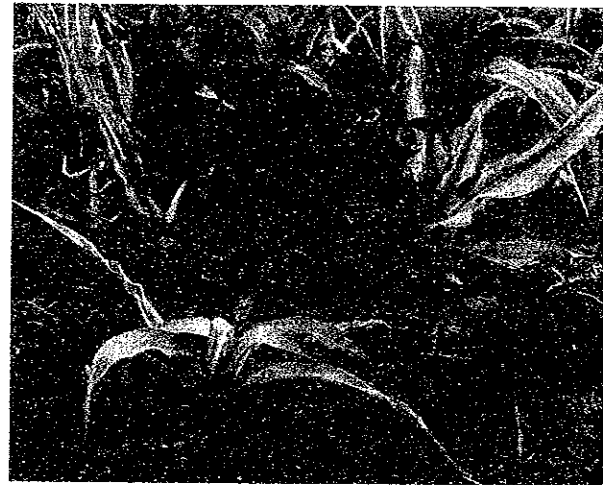
Zn deficiency symptom on maize  
(Namushakende)

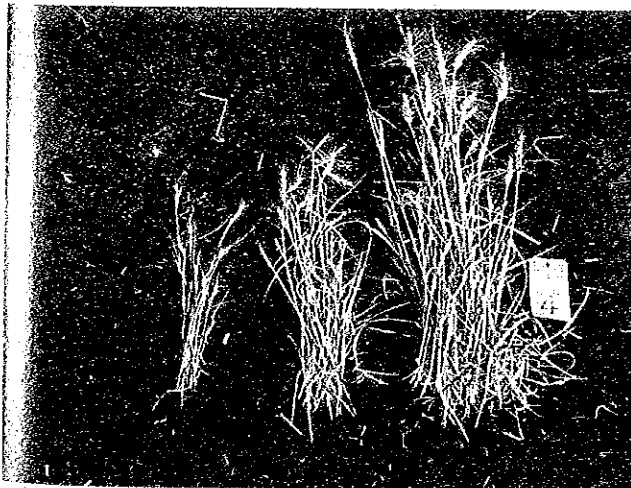
Difference of Cu deficiency of wheat between soils  
Namushakende AVS field soil  
(severe deficiency)  
No fertilizer (left) Control (center) Control + Cu (right)

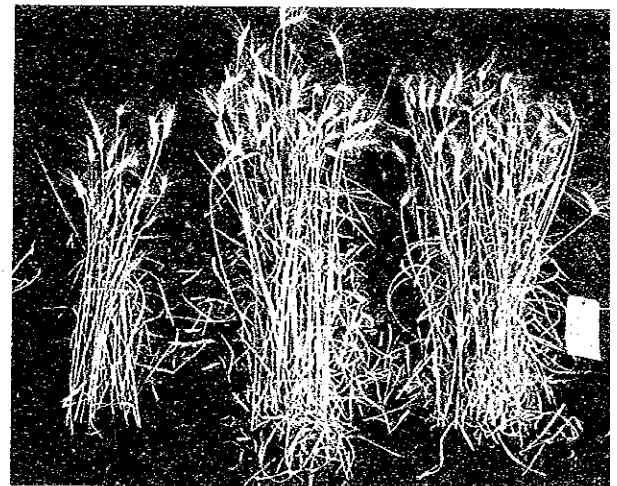
Limulunga soil (not so severe)  
No fertilizer (left) Control (center) Control + Cu (right)

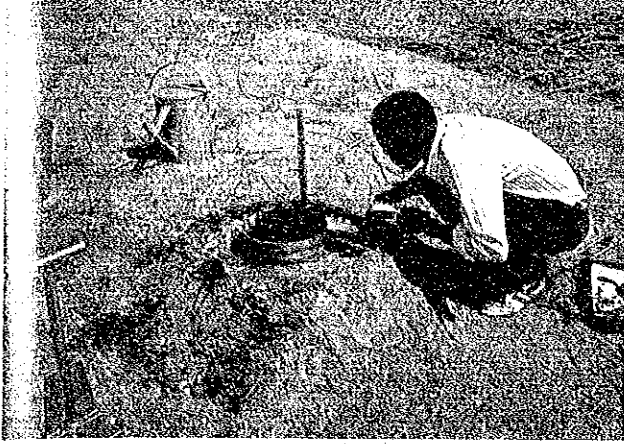
Soil intake rate investigation (Lealui)

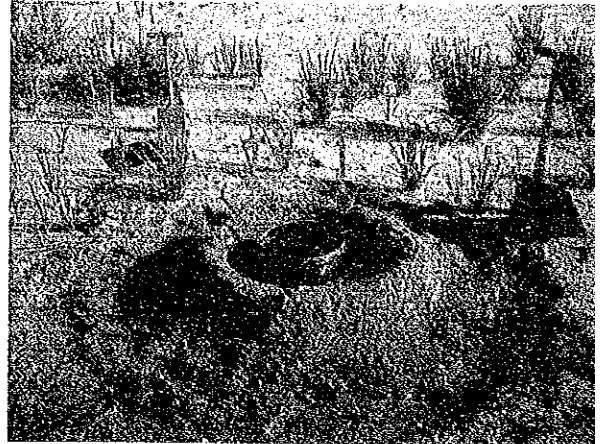
Soil intake rate investigation (Lealui)

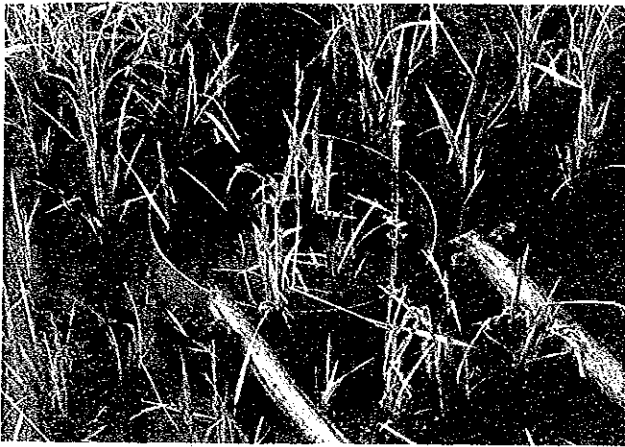
Paddy field water requirement measurement (Namushakende)

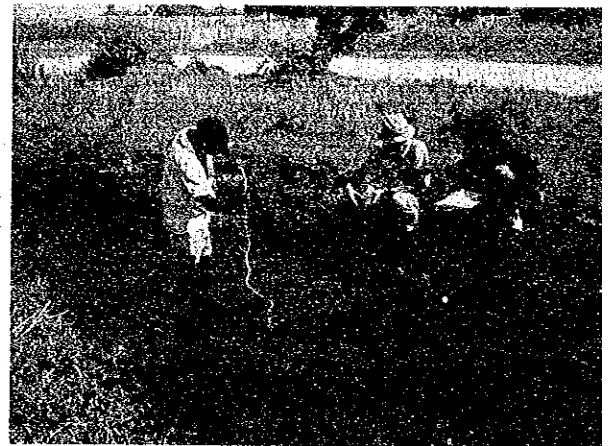
Natural stream flow discharge investigation at Sefula

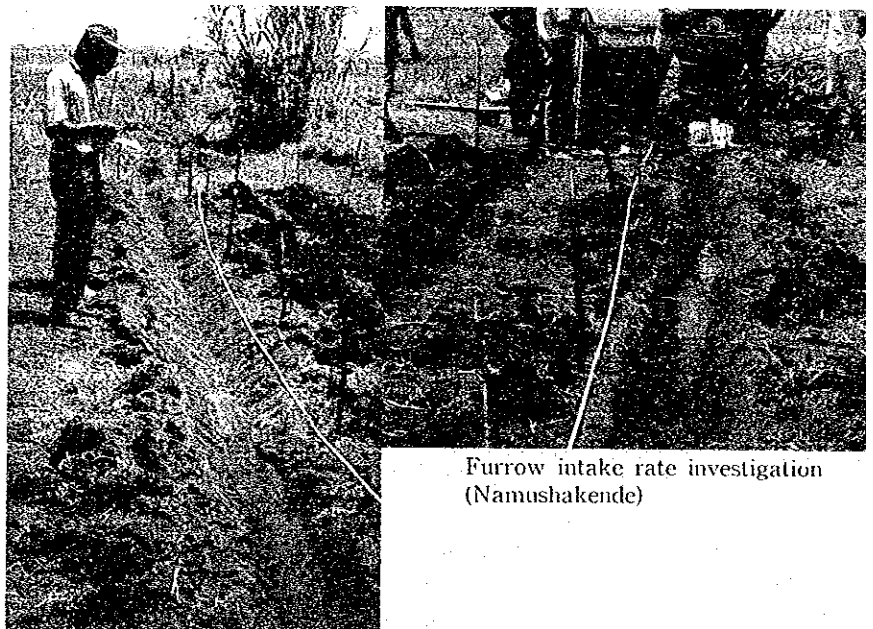
Furrow intake rate investigation (Namushakende)
