THE STUDY  
ON  
THE MAINTENANCE AND REHABILITATION  
OF  
BRIDGES  
IN  
MALAYSIA

FINAL REPORT

VOLUME I  
EXECUTIVE SUMMARY

JAPAN INTERNATIONAL COOPERATION AGENCY

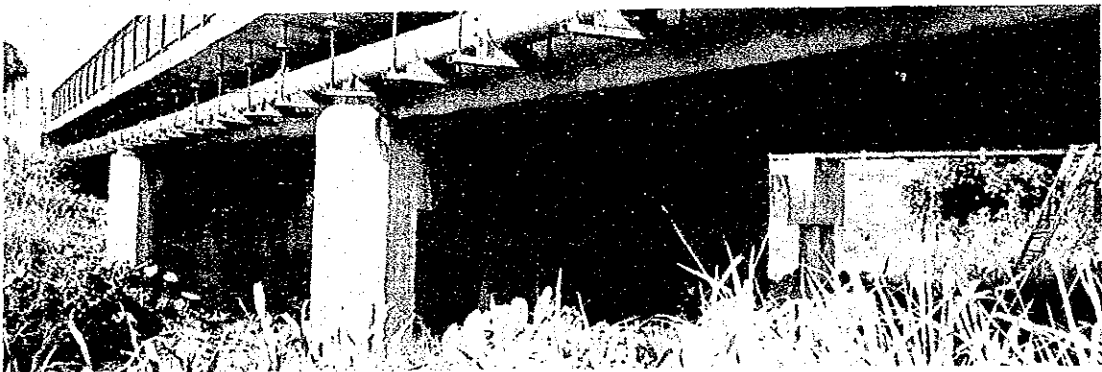
### 2. Steel Beam with Concrete Deck Slab Bridge (SBC)

General View

Paint Deterioration

Two-Way Cracks on Deck Slab Soffit

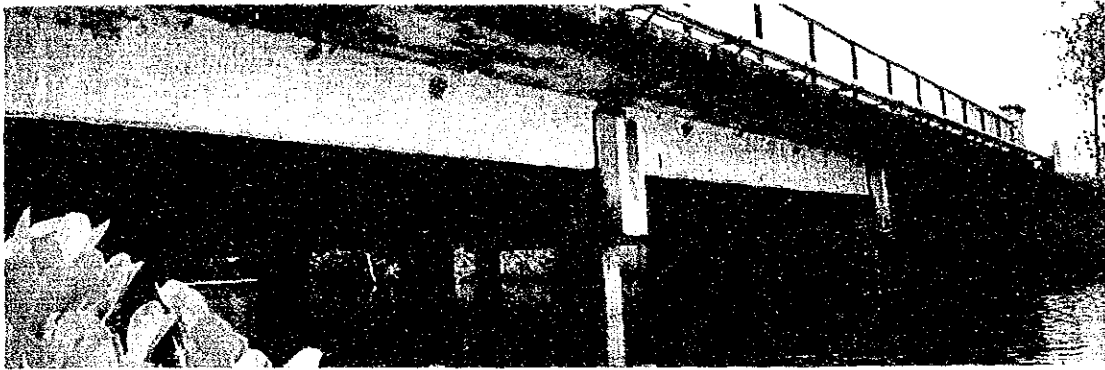
### 3. Reinforced Concrete Beam Bridge (RCB)

General View

Flaking and Rebar Exposure

Free Lime

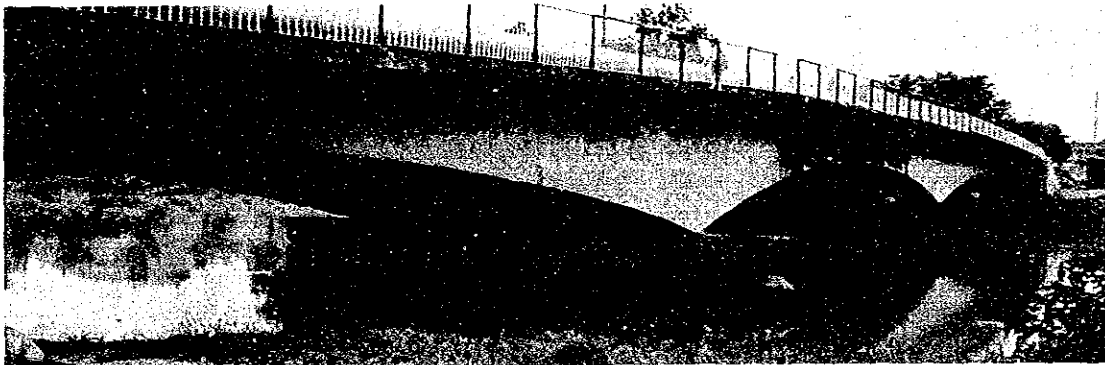
### 4. Reinforced Concrete Slab Bridge (RCS)

General View

Flaking and Rebar Exposure

Water Leakage and Flaking

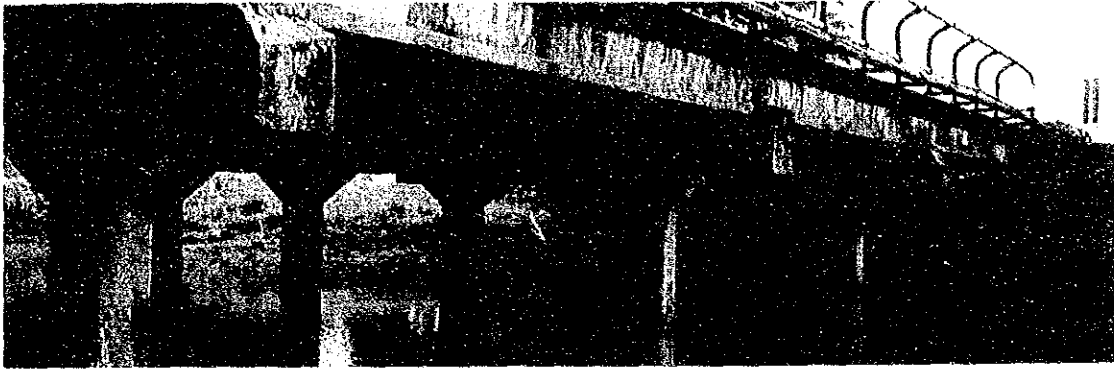
### 5. Precast Reinforced Concrete Beam Bridge (PRB)

General View

Free Lime and Water Leakage between Beams

Flaking and Rebar Exposure

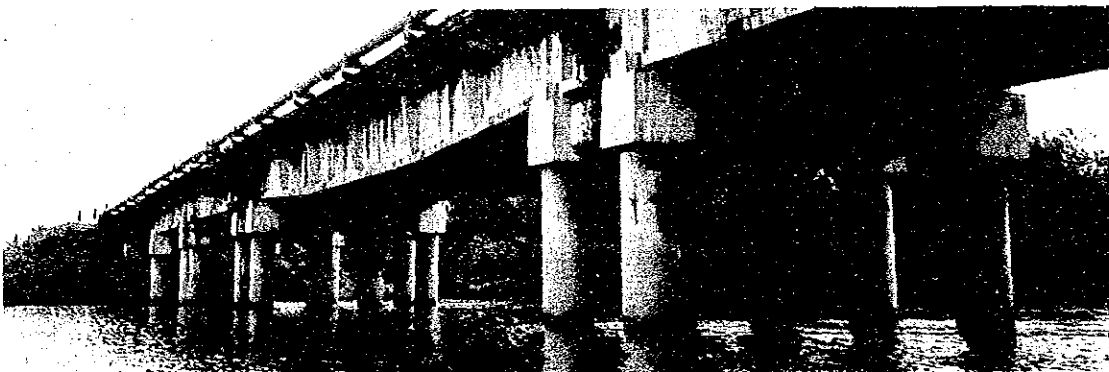
### 6. Prestressed Concrete Beam Bridge (PCB)

General View

Exposed P.C. Tendon on Beam Web

Rebar Exposure on Deck Soffit

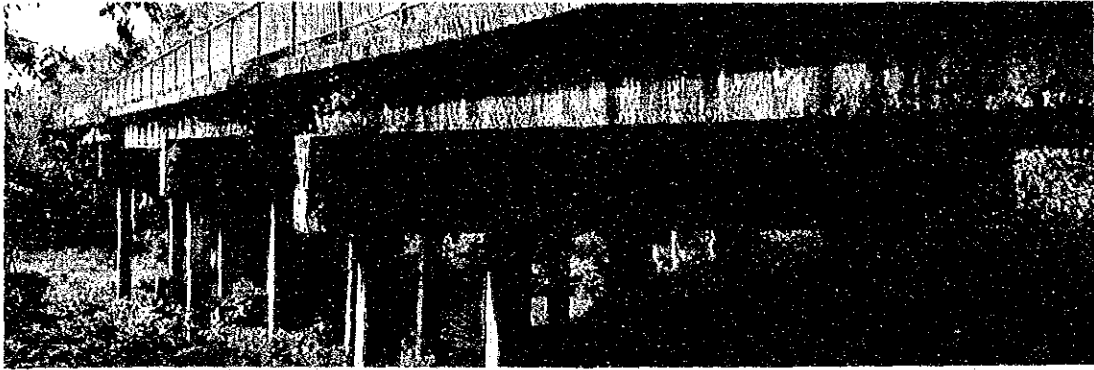
### 7. Pretensioned Inverted Tee Beam Bridge (IT)

General View

Free Lime and Water Leakage between Beams

Exposed P.C. Tendon on Beam Soffit

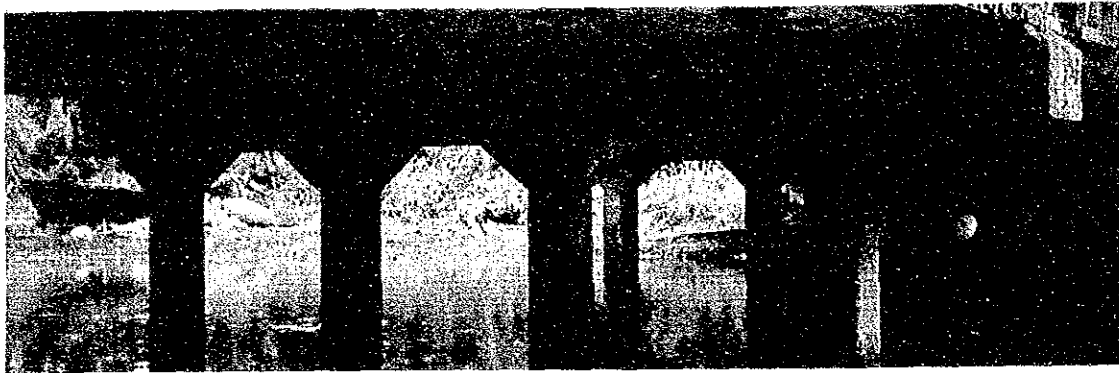
### 9. Pile Bent Type Abutment and Pier

General View

Abrasion due to Acid Attack

Longitudinal Cracks on Pier Column

- The chemical attack on concrete piles identified during NALS is not due to sulphates as originally anticipated, but more likely to be caused by a combination of acid attack and high water-cement ratio in the concrete. As a precautionary measure, it is concluded to apply rich mix concrete with unit portland cement content more than 300 kg/m<sup>3</sup> in the rehabilitation design.
- The foundation failure at Bridge No.00546980 is probably due to a combination of inadequate bearing capacity of the piles in the original design, negative friction due to consolidation settlement and lateral soil movement. It is therefore prudent to consider urgent rehabilitation measures to support the superstructure by constructing new rigid framed abutments close to the existing abutments.

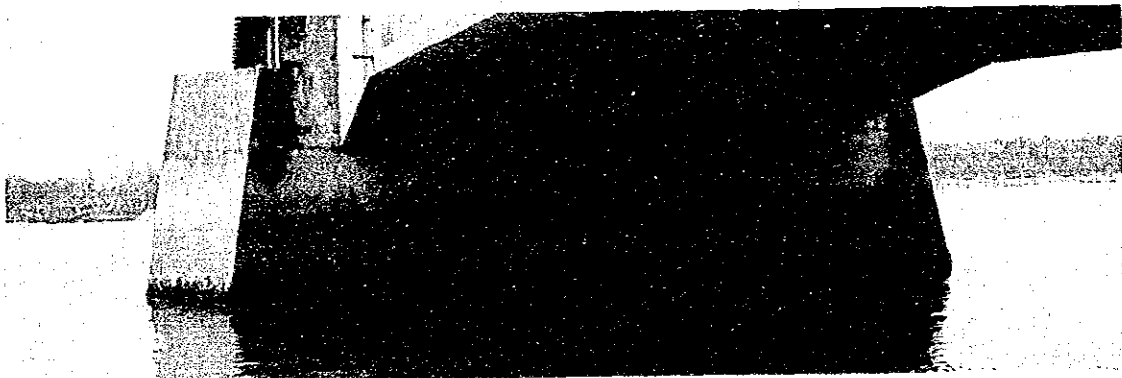
### 10. Wall Type Pier

General View

Flaking and Rebar Exposure

Vertical Crack on Wall

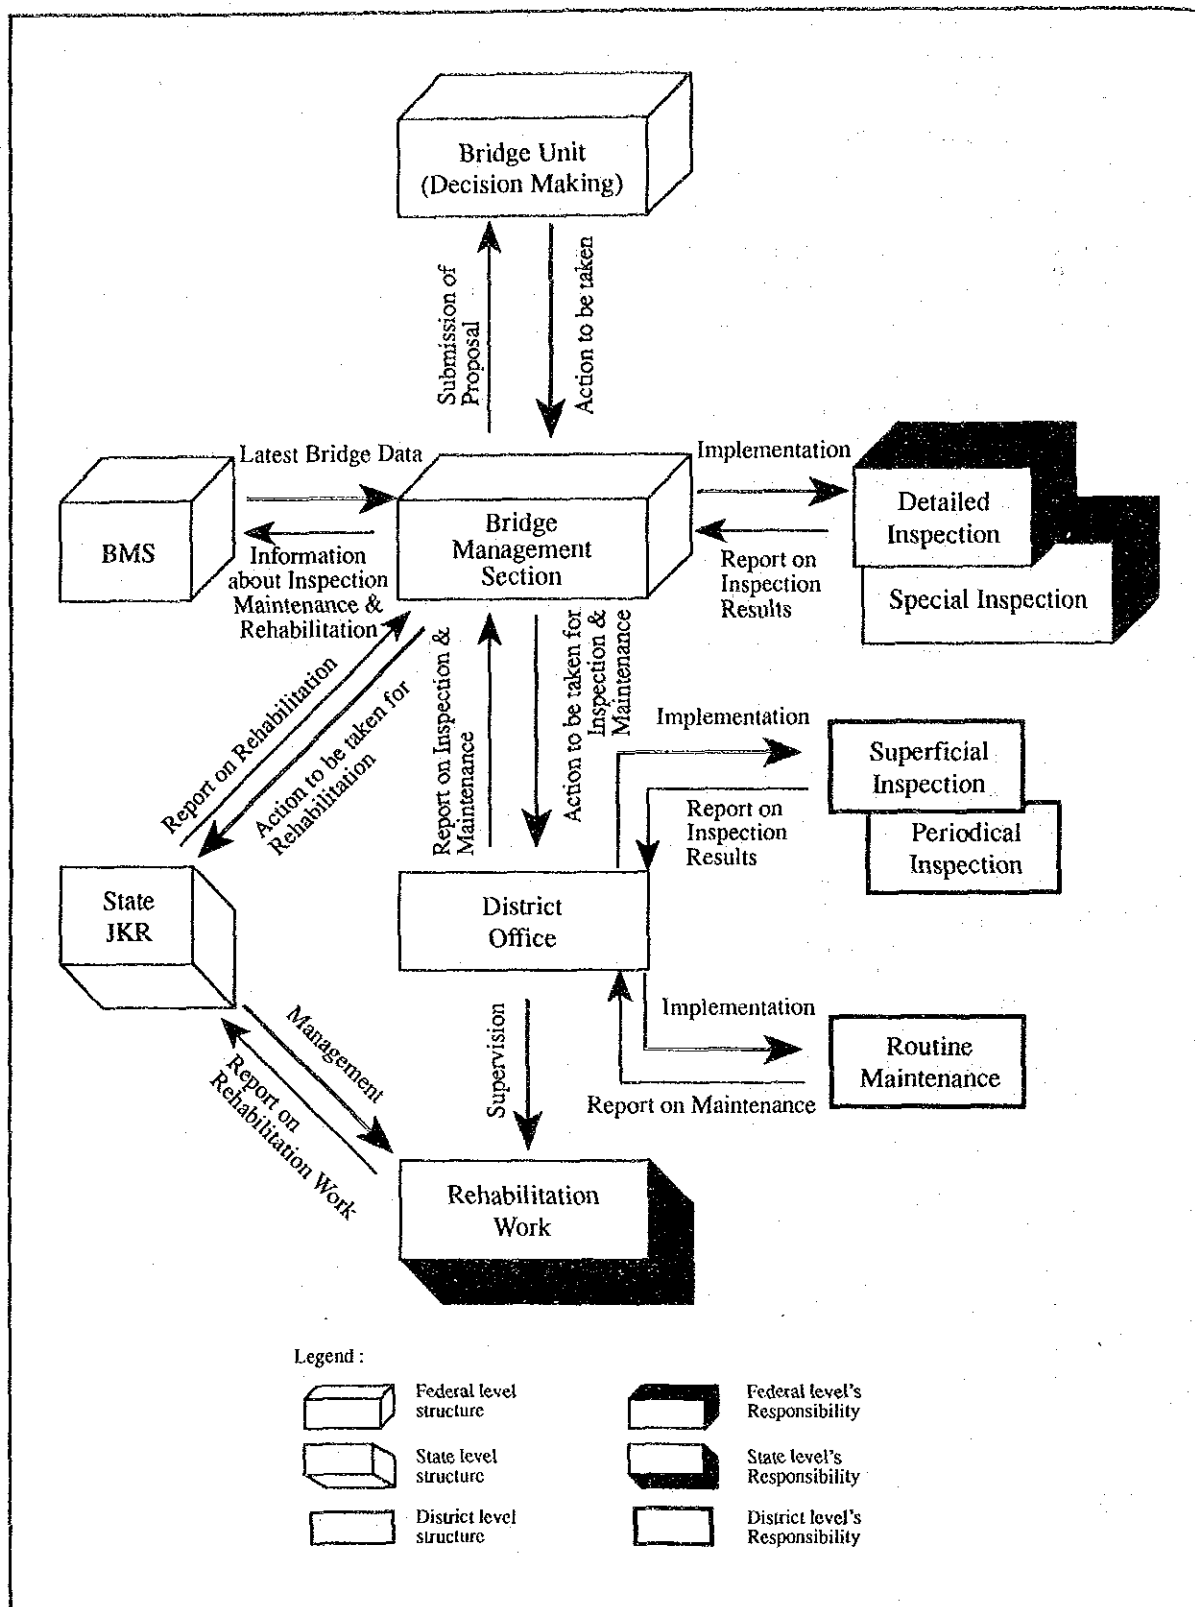
**Figure II-2 Schematic Flow of the Link Between Inspection and Bridge Management**

Figure II-2 shows the responsibilities of each structure, flow of bridge documents, etc. as described above.
