SELECTION OF 100 FEDERAL BRIDGES FOR VISUAL INSPECTION

FINDINGS OF VISUAL INSPECTIONS

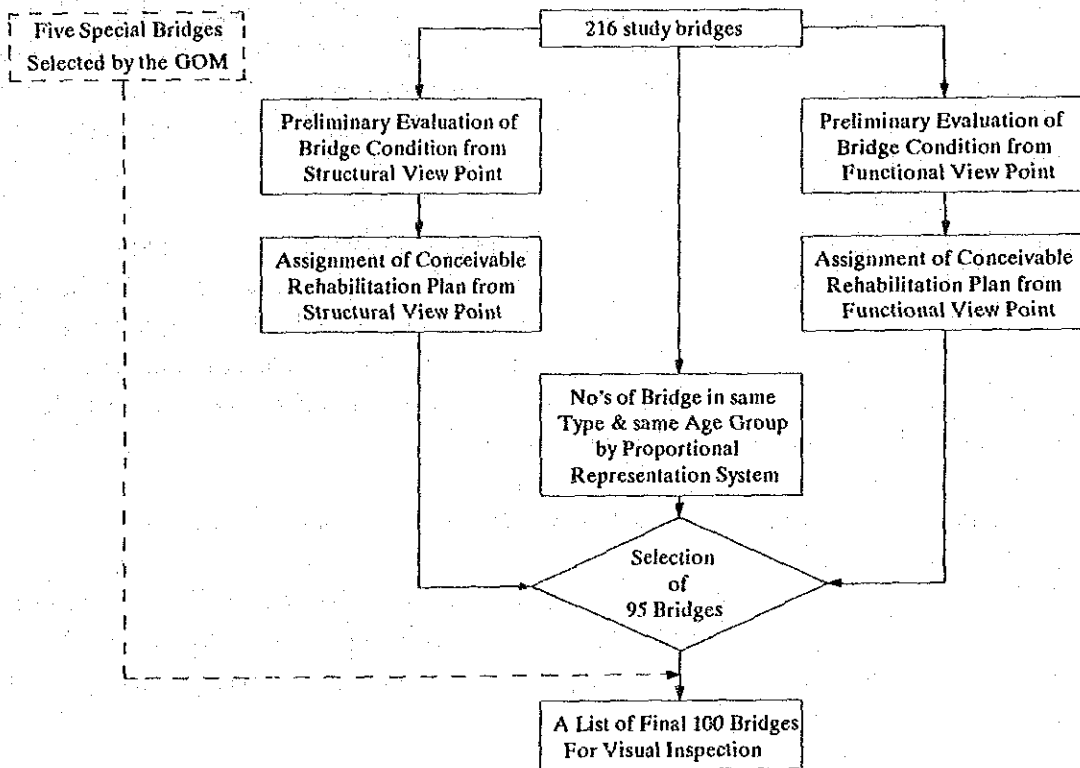
Figure 2-2 Selection Procedure for 95 Bridges

Secondly, the 216 bridges were classified into the same bridge type and age group. The percentage of bridge in terms of each bridge type and age group was calculated against 216 bridges. Representative bridges which have a large number of conceivable rehabilitation plans were generally selected within the specific number calculated by a proportional representative system in each bridge type and age group.

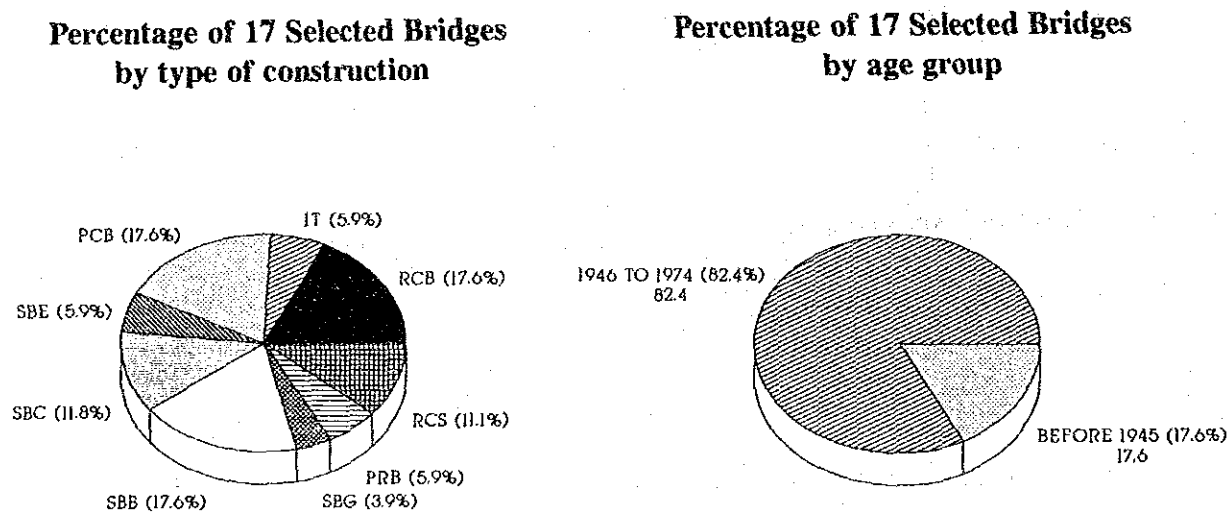
Figure 5-2 Statistics of the 17 Bridges Selected

Through the above exercise, 17 representative bridges were selected and the results are shown in Appendix-I. The statistics of the 17 selected bridges in terms of bridge type and age group were charted in Figure 5-2, which indicated that proportion of each bridge group on the 17 bridges selected is more or less the same as on the 95 bridges.
