SUBSOIL AND WATER INVESTIGATION

RIVER HYDROLOGICAL SURVEY

DETAILED STRUCTURAL SURVEY

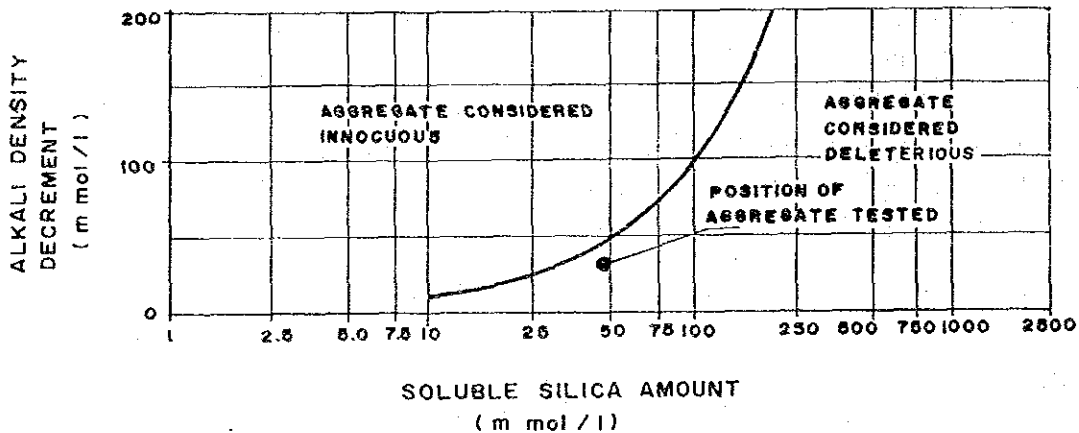
Figure 9-1 Judgement Diagram of Innocuous Degree of Aggregate

(Data Source : Appendix 7 of JIS A - 5308 - 1989)
