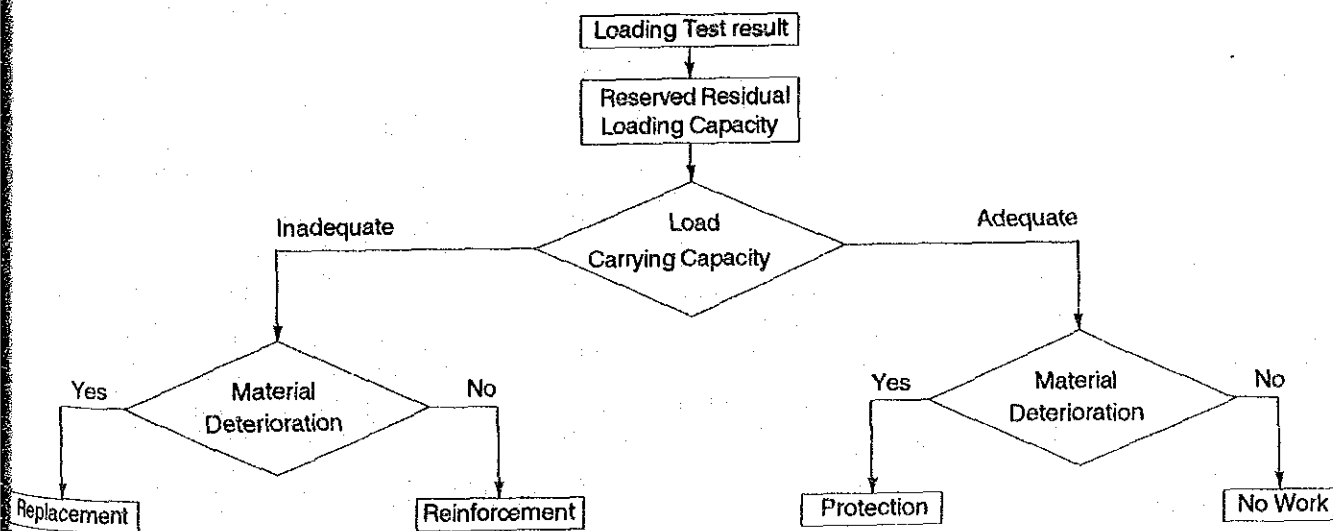
Figure 10-11 Conceptual Flow of Application of Test Results in Selection of Rehabilitation Plan

In the preliminary rehabilitation design, each of the 20 bridges will be theoretically assessed by applying an appropriate loading with due consideration of the reserved residual loading capacity to determine whether a bridge member has adequate load carrying capacity. This result will be used as one of the criteria to determine a broad rehabilitation plan. i.e. whether minor work including protection work or strengthening work including replacement is required if a bridge member has inadequate load carrying capacity.

Following the above broad classification of rehabilitation plans, the most suitable rehabilitation plan will be selected based on type, degree and extent of a damage detected as well as the cause of the damage, and cost comparison of several alternatives including type of material to be applied.

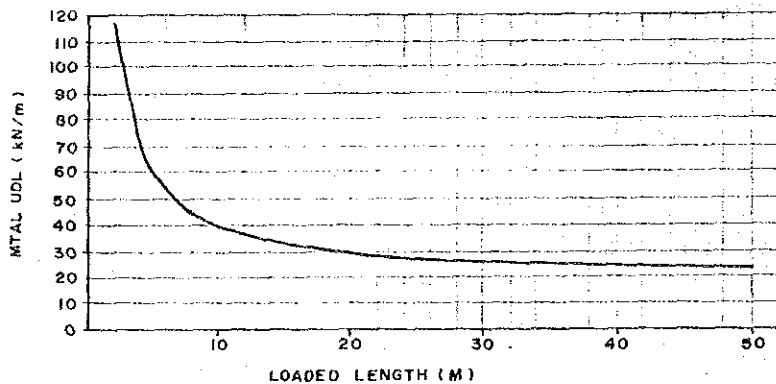
Figure 11-3 Loading Curve for MTAL UDL

The Medium Term Axle Load (MTAL) consists of a Uniformly Distributed Load (UDL) as shown in Figure 11-3 and a Knife Edge Load (KEL), 100 kN per notional lane, combined or a single wheel load. The MTAL-UDL loading curve was derived from the combined effects in terms of bending moment and shear from BS 153 HA load and 45 units HB loading guided. Therefore the MTAL load is almost the same as the loading previously applied by JKR as described above.

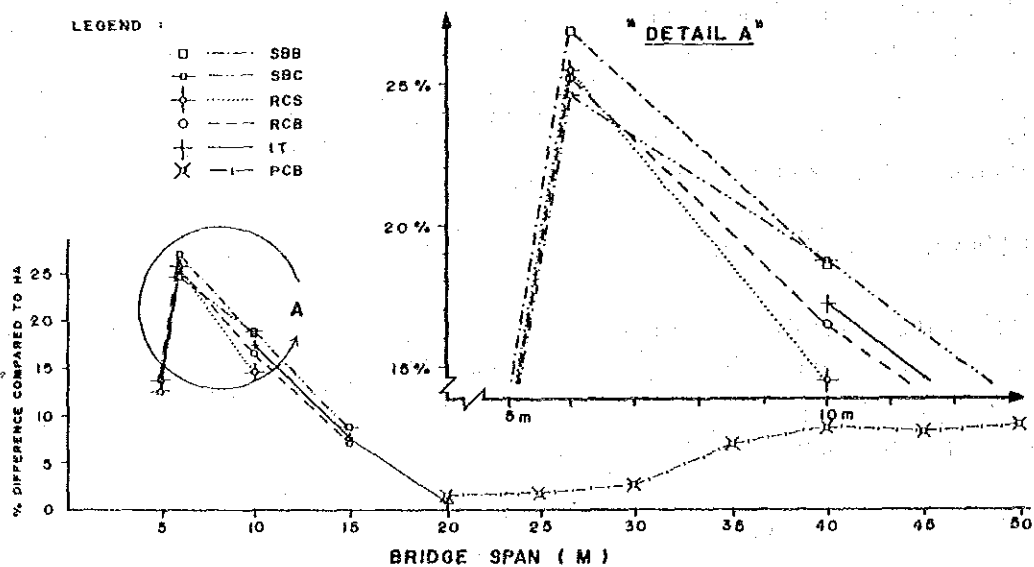
Figure 11-9 % Difference in Sectional Forces due to Dead Load and LTAL Compared to HA

While in case of LTAL as shown in Figure 11-9, the maximum percentage difference is 26.92% in SBB with span length of 6m and the bridges of which the percentage difference exceeding 20% are SBB, SBC,RCB and RCS having span length between about 6m and 9m. These bridges amount to about 28% of all the study bridges.

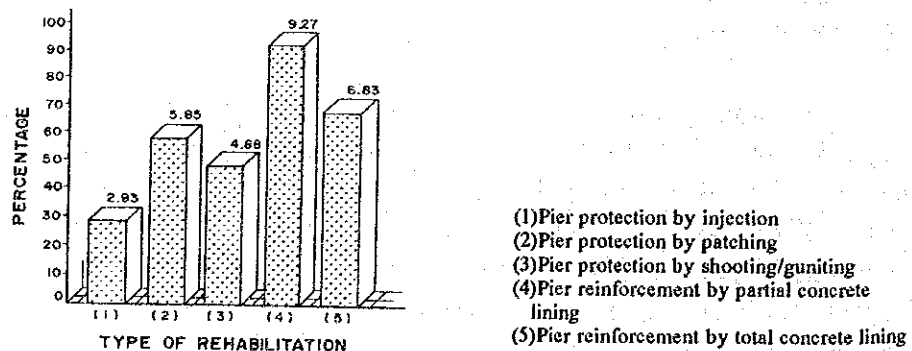
Figure 13-11 Rehabilitation Method for Piers

The most dominant type of rehabilitation plan for piers in all the bridges, as shown in Figure 13-11, is reinforcement of the damaged concrete material of the pier by partial concrete lining which involves 9.27% of all the bridges. The distress is caused by chloride attack on the rebar which has resulted in the rebar to corrode and expand, which in turn causes the concrete to crack. The next dominant rehabilitation method is pier reinforcement by total lining which involves about 6.83% of the bridges. Reinforcement of piers is required because of the seriousness of the crack, carbonation, chloride attack and loss of concrete matrix in the piers. The third most dominant rehabilitation method is pier protection by patching which involves 5.85% of the bridges in the study. Rehabilitation by patching is required due to flaking and loss of concrete matrix on the surface of the pier.
