3-3-2 Plan of Operation

3-3-3 Location and Condition of Project Site

b. Present Condition of Chroy Changwar Bridge

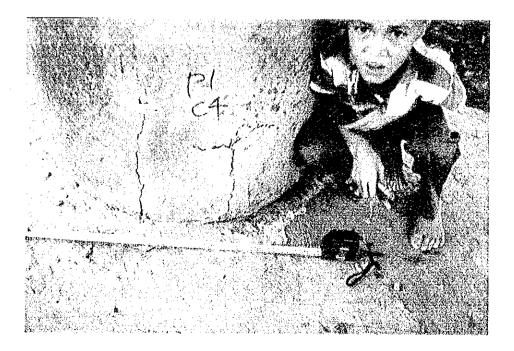
Photo 3-5 Concrete cracks at the bottom of column of pier

- Although local cracks and/or local separation of concrete were observed at the bottom of some columns of concrete pier, these deterioration are not significant and these concrete were judged to be sound. (Photo 3-5)

Some concrete cracks were observed at the bottom of column of pile bent type pier. These cracks are not structural and to be repaired by replacement mortar.
