REPORT OF RECONNAISSANCE OF
HAURSEAH LANDSLIDE
IN CIMANUK RIVER

February, 1992

3-1 INFERENCE OF SCOPE OF LANDSLIDE

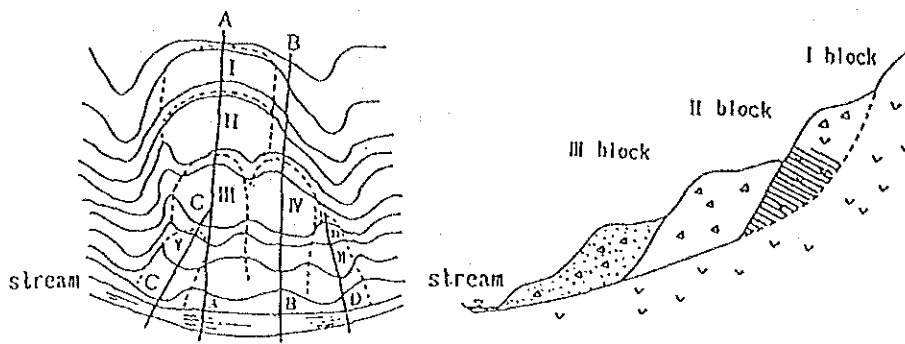
Fig-4 Division into blocks and courses of traverse

to landslide countermeasures. Fig-4 is a schematic diagram for motion block division. And Fig-5 is a schematic diagram for setting courses of traverse.

(a) Division into blocks and courses of traverse

(b) Section of A-A

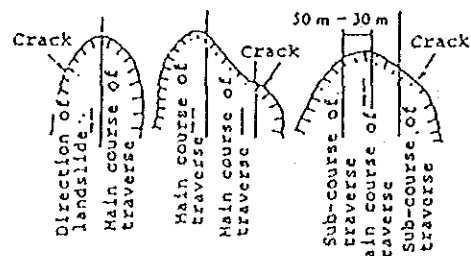
Fig-5 Selection of Courses of Traverse

Note:
Sub-courses of traverse are to be located at 30 to 50 m (50 m at the maximum).

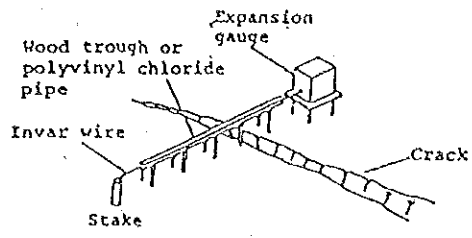
Fig- 6 Schematic Diagram of Installation of Expansion Gauges

The extensometer is an instrument to measure the amount of expansion / shrinkage of ground between two points, using an invar-wire with only small temperature expansion, and accuracy of 0.2 mm or higher. (Fig-6) It is often installed mainly astride a tensile crack or side crack to measure landslide displacement or installed to confirm the tail end. Also, extensometers are sometimes serially installed along the main course of traverse to grasp the overall motion of a landslide.

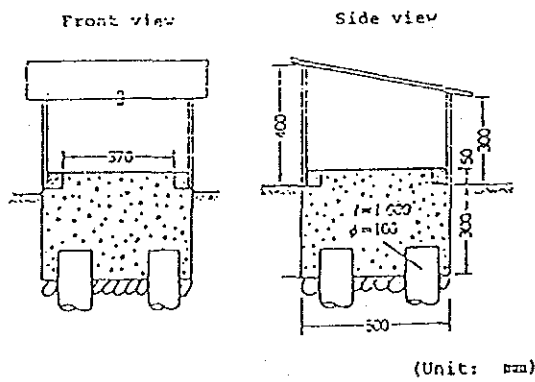
Fig- 7 Installation of Ground Dip Meter (example)

Generally the tiltmeter consists of bubble levels placed in N-S and E-W directions on a concrete foundation of 50 cm x 50 cm x 30 cm, as indicated in Fig-7. The base must be covered with a wooden box designed to hold instruments. The accuracy of this instrument should be 1 to 2 seconds.

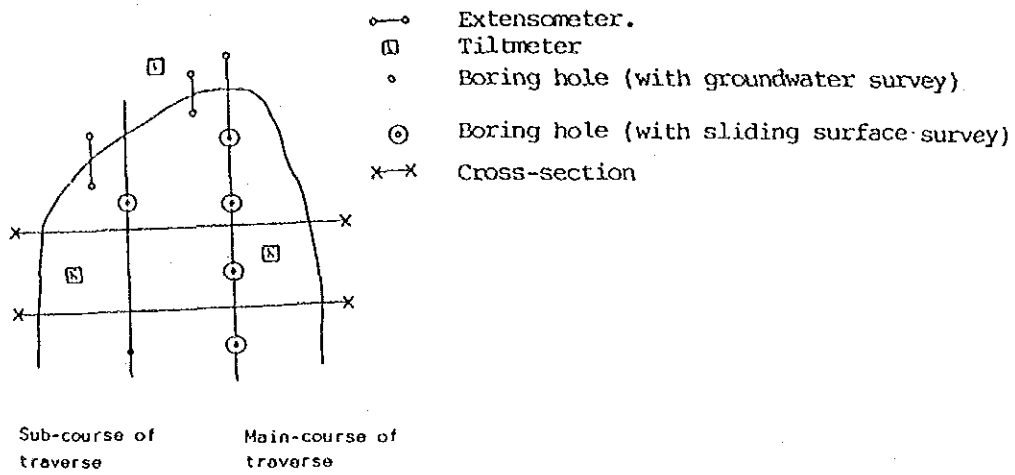
Fig- 8 Location of Boring hole etc.

After the drawing of topographical map, location of boring holes will be investigated on the map and proposed. Fig-8 is a schematic diagram for location of boring.

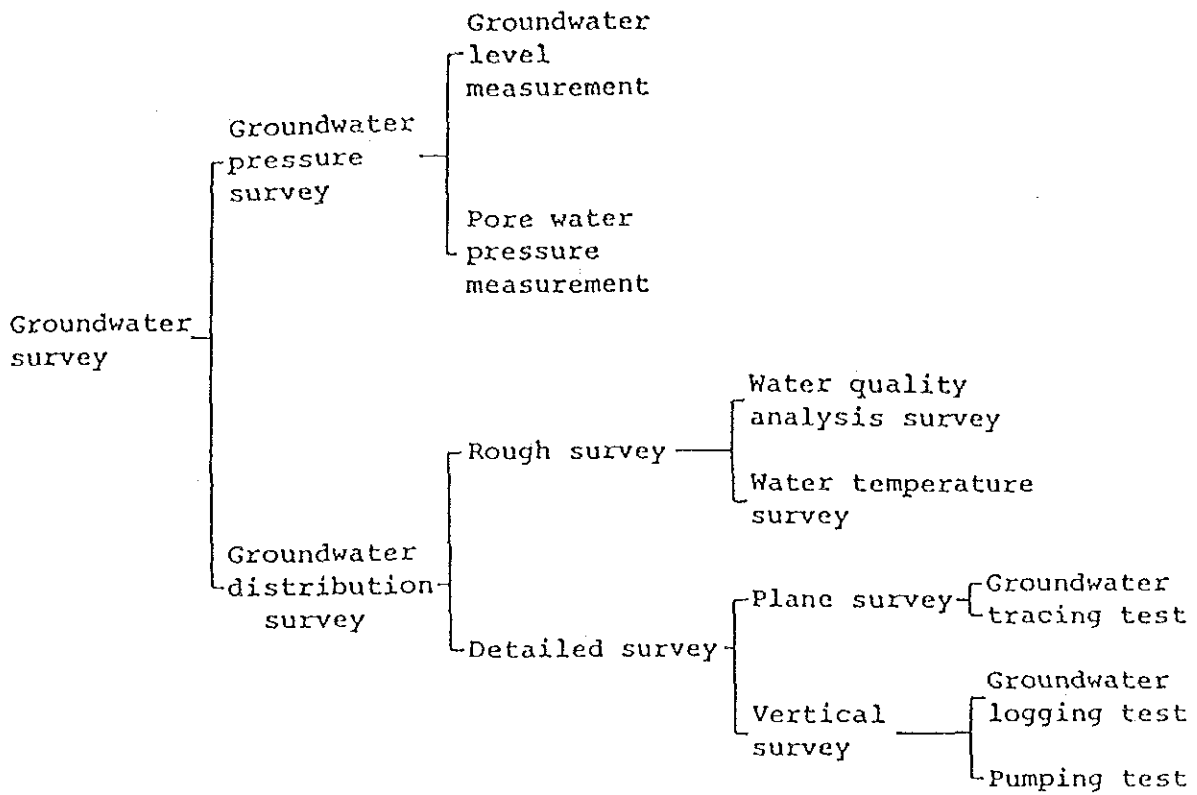
Fig-9 Items of Groundwater Survey

The commonest of all proximate causes of landslide is groundwater. Therefore, removing groundwater from the landslide area is an effective countermeasure and higher precision is required of the groundwater survey necessary to plan and design the countermeasure. Groundwater survey is also indispensable to the stability analysis of groundwater. It usually conducted in landslide areas can be classified as in Fig-9.

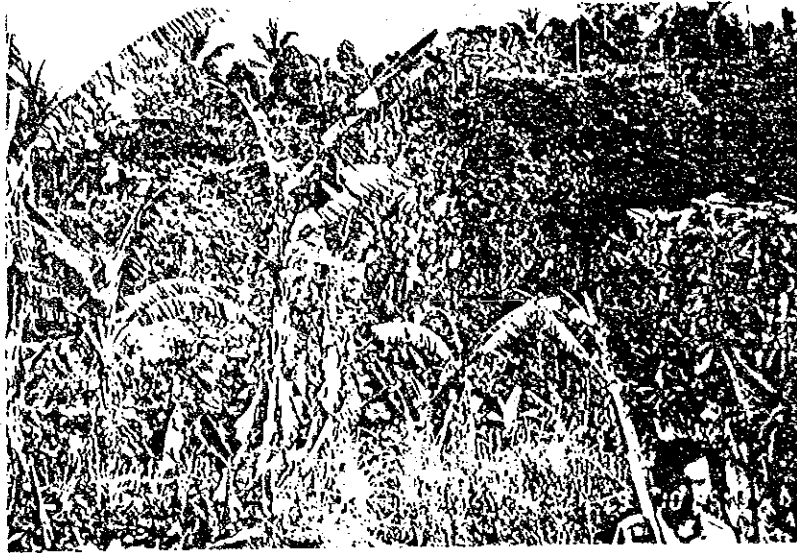
Scarp

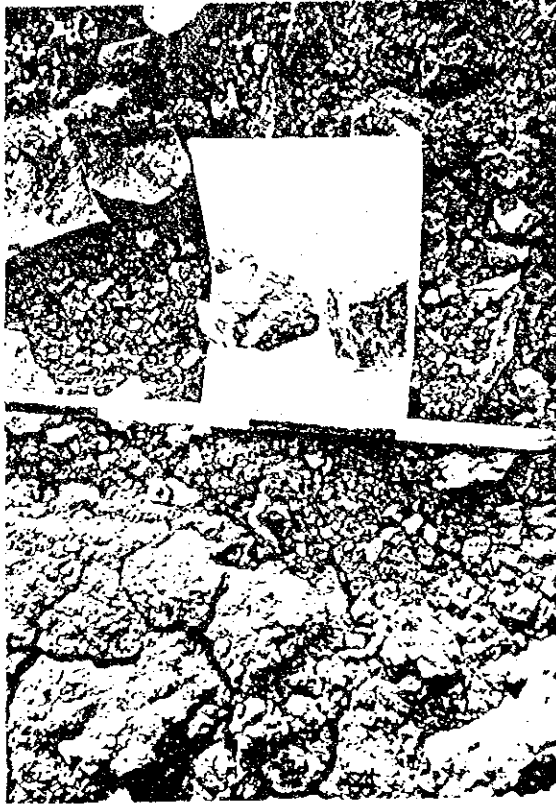
Clay rock

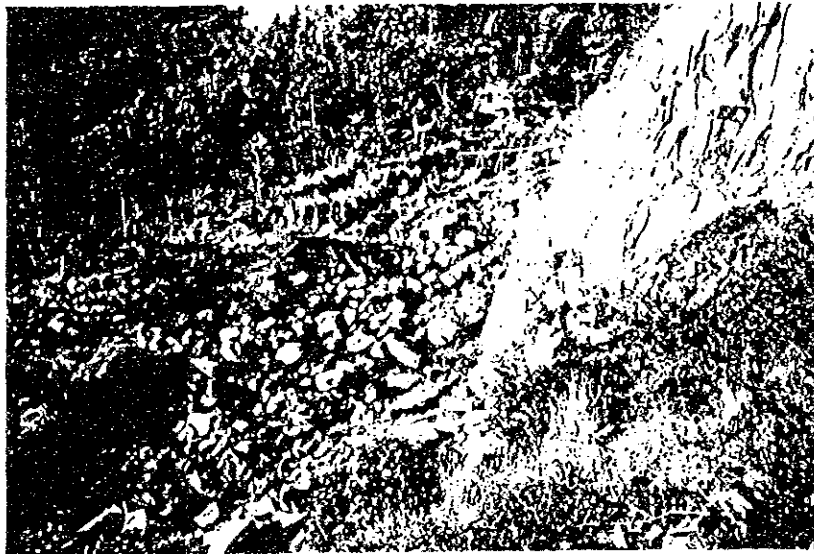
Manager of Cimanuk upstream sub-office said that the landslide had started to move from 1981-82, after Cipada river changed the water-route, and scoured the left bank, which is a tail of the landslide. It is one point. And another point is suggested as follows that the groundwater has an influence for movement of landslide because the landslide moves in the end of wet season and in the start of dry season.

Looking at the upstream (change of channels)

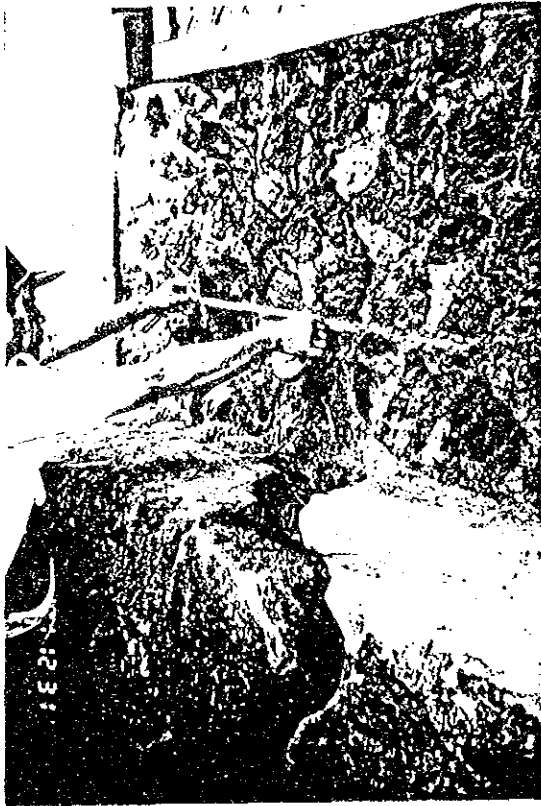
According to a chief of village, the landslide moved largely in 1981, 1982, and still now it has moved bit by bit in the end of wet season and in the start of dry season. Therefore about ten houses were broken. During this survey, we can see other houses which have cracks, masonry retaining walls which are pushed out.

Crack in houses
