THE BASIC DESIGN STUDY ON THE PROJECT

REHABILITATION OF RURAL ROADS

THE REPUBLIC OF ZIMBABWE

Basic Design Drawings

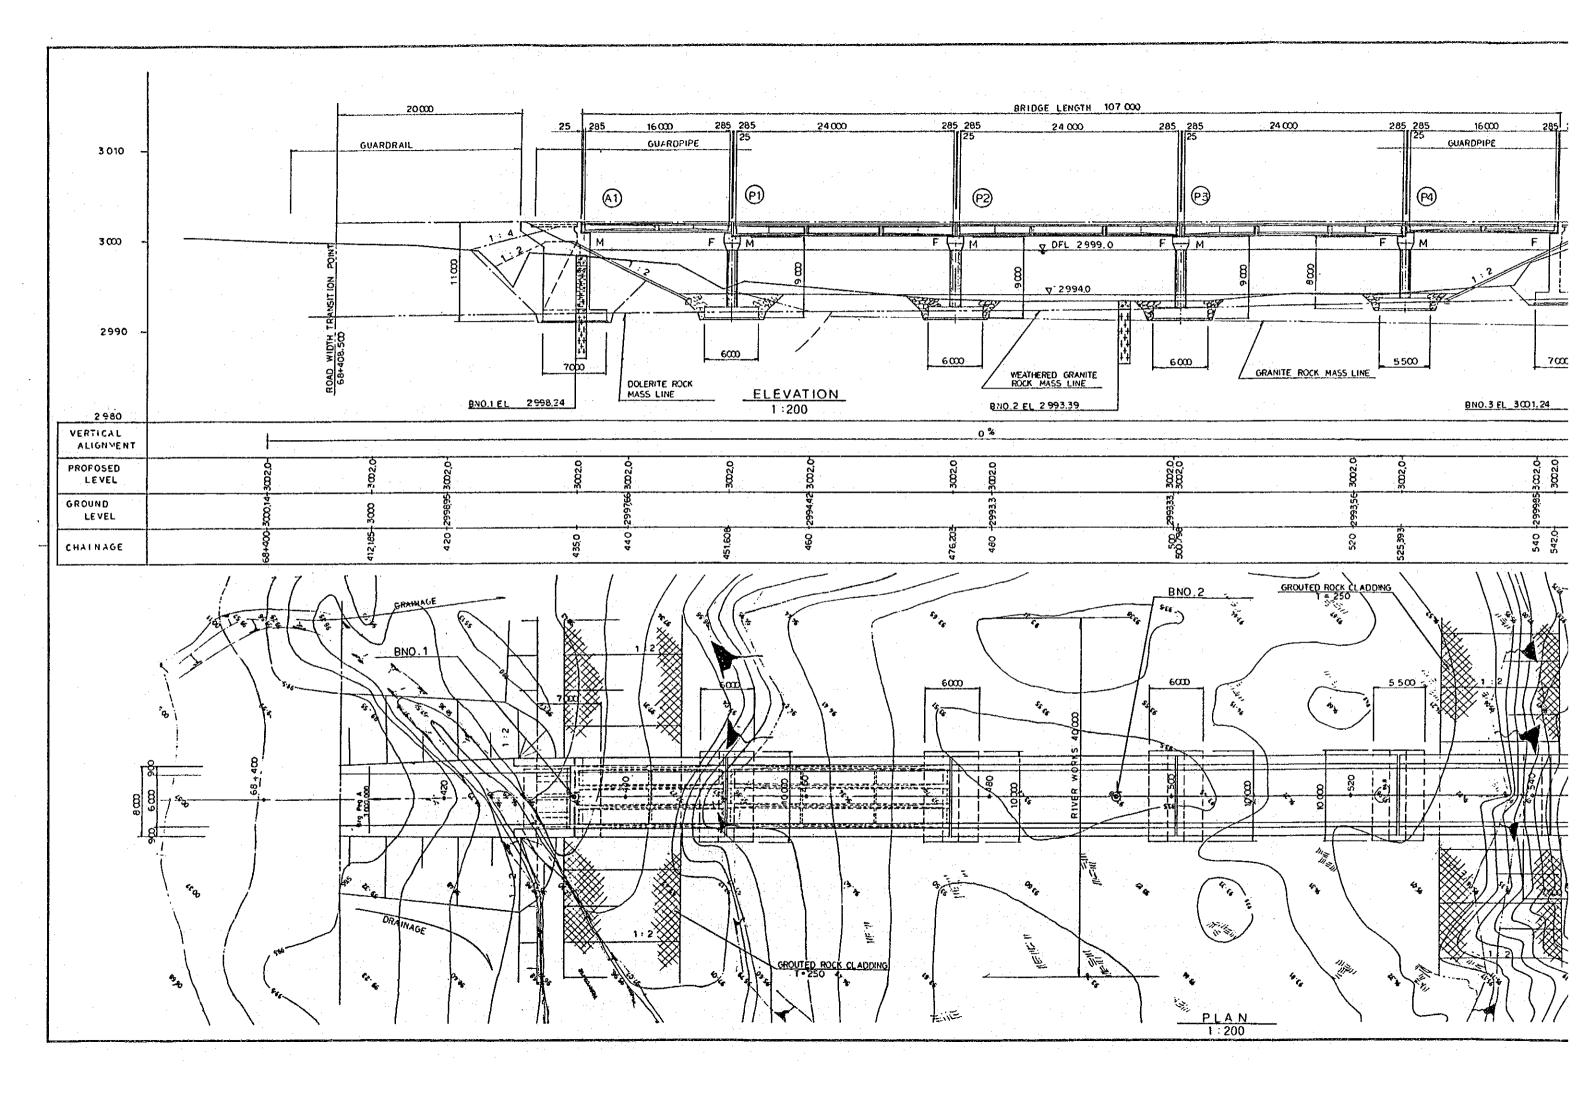
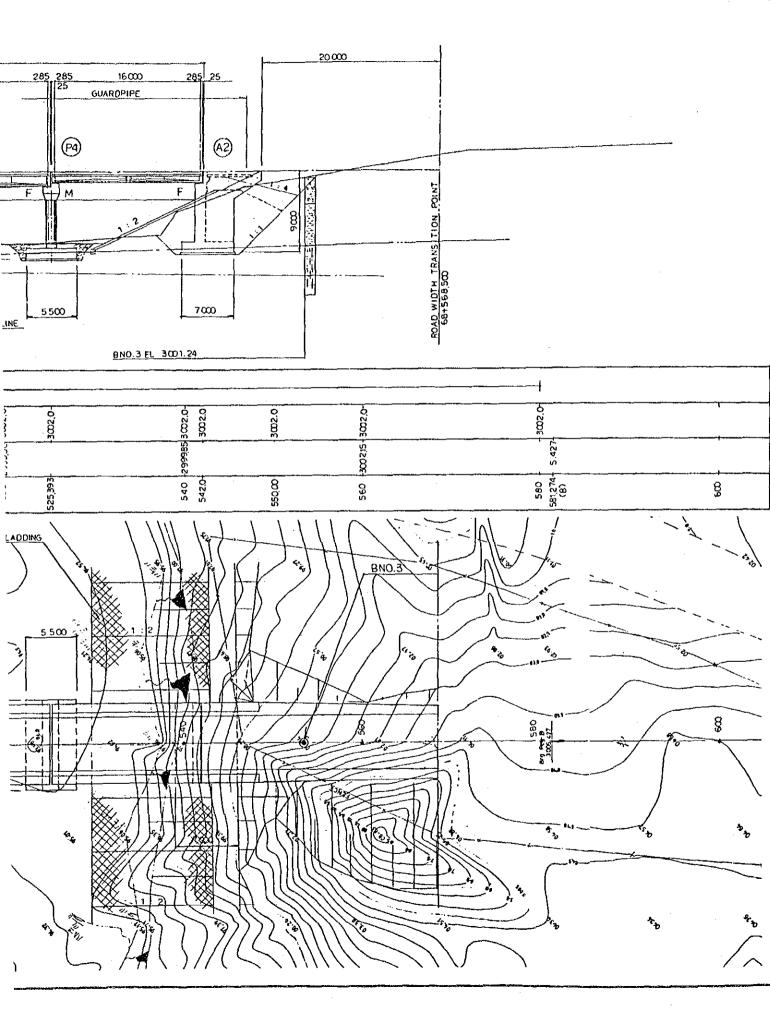
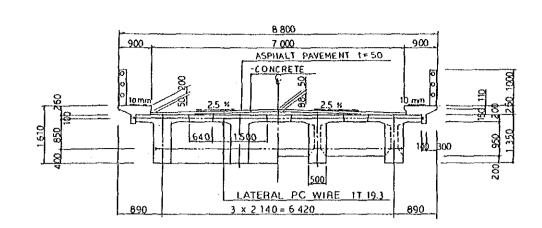
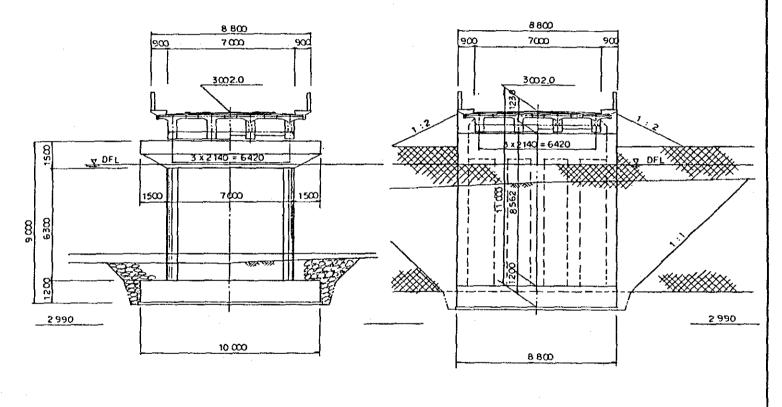
Fig. A-3 General View of Devure I Bridge (Route 344)

TYPICAL CROSS SECTION (24m) S = 1 : 50

DESIGN	SPECIFICATI	ON	
BRIDGE CLASS	FIRST CLASS (JAPAN)		
BRIDGE LENGTH	107.0 m		
BRIDGE SPAN	3@24m,2	2@16#	
BAIDGE WIDTH	0.9×2+7.0=8.0	BOM (TYPE 5)	
BAIDGE ANGLE	90,00,00,		
BRIDGE TYPE	TEE GIADER PRESTRESSED		
GIADER CONCRETE	C 50 - CYLINDE	R TEST 400KG/CM	
REINFORCEMENT	410 N/mm1		
PRESTRESSING STEEL	SWPR1 12#7	SWPR 19 1 T 19.3	
(1) TENSILE	155 KG/mm ¹	190 KG / mm ³	
(2) YIELD	135 KG / mm ¹	160 KG/mm ³

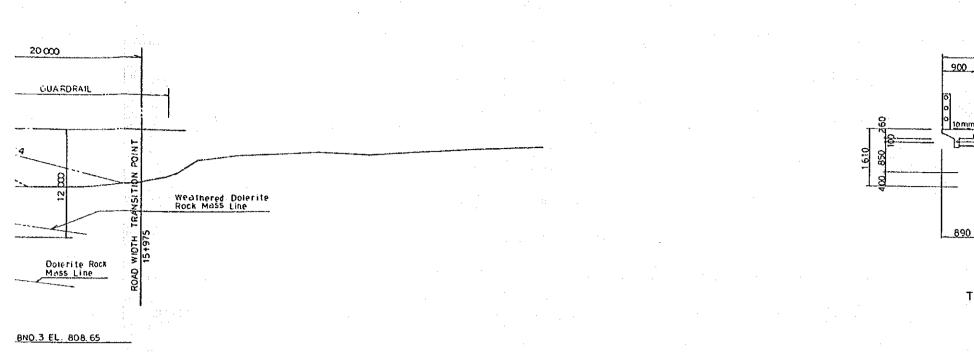
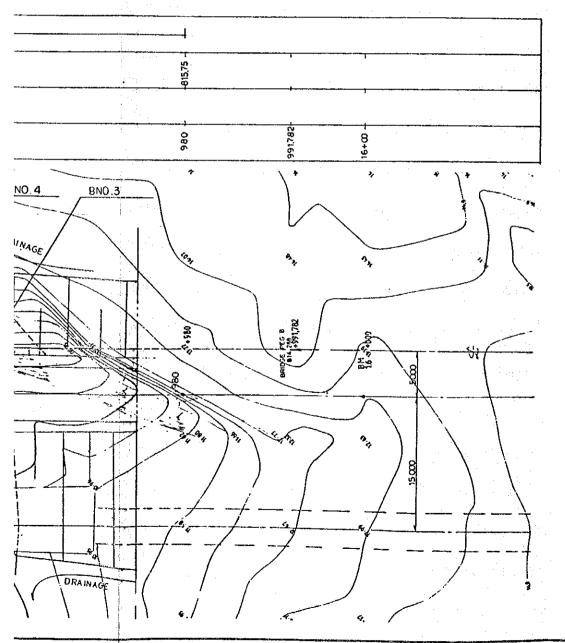
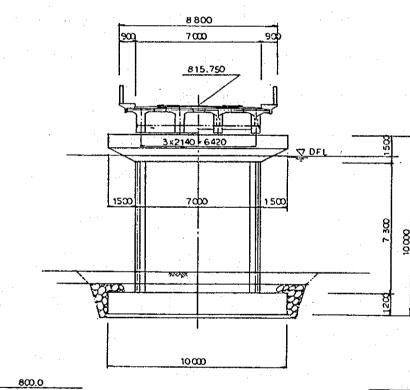
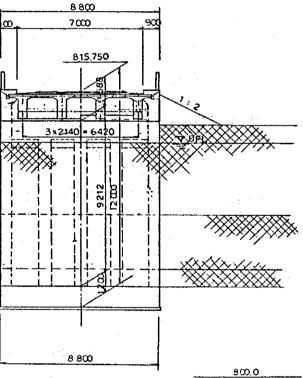
Fig. A-6 General View of Devure II Bridge (Route 359)

DESIGN SPECIFICATION FIRST CLASS (JAPAN) BRIDGE CLASS 173.0 m BRIDGE LENGTH 7024 m BRIDGE SPAN 0.9x2+7.0=8.80m (TYPE 5) BRIDGE WIDTH 90,000 BRIDGE ANGLE TEE GIRDER PRESTRESSED BRIDGE TYPE GIRDER CONCRETE REINFORCEMENT 410 N/mm* PRESTRESSING STEEL SWPR1 1247 SWPR19 1T19.3 (1) TENSILE 155 KG/mm² 190 KG/mm² (2) YIELD 135 KG / mm² 160 KG / mm²

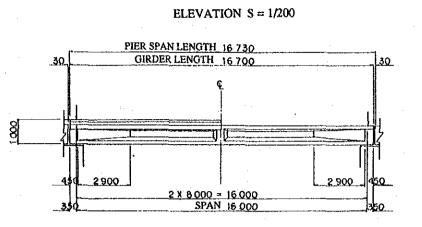
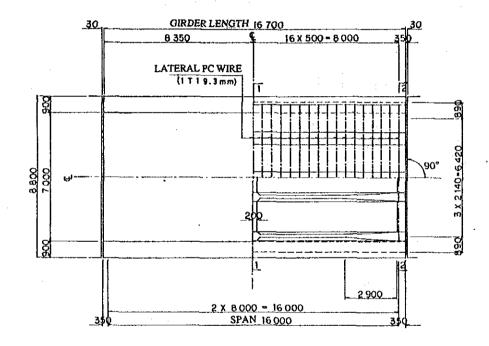
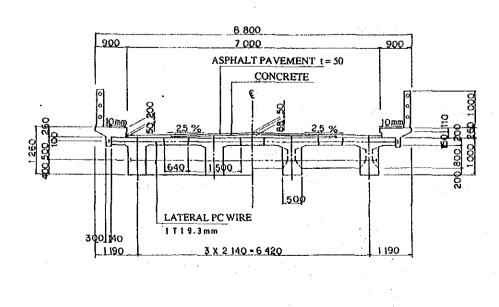
Fig. A-9 Structural Drawing of Superstructure (Span 16 m)

GIRDER SECTIONS S = 1/60

BRIDGE TYPE	PRESTRESSED CONCRE TEE GIRDER	
GIRDER LENGTH	16.70 m	
SPAN	16.00 m	
BRIDGE WIDTH	7.00 m	
ROAD WIDTH	8.60 m	
LIVELOAD	FIRST CLASS LOADING IN JAPAN	
SKEW	90*00

DESCRIPTION	MAIN GIRDERS	CROSS BEAM AND DECK SLAB	
CONCRETE	CLASSIFICATION (kg//cm2)	CLASS C50 (400)	CLASS C40 (300)	
COMPRESSIVE STRENGTH AT PRESTRESSING		350	250	
ALLOWABLE COMPRESSIVE	IMMEDIATELY AFTER PRESTRESSING	180	140	
STREESS	SERVICABILITY	140	110	
ALLOWABLE TENSILE	IMMEDIATELY AFTER PRESTRESSING	-15	0	
STREESS	SERVICABILITY	-15 ·	0	
ALLOWABLE SHEARING STREESS	SERVICABILITY	5.5	-	
	MAXIMUM	5.3	4.0	
PRESTR	ESSING WIRE (kg(/mm2)	SWPRI 1207	SWPR1 1T19.3	
TE	NSILE STRENGTH	155	190	
YIELD STRESS		135	160	
ALLOWABLE TENSILE STRENGTH	AT PRESTRESSING	121.5	144	
	IMMEDIATELY AFTER PRESTRESSING	108.5	133	
	SERVICEABILITY	93	- 114	
REINFORCEMENT BARS (N/mm2)		HOT ROLLED TENSILE STEEL 410N/mm2

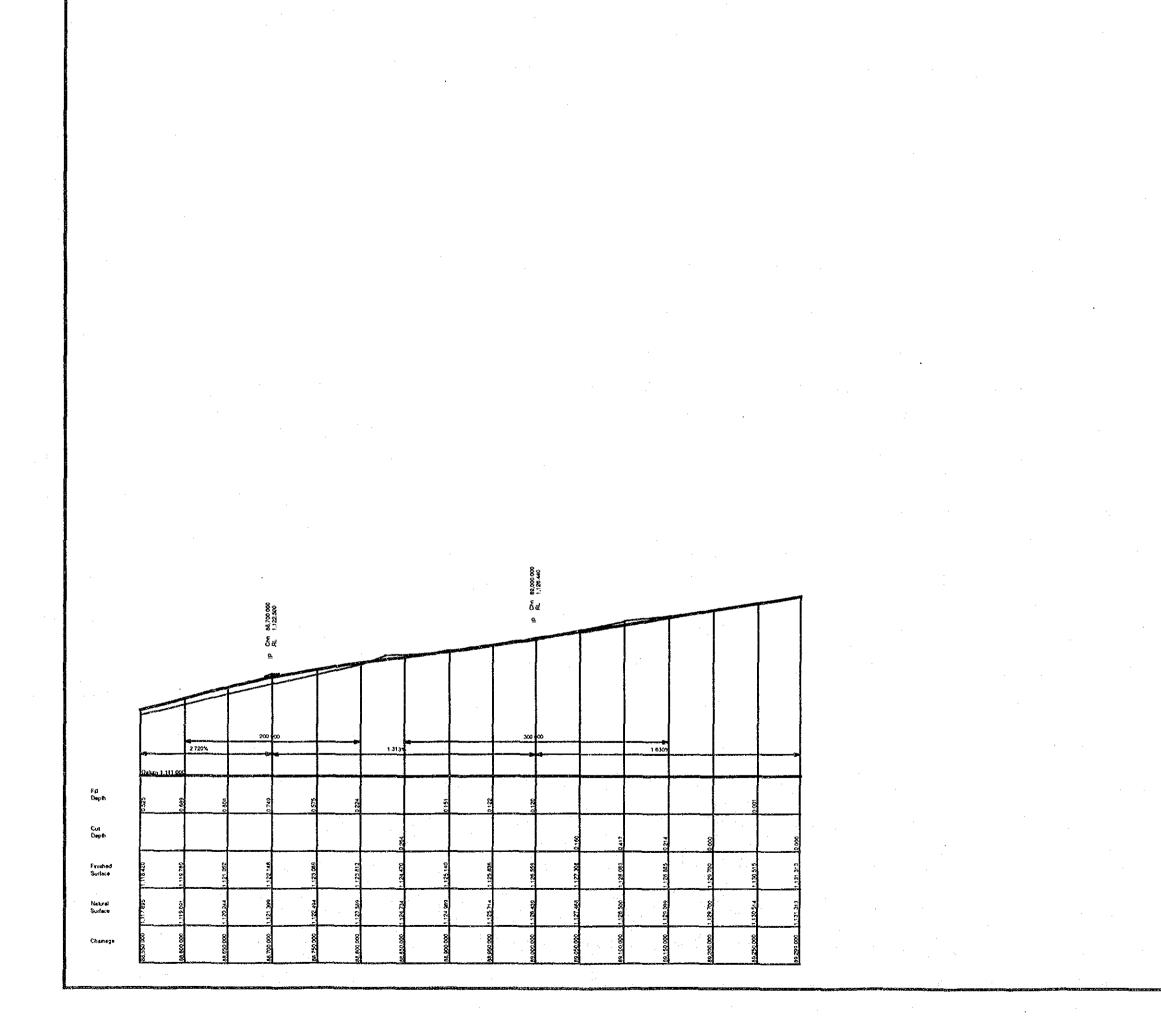
Fig. A-15 PROFILE (6/12)

SOTE BRIDGE SITE (ROUTE 344) 2/2

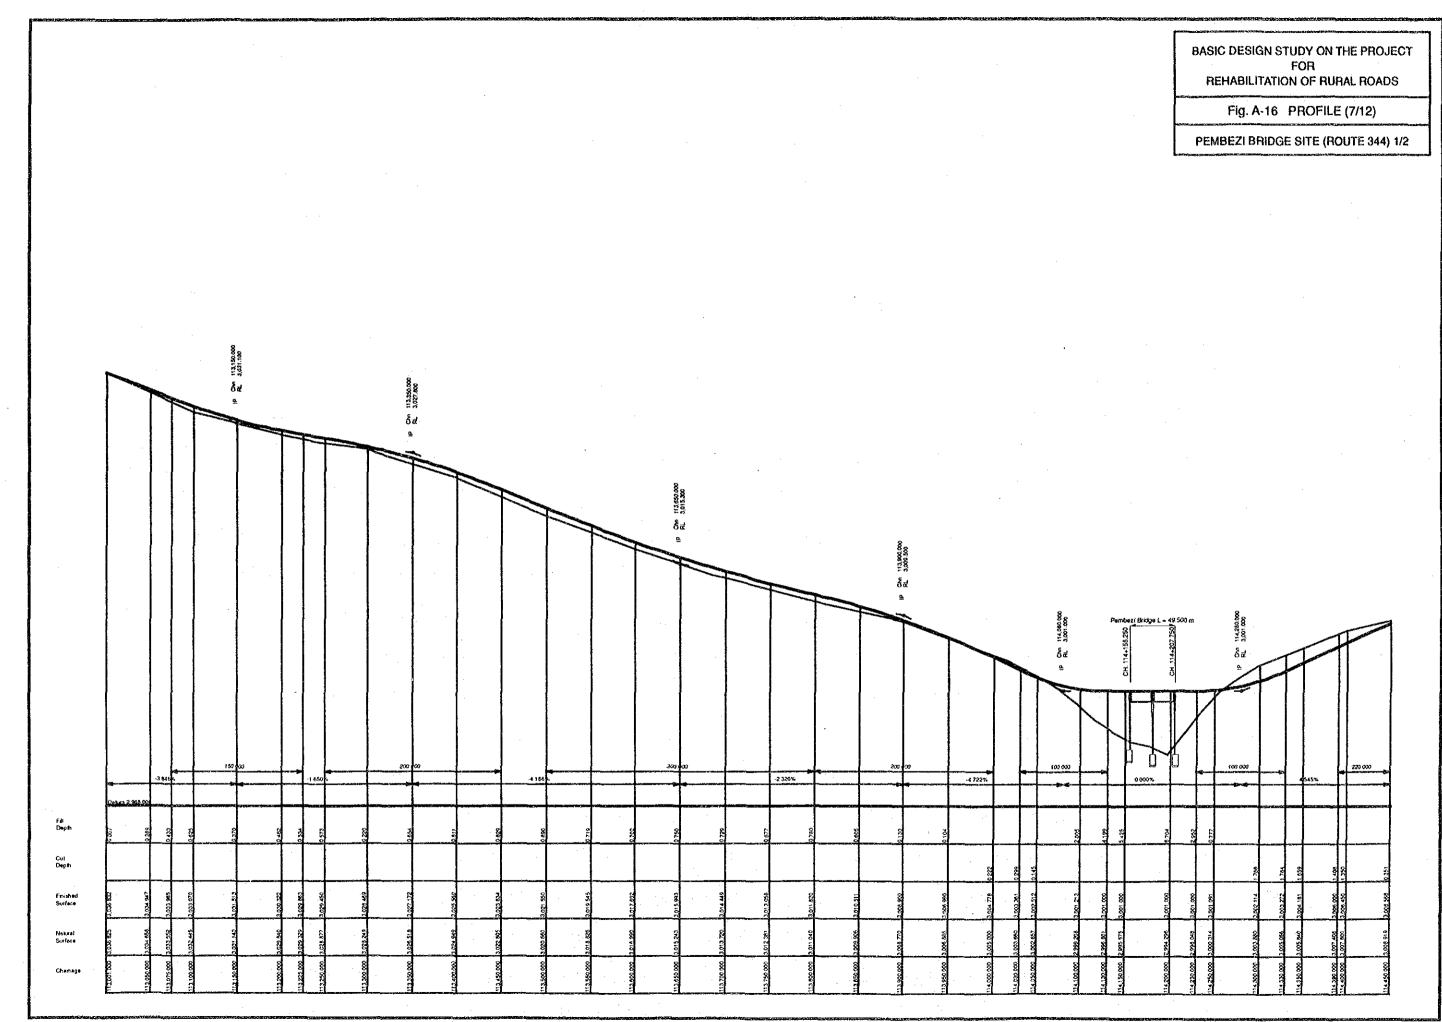
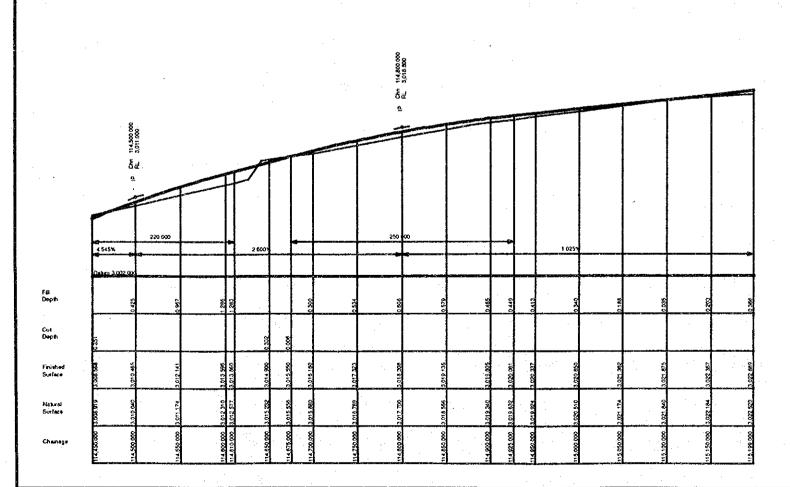
Fig. A-17 PROFILE (8/12)

PEMBEZI BRIDGE SITE (ROUTE 344) 2/2

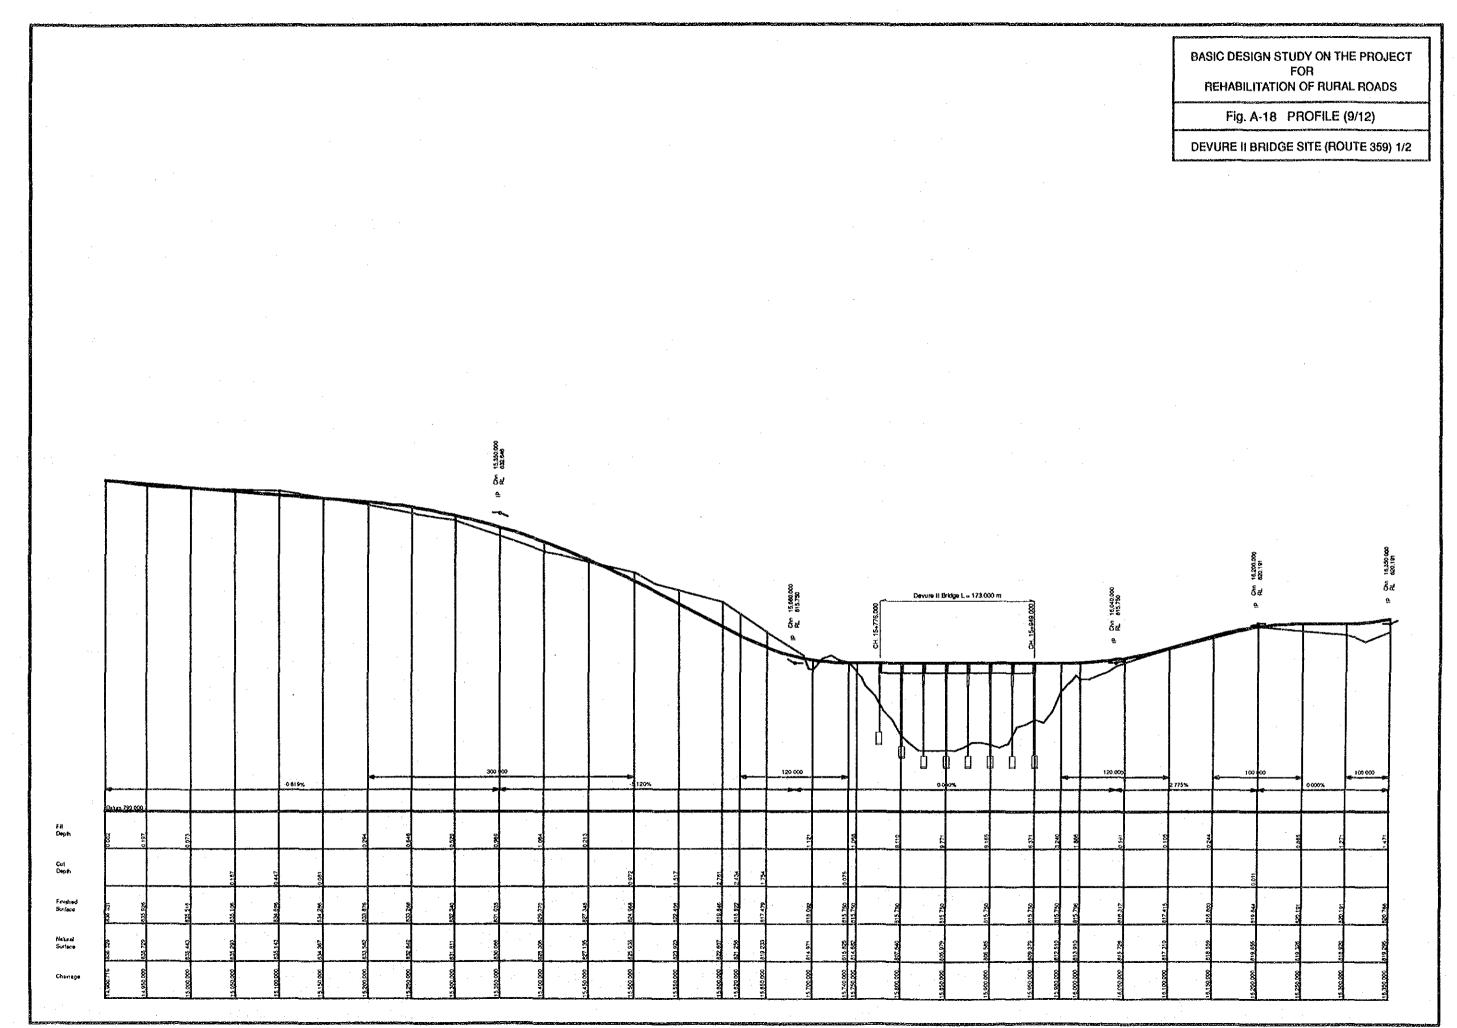
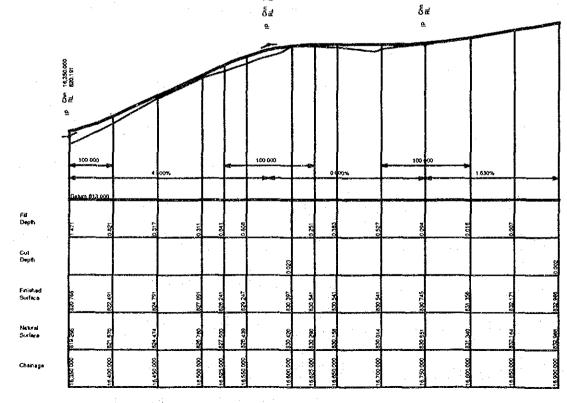
Fig. A-19 PROFILE (10/12)

DEVURE II BRIDGE SITE (ROUTE 359) 2/2

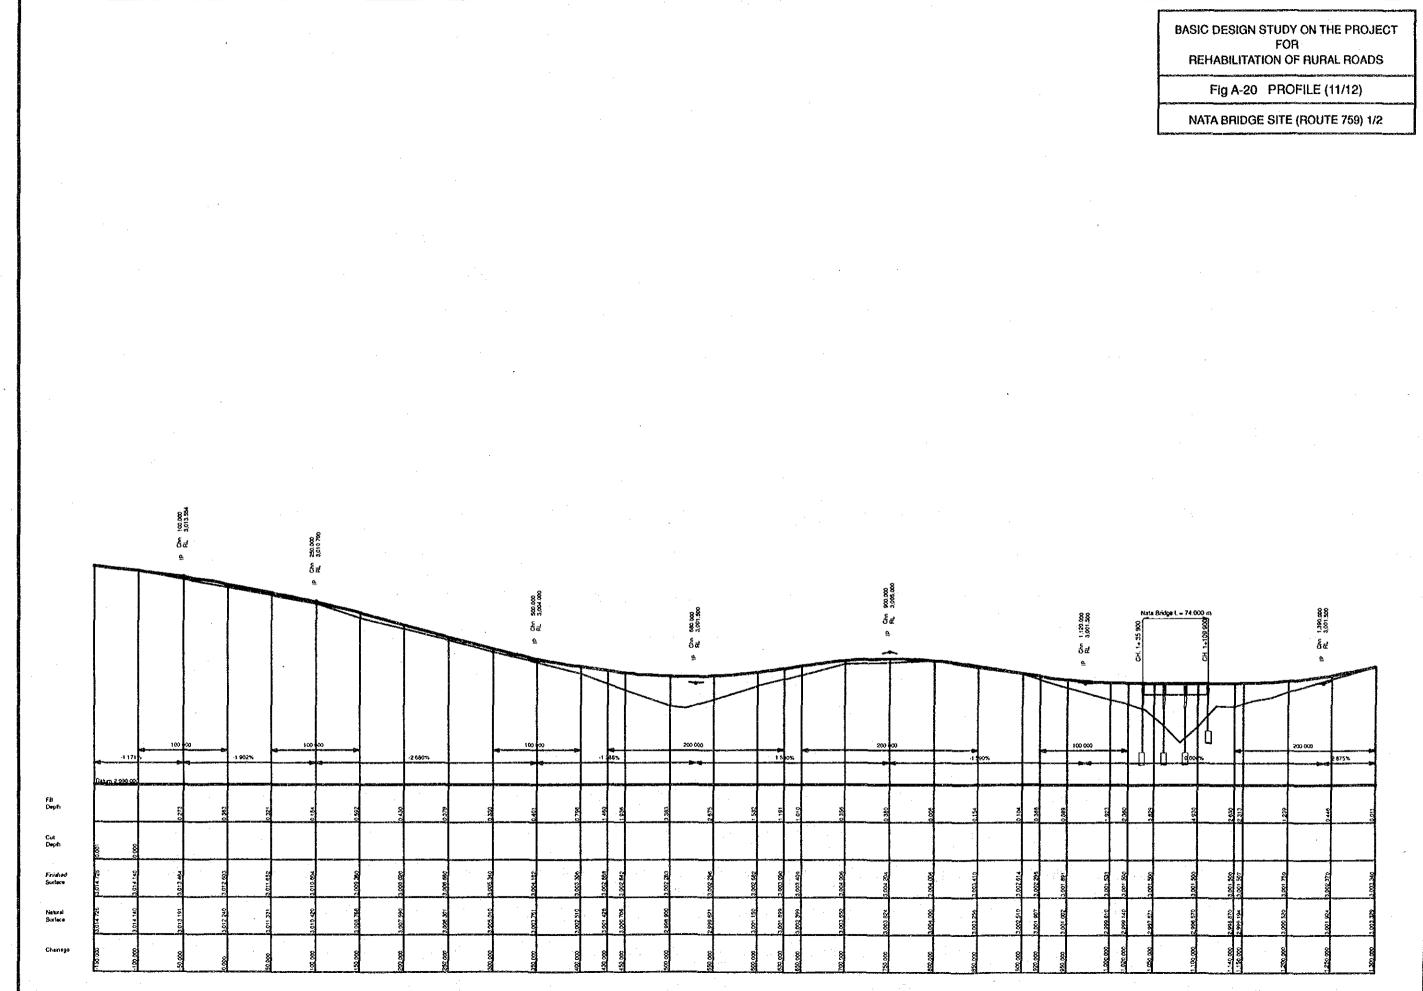
BASIC DESIGN STUDY ON THE PROJECT FOR REHABILITATION OF RURAL ROADS Fig. A-21 PROFILE (12/12) NATA BRIDGE SITE (ROUTE 759) 2/2

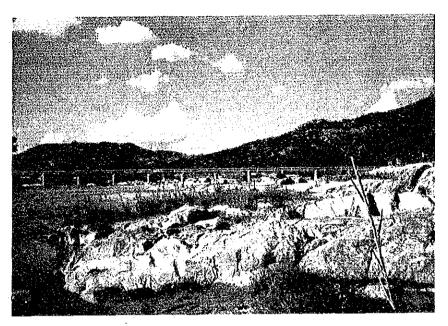
Photo-1 Odzi Bridge (Route 357)

Viewing the existing Odzi Bridge from the proposed new bridge site at the left bank. The existing bridge has 15 spans of a R.C. simply supported girder. The dimension is 146 m in total length and 3.7 m in width.

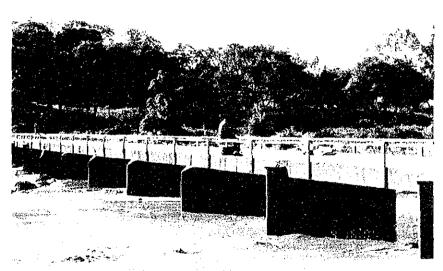
Photo-2 Odzi Bridge (Route 357)

Showing the existing bridge condition looking from the left bank of downstream. There was a warning board at the bridge entrance saying that (1) Speed 10 MPH (miles/h), and (2) No traffic if water over guard rails.

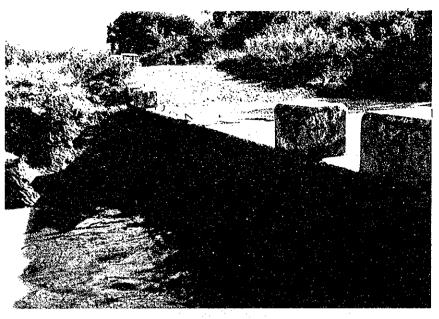
Photo-3 Ungwe Bridge (Route 956)

Showing the upstream side view of the existing Ungwe Bridge. The bridge consists of a R.C. slab and gravity type abutments. A bridge opening of 3.1 m is narrower than the river width. In the dry season, Ungwe River has no flow.

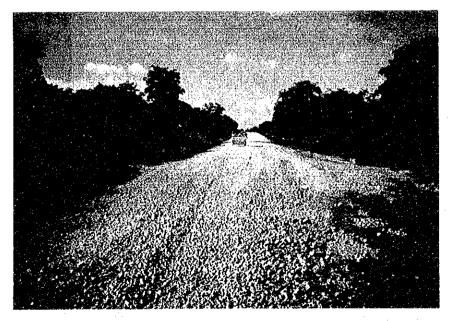
Showing the existing condition of Route 956. This route was once upgraded to a gravel surface road, 8 m in width, including the improvement of alignment.

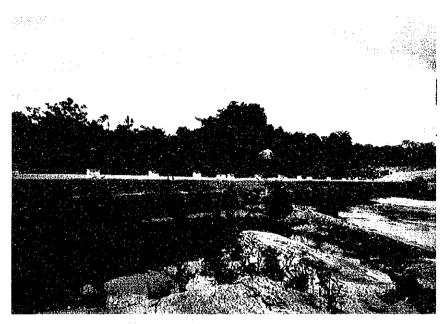
Photo-5 Devure I Bridge (Route 344)

Viewing the existing bridge from the left bank of upstream. The dimension of the bridge was 101 m in total length, and 4.0 m in total width.

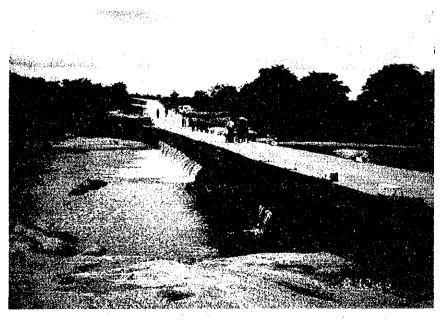
Photo-6 Devure I Bridge (Route 344)

Viewing the existing bridge from the left bank of downstream. As the photo was taken in March, after the rainy season, the river flow was observed, but, in the dry season, the river has no flow. Almost half of the pipe openings were blocked by driftwood, debris, and sediments.

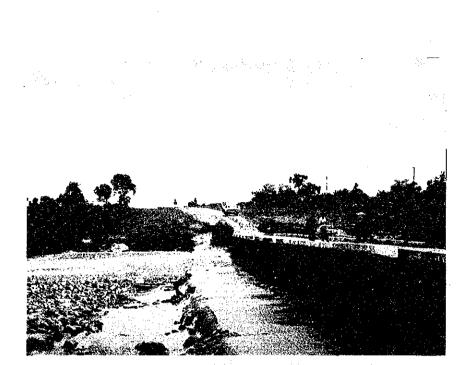
Photo-7 Sote Bridge (Route 344)

Viewing the existing bridge from the left bank of downstream. According to the DSR's definition, this bridge will be categorised as a arch causeway.

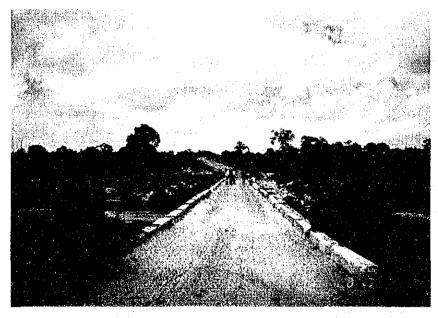
Photo-8 Sote Bridge (Route 344)

Viewing the existing bridge from the right bank (Gutu side). The bridge dimension was 89 m in total length, 4.3 m in total width, and 3.7 m in effective width.

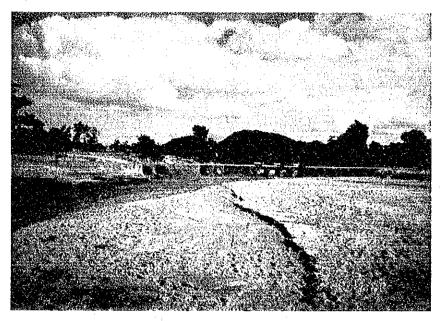
Photo-9 Pembezi Bridge (Route 344)

Viewing the perspective of existing bridge from the upstream. The structure type was a piped drift combined with R.C. and stone masonry. The dimension of the existing bridge was 53 m in length and 8.6 m in width.

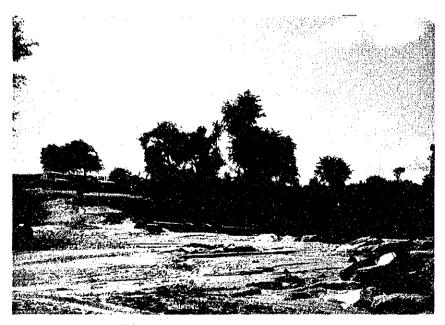
Photo-10 Pembezi Bridge (Route 344)

Showing the downstream side of existing bridge. According to the information from DSR's staff, this bridge was newly constructed with around 3 weeks construction period, after the former structure was washed away by the flood in January.

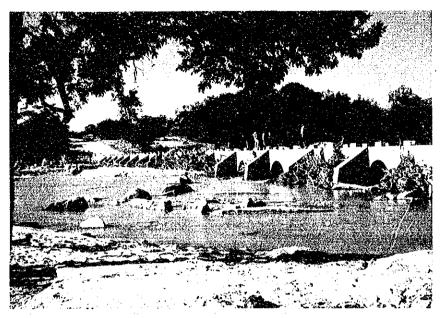
Photo-11 Devure II Bridge (Route 359)

Viewing the existing bridge from the right bank of upstream. The bridge had buttress at the upstream side. The bridge length was 170 m, and the width was 4.2 m.

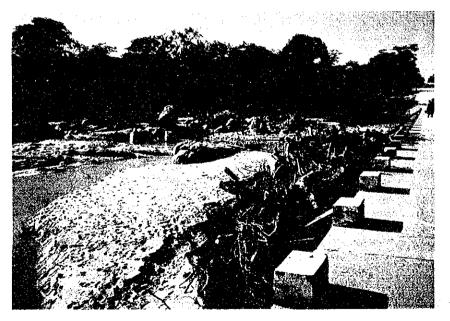
Photo-12 Devure II Bridge (Route 359)

As shown in the photo above, which was taken in March, the stack of driftwood and sediments, brought by the flood in January, blocked many openings of the bridge.

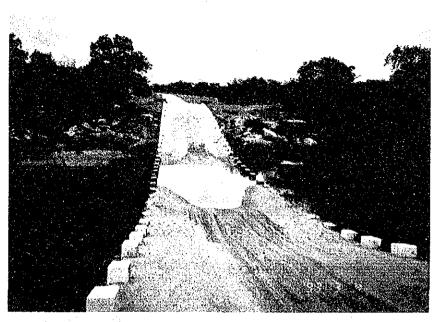
Photo-13 Nata Bridge (Route 759)

Viewing the existing structure from southwest (Plumtree side). The structure type was a drift with a 100 m of length, and 5.5 m of width. Nata River has no flow in the dry season.

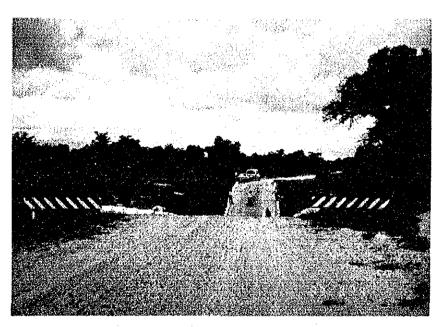
Photo-14 Nata Bridge (Route 759)

Viewing the existing structure from northeast (Samenani side). According to the hearing at the site, the flood water level has not reached the river bank elevation.
