THE STUDY
ON
THE OIL-BERTHS RECONSTRUCTION
OF PORT OF DJIBOUTI
IN THE REPUBLIC OF DJIBOUTI
FINAL REPORT

SUMMARY

MARCH 1994

PACIFIC CONSULTANTS INTERNATIONAL (PCI)
TOKO ENGINEERING CONSULTANTS LTD.

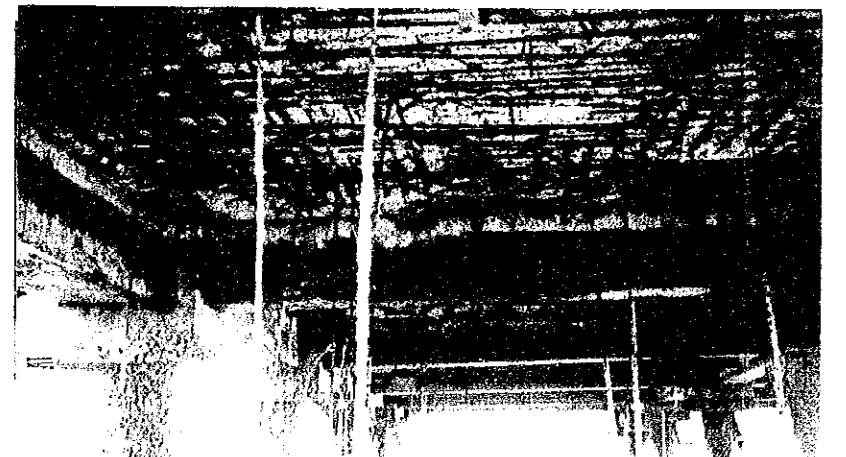
The results of the investigation on the reinforced concrete structures reveals significant corrosion of reinforcing steel bars. The corrosion has further progressed and the sections of the steel bars noticeably reduced. At Berth No. 11, the corroded steel bars hung down at many locations.

Photo - (F) Berth No. 11 (19/9/' 93)
Exposed bottom steel bars.

- d) If no measures are taken to improve the existing conditions of the berths, the degradation of concrete and reinforcing steel bars will continue, and may cause further reduction of their strength. Since the dolphins and platforms are in an unstable condition, a severe accident will occur without rehabilitation.

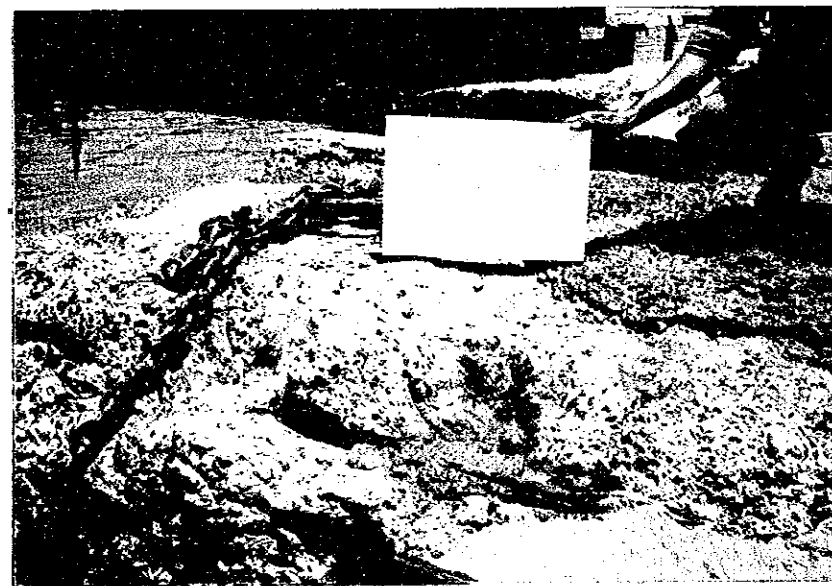
Photo - ③ Berth No.12 south dolphin (18/9/' 93)
Deteriorated superstructure concrete and exposed steel bars.
