LOCATION OF WATER QUALITY, SEDIMENT AND CURRENT SURVEY POINTS

FEASIBILITY STUDY FOR CAI LAN PORT CONSTRUCTION PROJECT

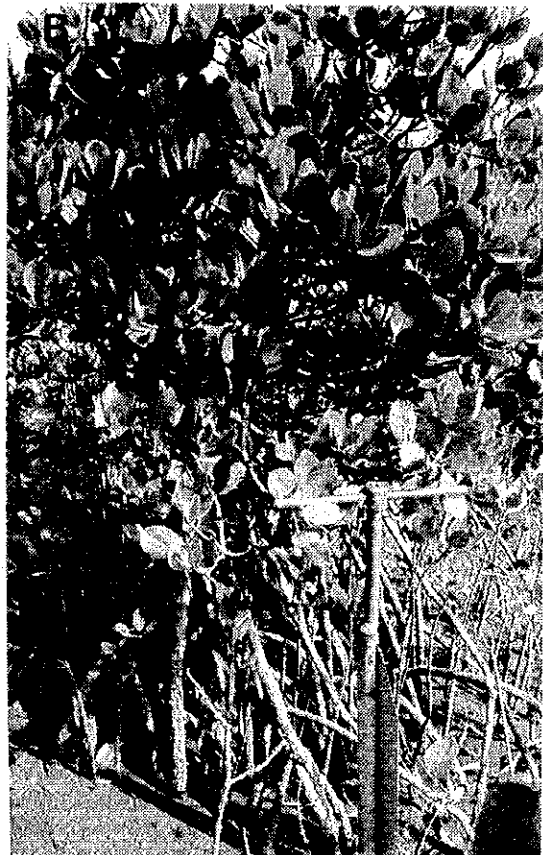
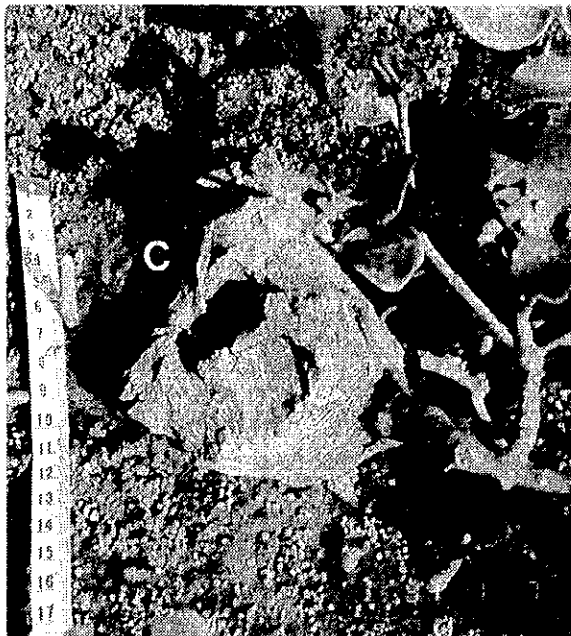
Plate 6-1: Instrumentation utilized in the BCBA field surveys, January 1994.

- (A) The LD 80A electronic redox meter (blue box beside back pack) with Platinum-spike tip probe placed into fresh sample of mangrove substratum obtained with stainless steel D - section corer.
- (B) Tree in lower inter tidal mangrove on North side Bai Chay Bay. Approx. height 2.1m. D - section corer beside *R. stylosa* aerial pro root system.
- (C) and (D) forester tape beside dwarf and stunted *Avicennia marina* tree in upper tidal zone of extensive *Avicennia* mangrove sand flats near Le Loi village (site 4 on Fig 6.2). These stunted trees are a growth form induced by the combined prolonged effects of cattle foraging and firewood cutting.

Date	Instrument	Function	Source
7.1.94	D-section corer (see Plate 6-1).	To take un-compacted soil or mud samples.	Environmental Specialist.
9-10.6.94	LD80A redox, pH and temperature probe system (see Plate 6-1).	To measure mud anoxic status in the field; macrochemistry of sulphate-sulphite and oxygen status.	Environmental Specialist. This was involved in technology transfer to Vietnamese counterparts. The instrument is computer-compatible and recommended in "The Mangrove Ecosystem - Research Methods", UNESCO 1984.
	Salinity refractometer (Atogo brand, calibrated in ppt)	To determine water salinity.	Dr N. H. Tri, Mangrove Ecosystem Research Centre.

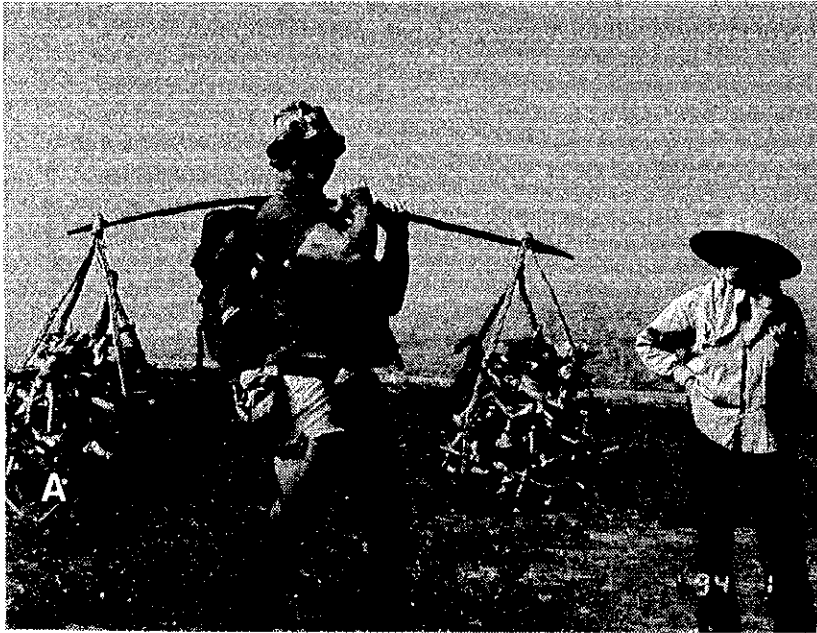
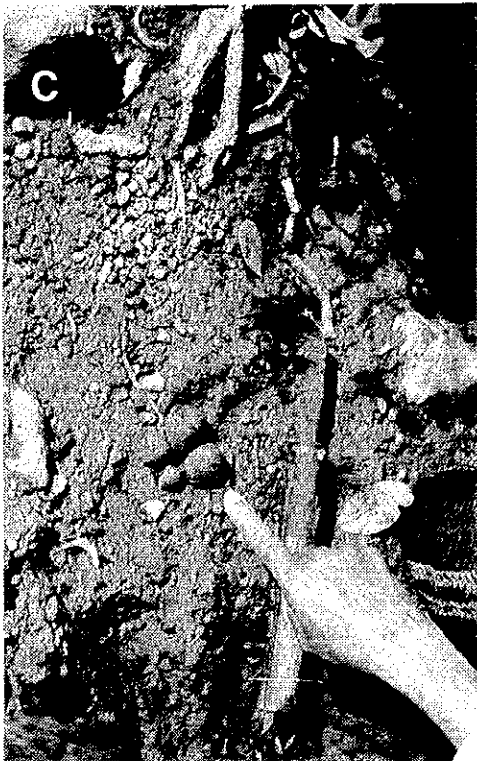
Plate 6-2: Fuel and food from the mangroves in zone D (Fig 6.2).

- (A) A harvest of firewood from the mangrove *Avicennia marina* growing extensively on salt flats, northern Bai Chay Bay.
- (B) Bundles of firewood collected from the mangrove *Aegiceras corniculatum* left to dry near a village landward of the mangrove belt.
- (C) Recently harvested mangrove mud-dwelling mollusks (*Meretrix* and *Mactra* sp); up to 2 kg per hour can be gathered in places.
- (D) Discussions with local people.

The mangrove vegetation supports important populations of edible molluscs, including oysters, mussels and other bivalves as well as a variety of snails. Some of these shellfish are illustrated in Plates 6-2 and 6-3. Oysters (*Ostrea* sp.) are collected by hand. Some mud-dwelling burrowing species such as *Cylina sinensis*, *Meretrix meretrix* and *Mactra quadrangularis* require digging, usually with simple implements (Plate 6-2 C).

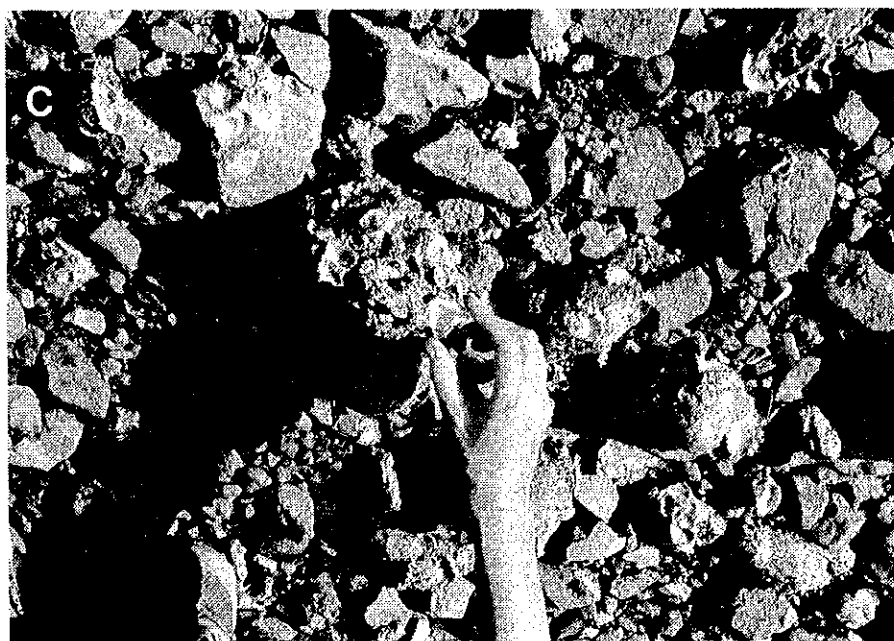
Plate 6-3 : Zone G shorescape near Cai Lan Port, December 1993.

- (A) Local people obtaining oyster (*Ostrea* sp.) from rocks in lower littoral.
- (B) Stunted mangrove (*Avicennia marina*).
- (C) Zone G has very limited remaining shellfish resources. The zone has been classified as having low ecological-economic status.

The molluscan fauna of Quang Ninh Province, including Bai Chay Bay, appears to equate with the highly valued mangrove mollusc resources of Malaysia as described by Wong *et al.* (1984). The biological richness of the Quang Ninh shellfish resource is underscored by the biogeographically interesting fact that of the 254 known species of mollusc within the Asia-Pacific Region, almost 70 % of them can be found in Quang Ninh Province. The most important in terms of abundance and distribution include *Nerita*, *Clithon*, *Litorina*, *Cerithium* (whose abundance can reach 200-300 m<sup>-2</sup> as observed during the field surveys), *Natica maculosa*, *Modiolus*, *Ostrea* (Plate 6-3 A and C) *Mactra quadrangularis*, *Teredo* and *Bankia*.

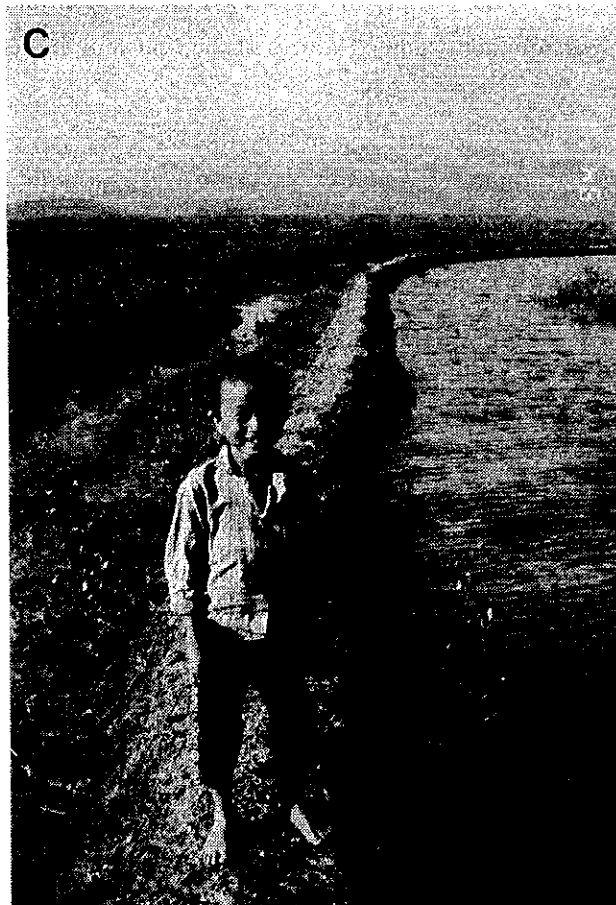
Plate 6-4: Food, fodder and the future.

- (A) Sipunculid worm collected in upper littoral near *Aegiceras* mangrove trees near site 3 (Fig 6.2).
- (B) Cattle grazing on the nutritious sweet and sour leaves of *Avicennia marina* : the minerals (salt) contained in these mangrove leaves are important for cattle health.
- (C) Man-made dyke beside extensive mangrove belt.

Other crustaceae are important too. Both traditional aquaculture and more advanced systems of aquaculture feature prawn culture. Like the molluscs mentioned above, the prawns are very important in both the daily and market activities of the local people of Bai Chay Bay. Plate 6-4C illustrates a more traditional aquacultural system, typical of the northern shores of Bai Chay Bay
