CHAPTER 4 PRESENT TRANSPORTATION SYSTEM IN DAR ES SALAAM

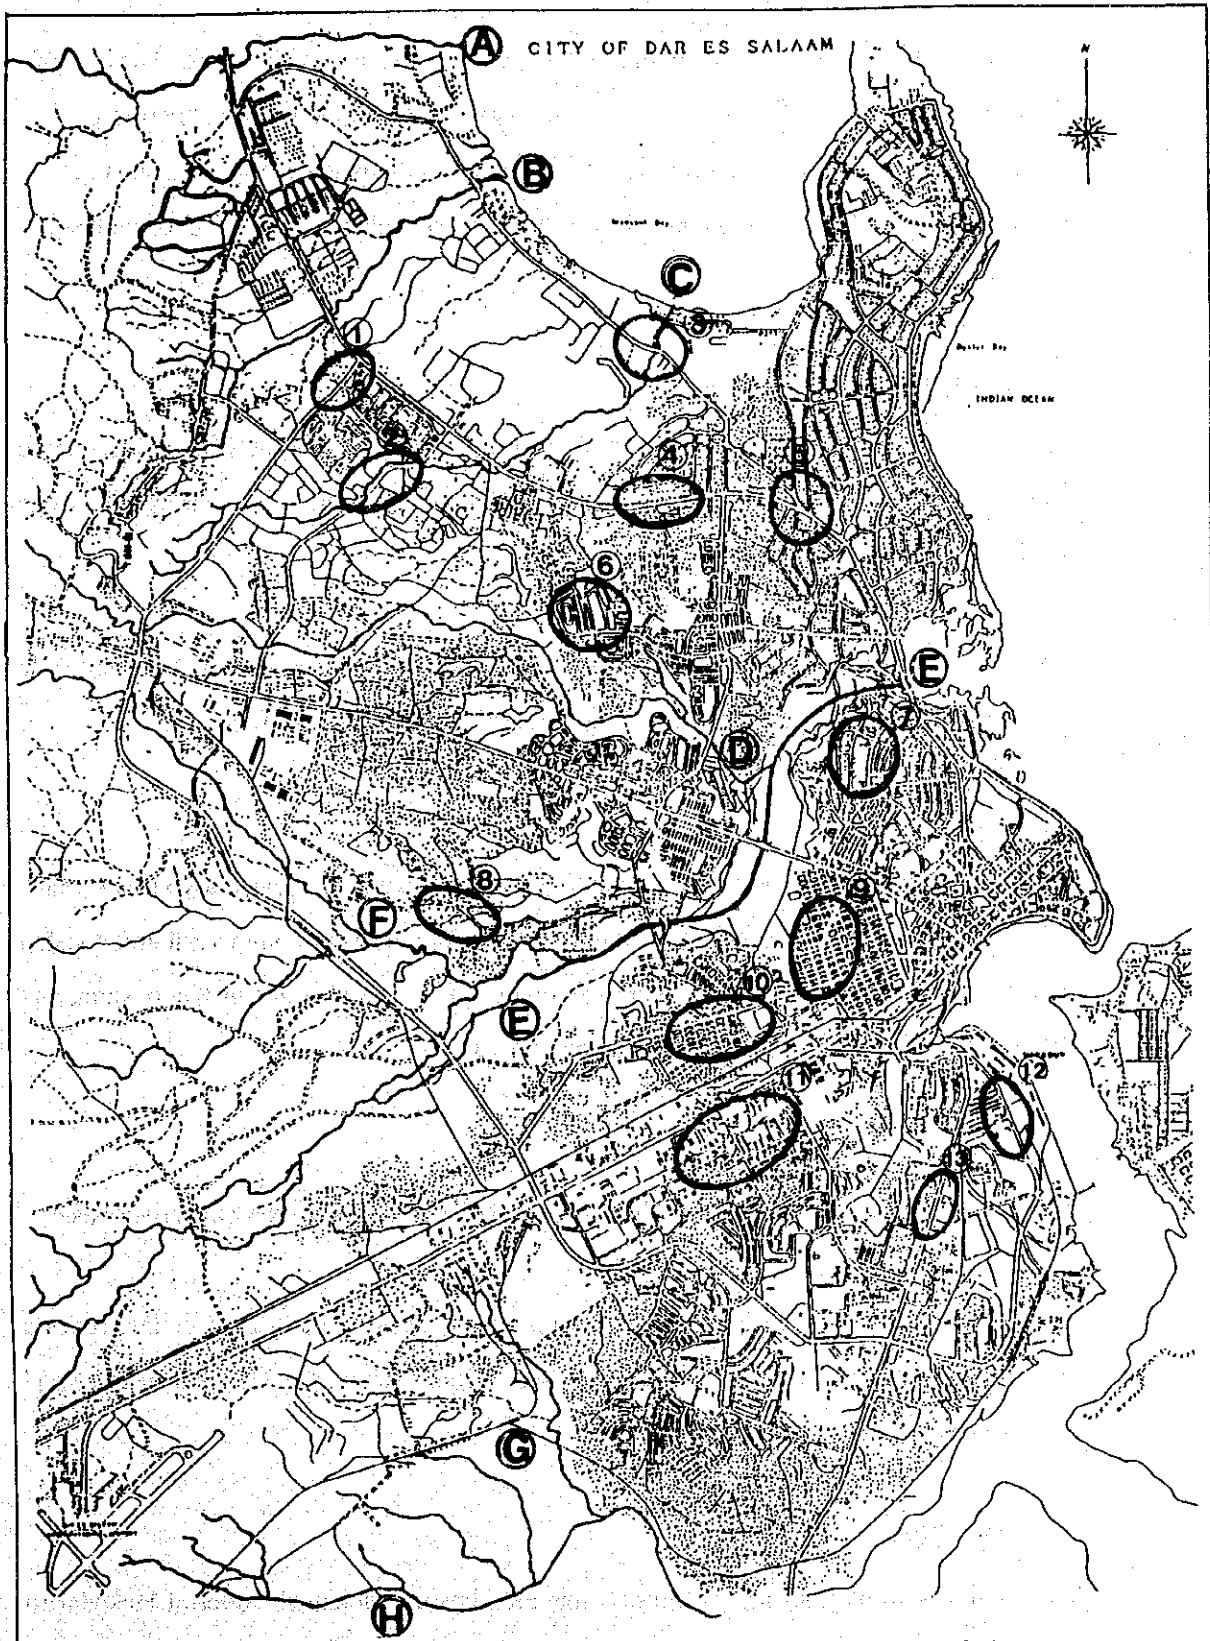
Fig. 5.1

Location Map of flood Hazard
 Survey Stations
 River Basins

The following is a general description of findings for flooding conditions identified at 13 specified survey locations (see Fig. 5.1).
