機材修理表

JICA 機器検査修理概表

③ 野口記念医学研究所提出業務報告書

Re.: Result of Inspection and Repair of Equipment for the
Noguchi Memorial Institute for Medical Research (N.M.I.M.R.)

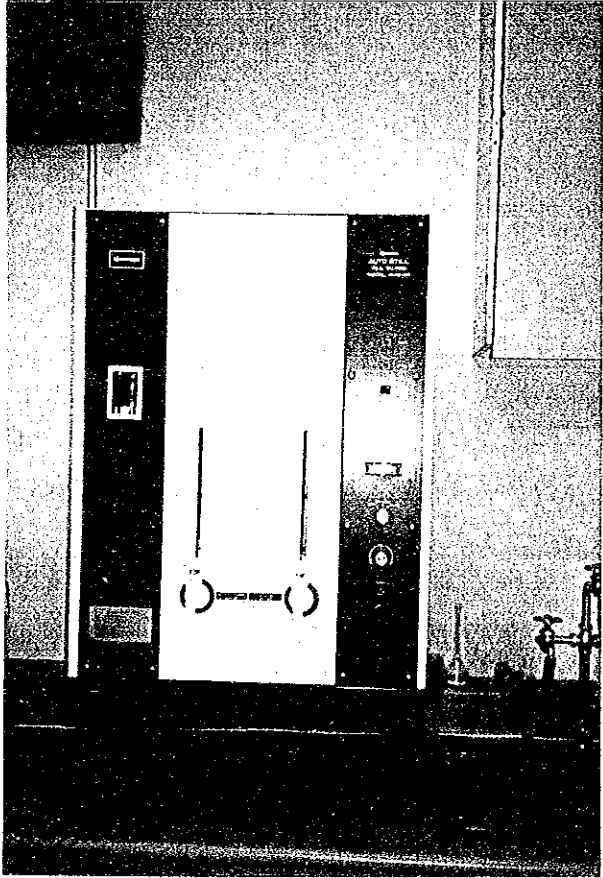
修理番号NO. 追加17

2. 本体	<input type="radio"/>	正常	<input type="checkbox"/>	改造	<input type="checkbox"/>	不良	<input type="checkbox"/>
	3. 電源	電源電圧 12V		規格印加電圧 12V				
取り扱い説明書	<input type="checkbox"/>	あり	<input type="radio"/>	なし	一部分持参追加			
回路図面	<input type="checkbox"/>	あり	<input type="radio"/>	なし	現物を見て作成			
機器故障内容概要	1. フィルター、イオン交換樹脂の劣化 2. 3. その他							
修理実施	1994年 1月10日 及び 修理結果: 完了							
<input type="checkbox"/> 修理不能	1. 部品がない 2. 工具がない 3. 電源電圧不足 4. 回路図がない 5. 取り扱い説明書がない その他							
<input type="radio"/> 修理完了	1. 規格の概能を回復 2. 実用上支障ない程度に回復 3. 一応使用できる程度 4. やっと使える程度 その他							
技術の指導	備考 1. 日常の定期保守点検の指導

修理年月日	1994年 1月10日	天候 晴 曇 雨
修理内容 フィルターの洗浄、イオン交換樹脂の交換		
修理必要部品		
参考事項 (写真, 今後の対応)

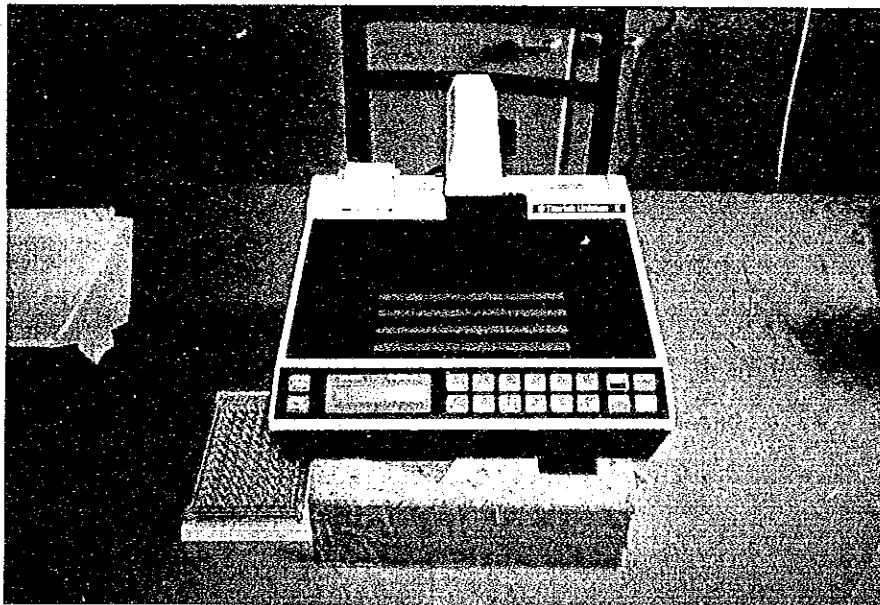
修理番号NO. 追加18

機 材 名	Titer tek Uniskan						備 考	
製 品 番 号	361							
製 作 年 月	RS-232C							
メーカ名称	大日本製薬							
使 用 場 所	Virology Dept. (Room No. 148)				供与年度			
運 用 環 境	○	空調付		高 温		多 湿		屋 外
機 器 の 状 態		未使用	○	普 通		中 古		酷 使
修 理 依 頼	JICAからの連絡					あ り	○	な し
写 真 撮 影	○	撮 影 済		未 撮 影		スケッチ済		
チエック内容	1. 外 見	○	正 常		改 造		不 良	
	2. 本 体		正 常		改 造	○	不 良	
	3. 電 源	電源電圧 100V		規格印加電圧 120V				
取 扱 説 明 書	○	あ り		な し	一部分持参追加			
回 路 図 面		あ り	○	な し	現物を見て作成			
機 器 故 障 内 容 概 要	1. プログラムカートリッジの不良、交換が必要 2. 3. その他							
修 理 実 施	1994年 1月10日 及び 修理結果: 未 完							
修 理 不 能	1. 部品がない 2. 工具がない 3. 電源電圧不足 4. 回路図がない 5. 取り扱い説明書がない その他							
修 理 完 了	1. 規格の概能を回復 2. 実用上支障ない程度に回復 3. 一応使用できる程度 4. やっと使える程度 その他							
技 術 の 指 導	備考

プログラムカートリッジの不良、代替がない（製造中止）ため交換不可

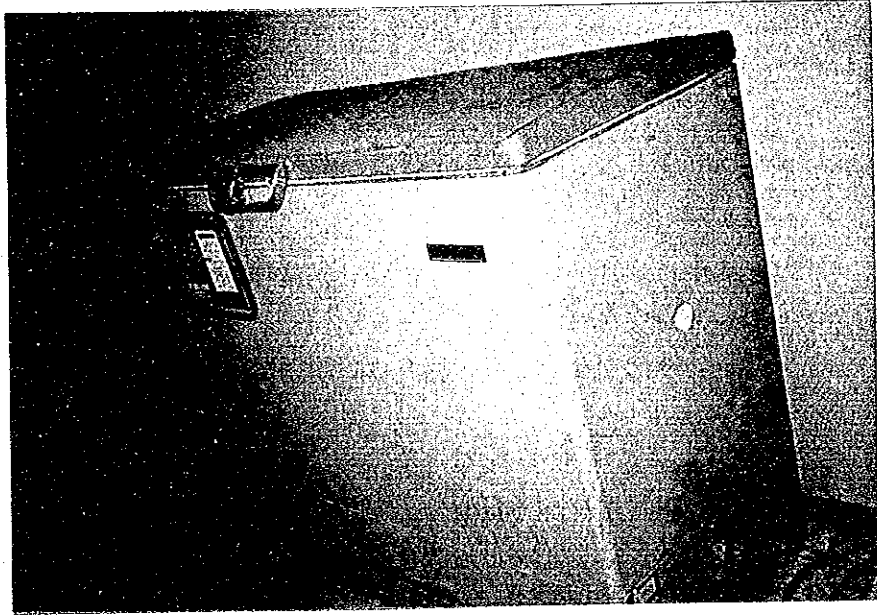
修理番号NO. 追加20

機材名	ディープフリーザー						備考	
製品番号	ULT-1285-C							
製作年月								
メーカー名称	レプコ							
使用場所							供与年度	
運用環境	<input type="radio"/>	空調付		高温		多湿		屋外
機器の状態		未使用		普通		中古	<input type="radio"/>	酷使
修理依頼	JICAからの連絡					あり	<input type="radio"/>	なし
写真撮影	<input type="radio"/>	撮影済		未撮影		スケッチ済		
チェック内容	1. 外見		正常		改造	<input type="radio"/>	不良	
	2. 本体		正常		改造	<input type="radio"/>	不良	
	3. 電源	電源電圧 240V			規格印加電圧 240V			
取り扱い説明書		あり	<input type="radio"/>	なし		一部分持参追加		
回路図面		あり	<input type="radio"/>	なし		現物を見て作成		
機器故障内容概要	1. コンプレッサー損焼							
	2.							
	3.							
	その他							
修理実施 1993年 9月20日 及び 修理結果: 不能								
<input type="radio"/>	修理不能	1. 部品がない 2. 工具がない 3. 電源電圧不足 4. 回路図がない 5. 取り扱い説明書がない その他						
<input type="checkbox"/>	修理完了	1. 規格の概能を回復 2. 実用上支障ない程度に回復 3. 一応使用できる程度 4. やっと使える程度 その他						
技術の指導	備考							
	1. 廃棄処分を提案
