APPENDIX 7

RESULTS OF NATURAL CONDITIONS SURVEY

7.1 Topographical Survey

7.2 **Geological Survey**

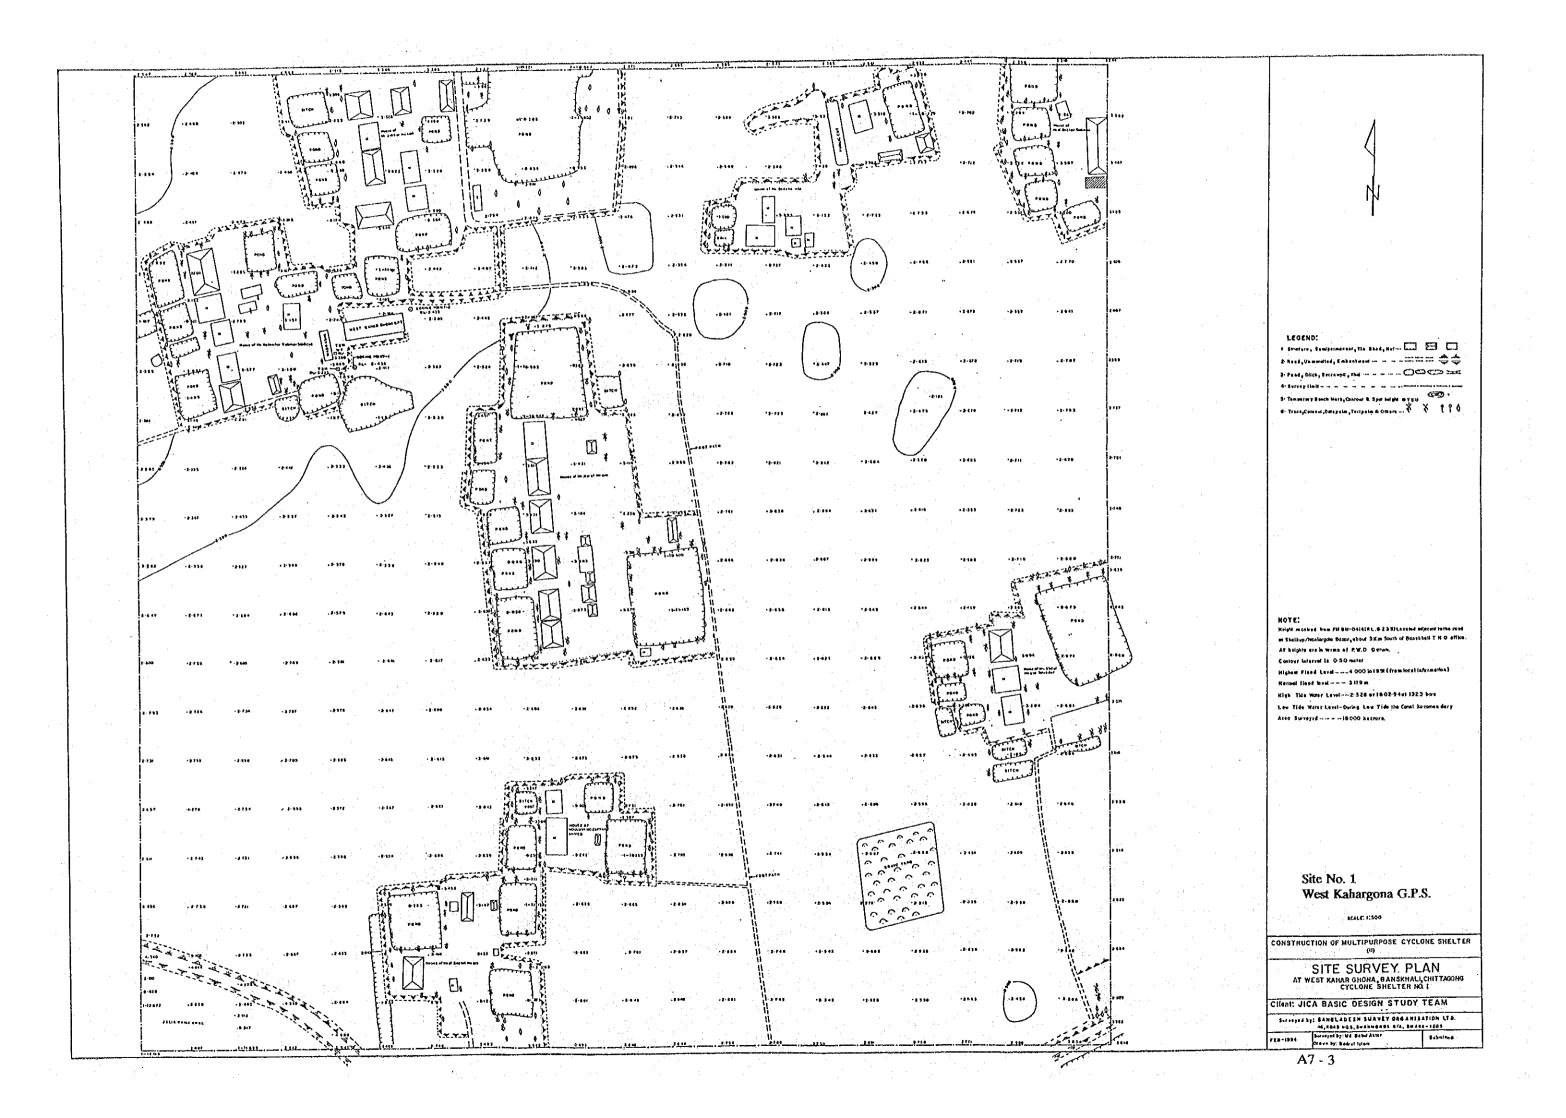
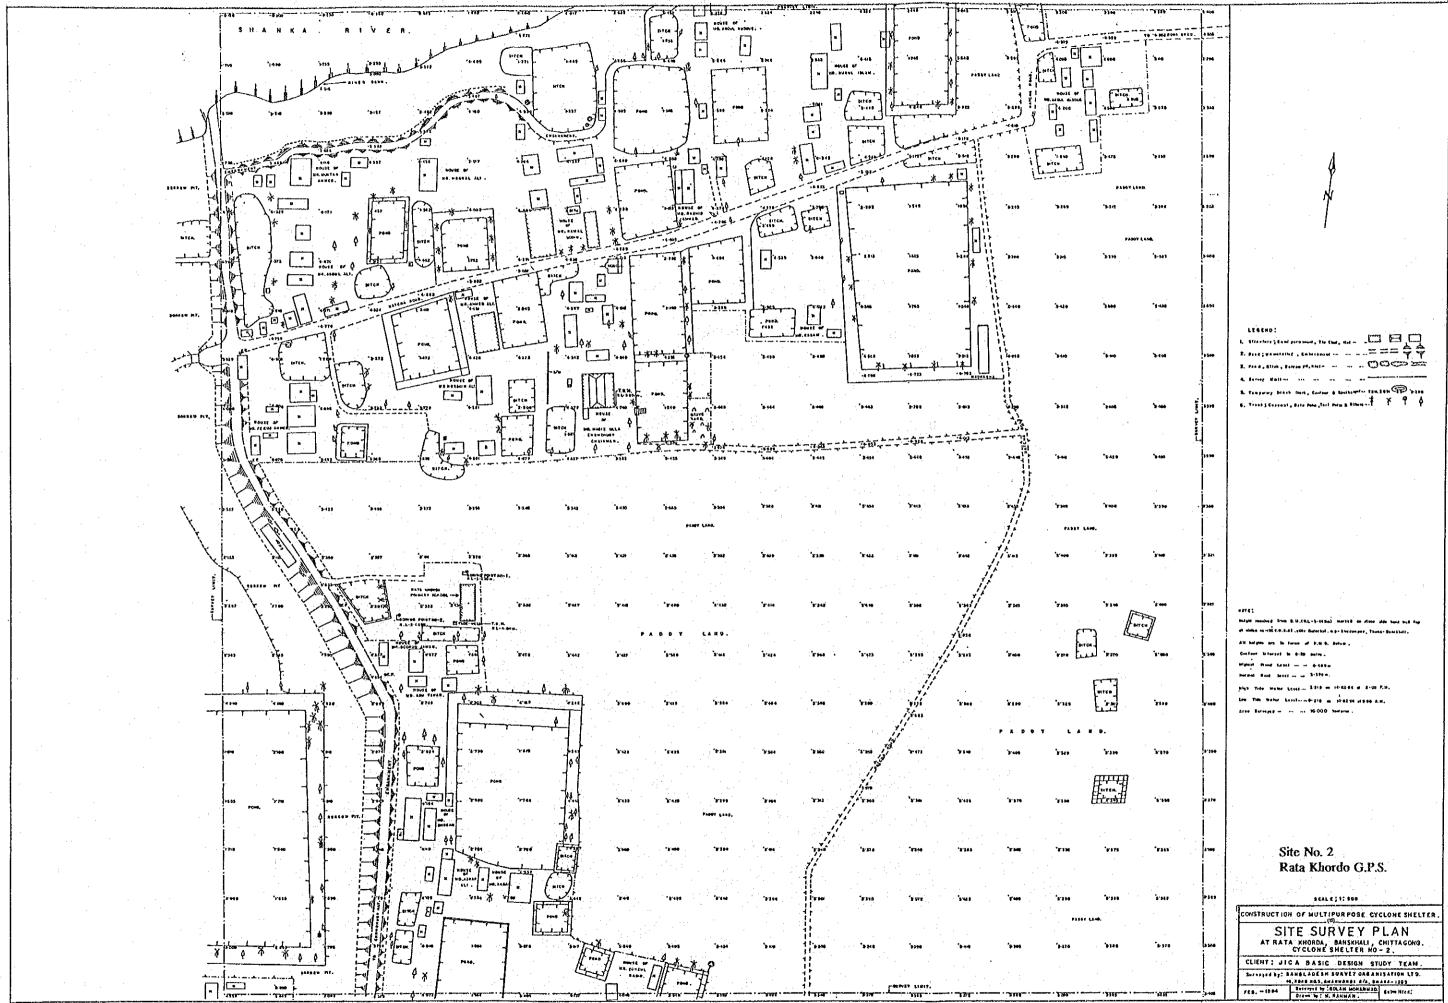
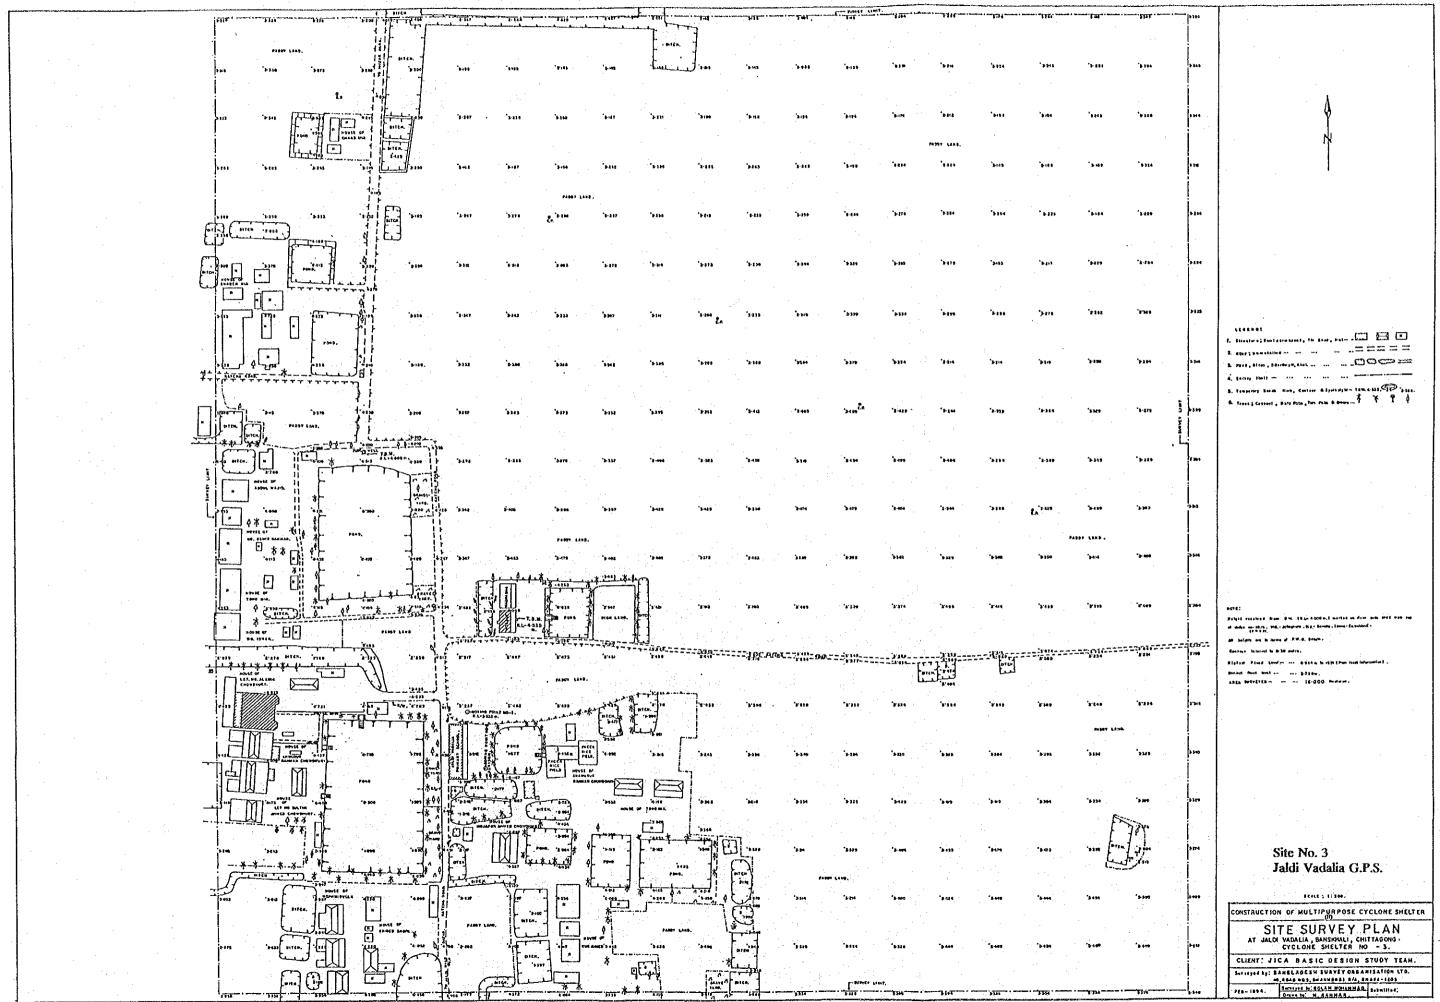
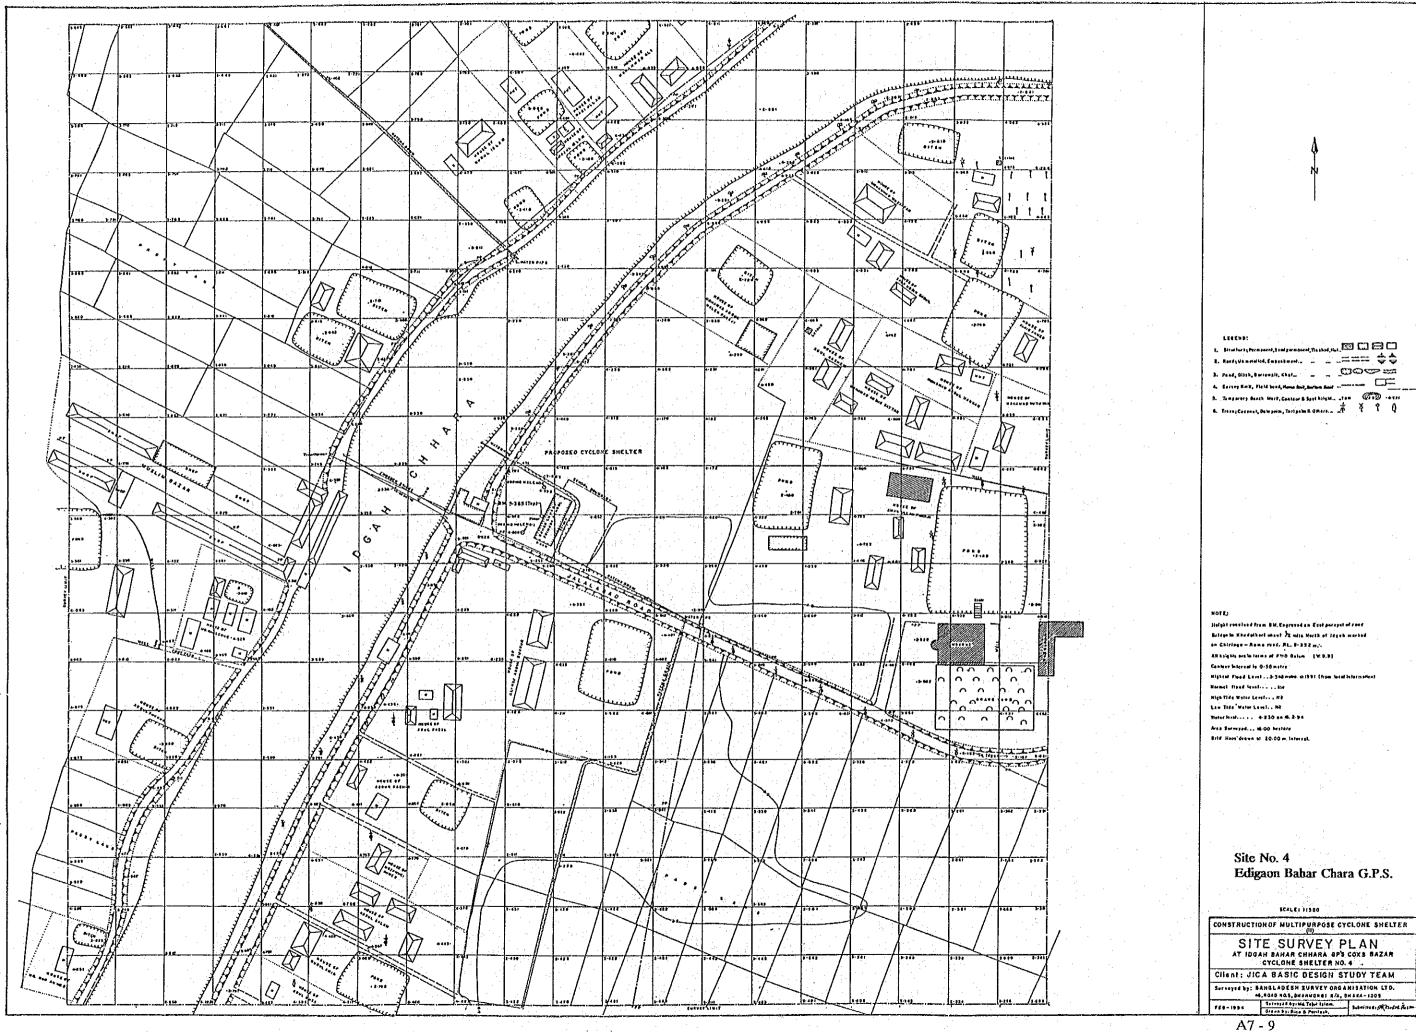
The topographical plan for each site, prepared based on the results of the survey, is given as follows.

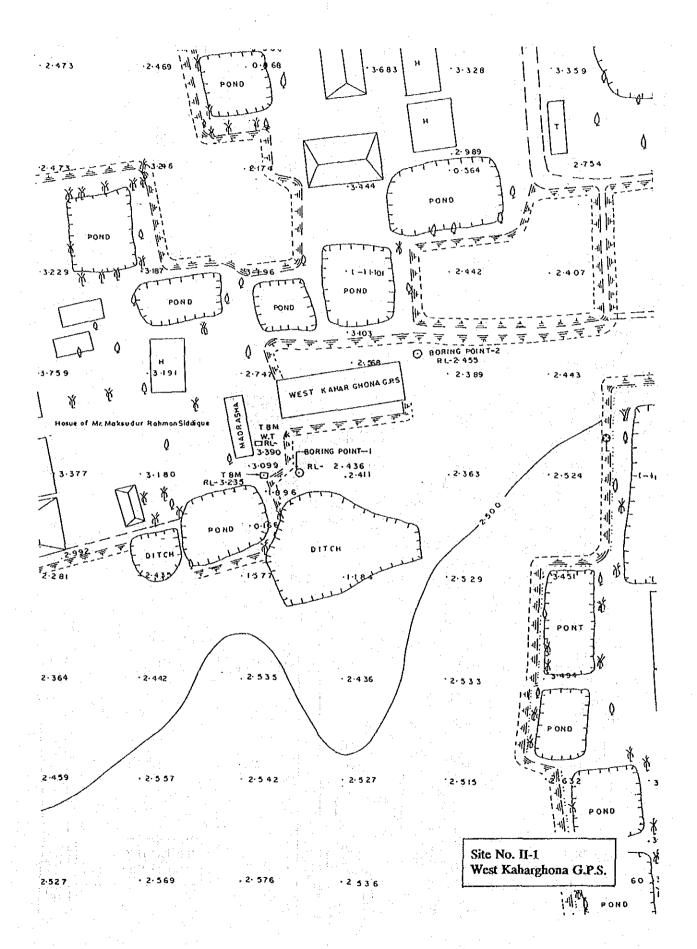
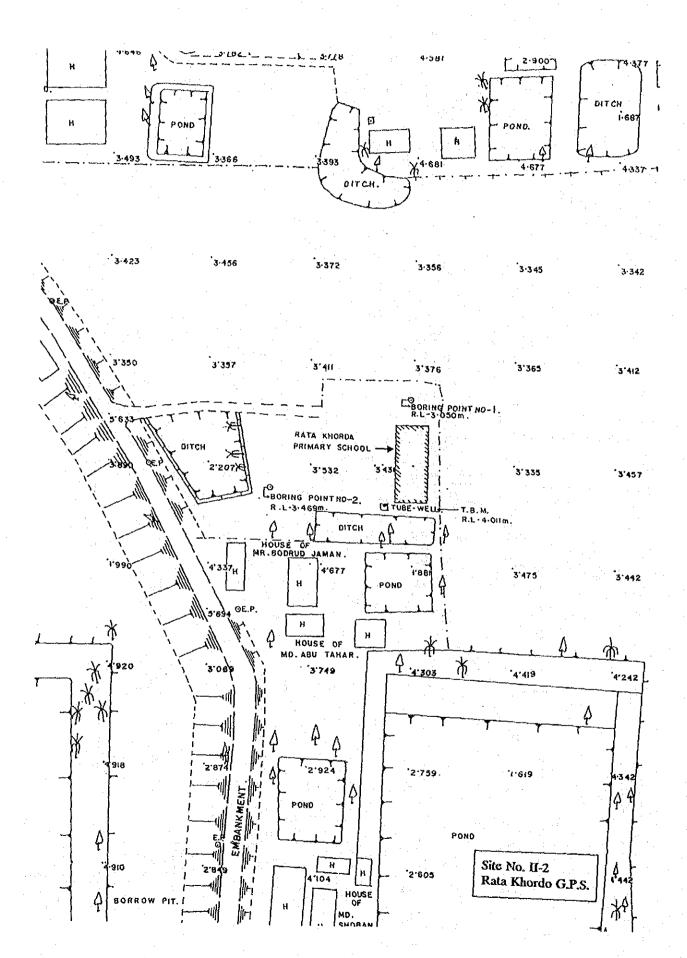
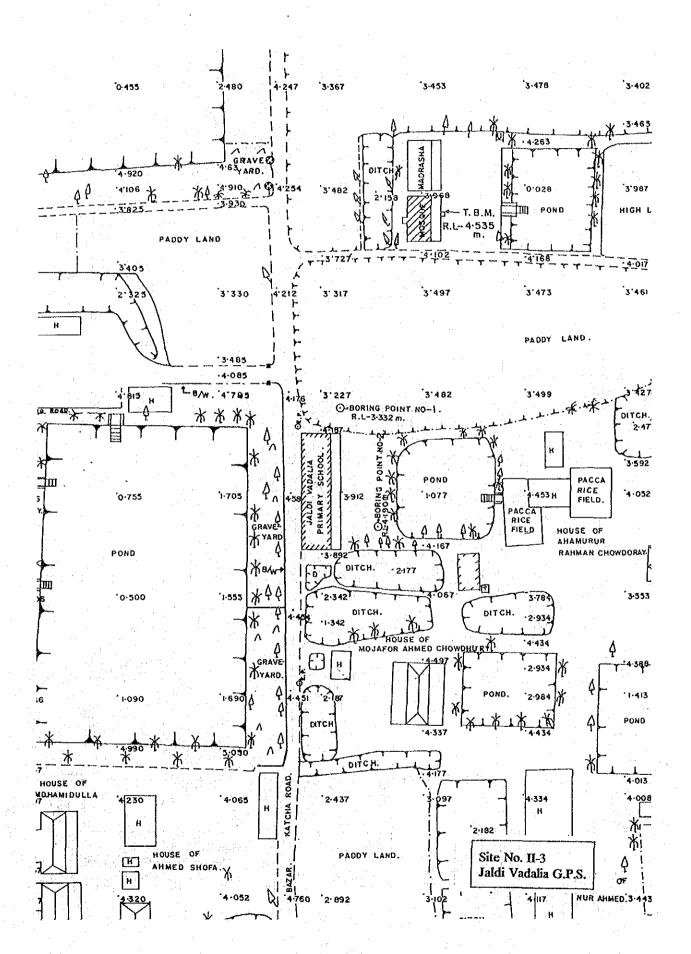
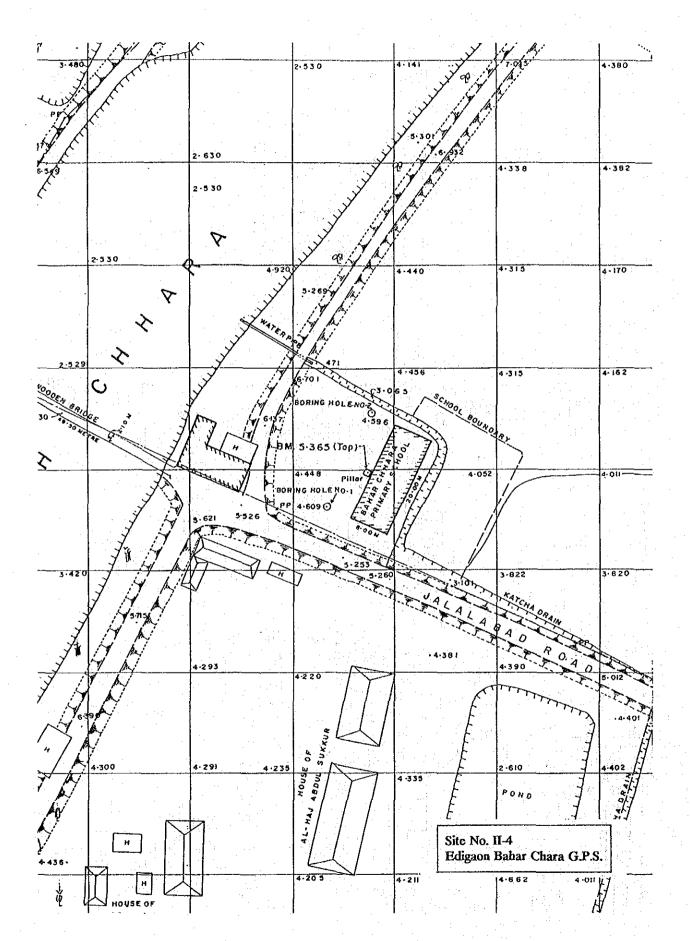
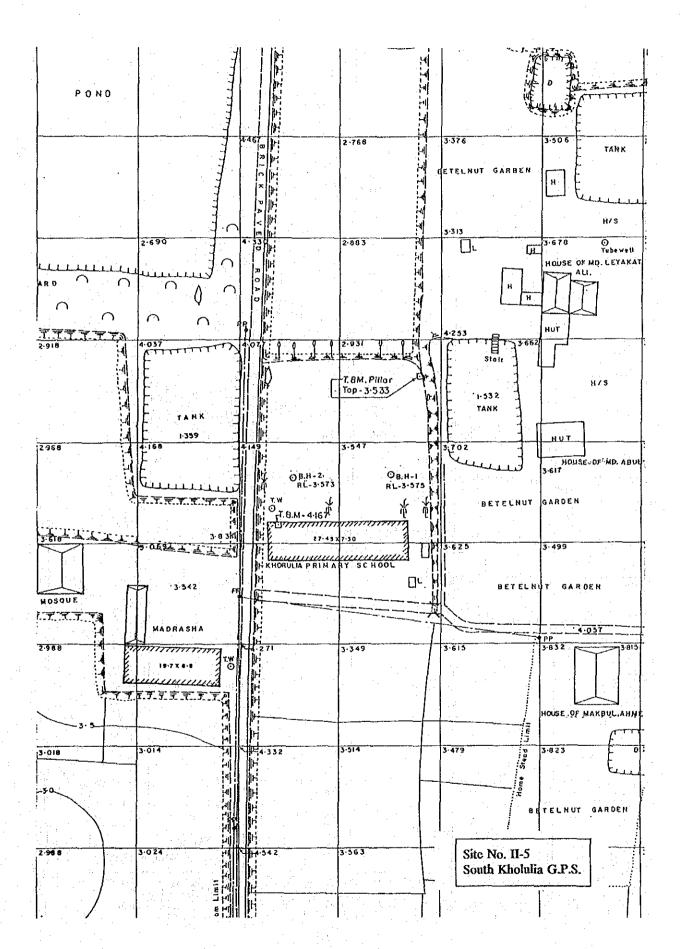
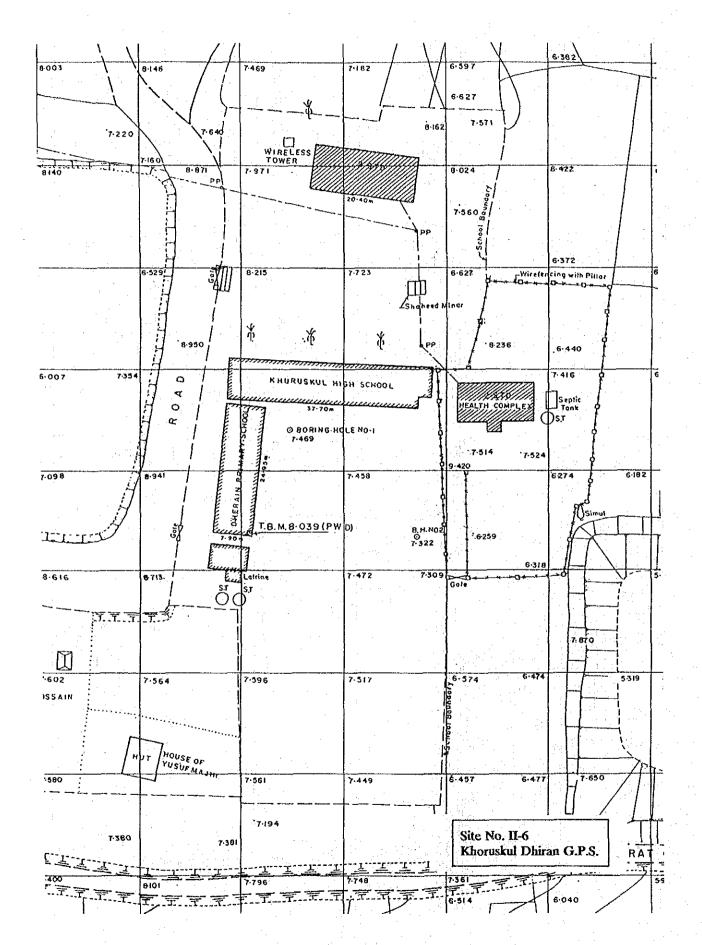
LOCATIONS OF BORING HOLES

The results of the geological survey are given as follows.
