2 - 3 - 6 Outline of Existing Facilities and Equipment

(1) Present condition of the Amyria Plant facilities and equipments

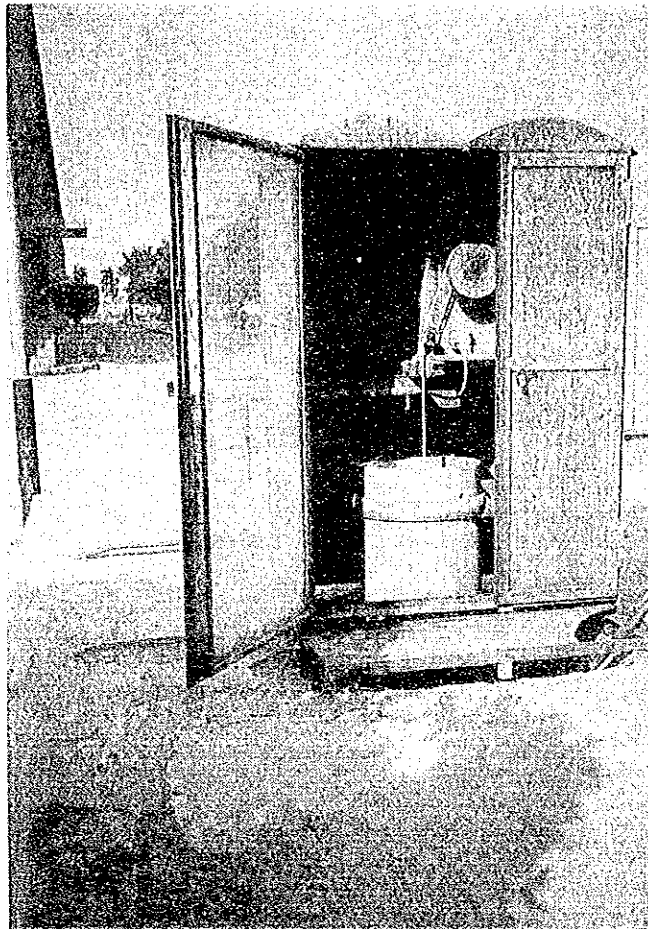
Photograph 2 - 12 Water treatment plant water level meter transmitter unit

The main unit of the water level meter of the clear water reservoir is in advanced state of corrosion.

Raw water flow meter, treated water flow meter and other equipment are available in the water treatment plant, but they must be improved because the required instrumentation units are not properly equipped.

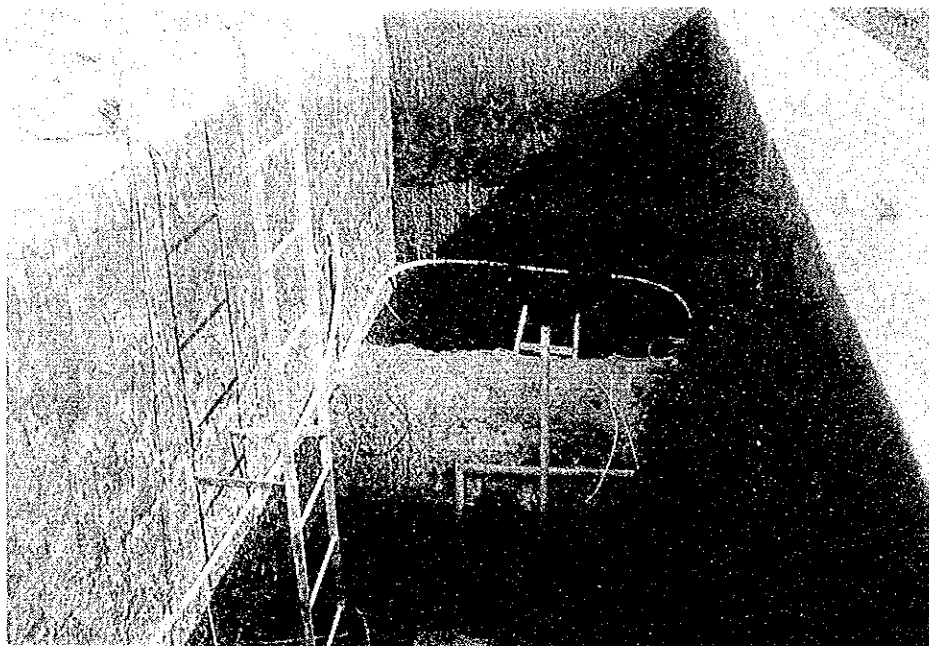
Photograph 2 - 13 Distribution water flow meter (for mains pipe) detector unit pit

The following measuring instruments are obsolete, and their functions are stopped.

- Raw water screen loss head meter
- Sedimentation basin drainage pit level switch
- Distribution shaft water level meter
- Water distribution flow meter (for high-pressure and low-pressure area mains)

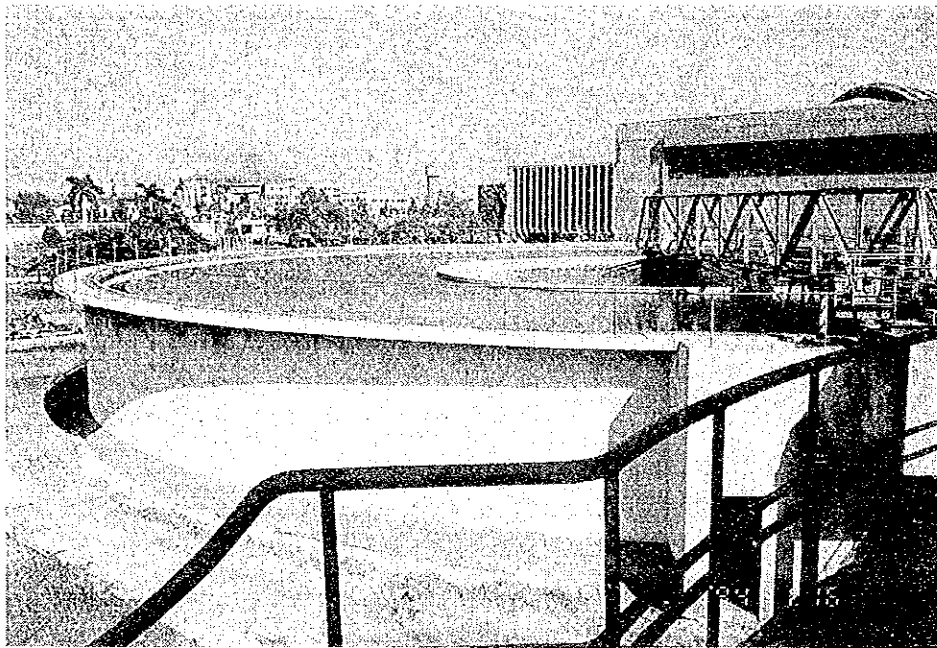
As for the present status of the existing civil structures, no abnormality in particular was observed as a result of the visual inspections carried out this time.

Photograph 2 - 16 Sedimentation basin (there is no structural problem)

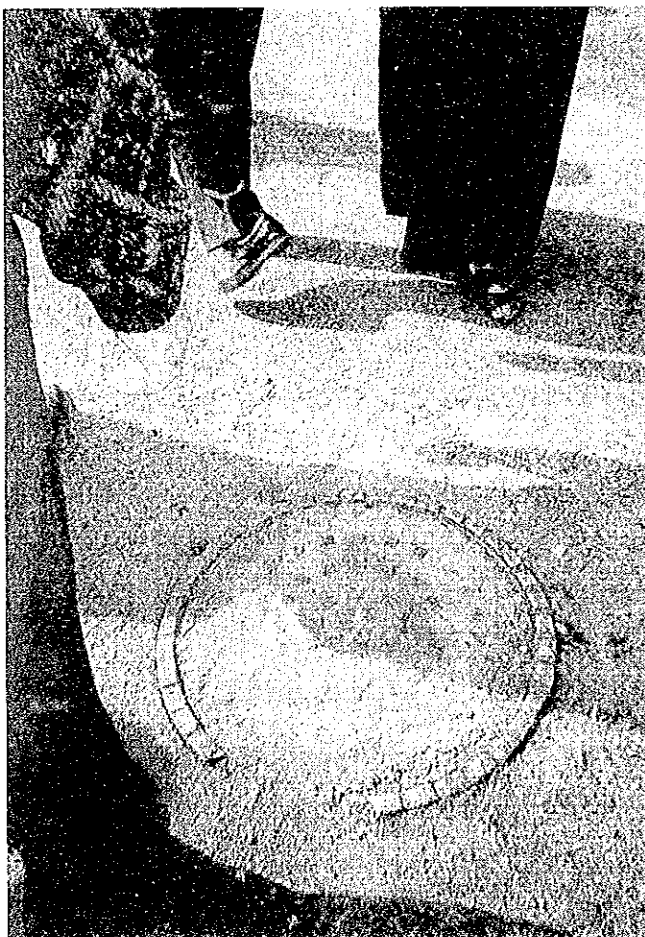
Photograph 3-3
Manhole of the sewer
receiving waste water from
the shared used tap shown in
the photograph above

If the volume of potable water supplied by the Amyria Plant is increased, the volume of waste water discharged from the households of the supply area will increase accordingly. Since 85 % of the Amyria water supply area is served by sewer systems, however, most of the waste water resulting from the potable water system will be treated at the sewage treatment plants. Thus, the noxious influence on the environmental conditions are presumed to be negligible.
