5. Conditions of the Project Site

Report on Soil Investigation

THE PROPOSED CONSTRUCTION EQUIPMENT TRAINING CENTRE

REPORT ON SOIL INVESTIGATION
FOR
THE PROPOSED CONSTRUCTION EQUIPMENT TRAINING CENTRE
AT AKUREGODA ROAD
PELAWATTE-BATTARAMULLA

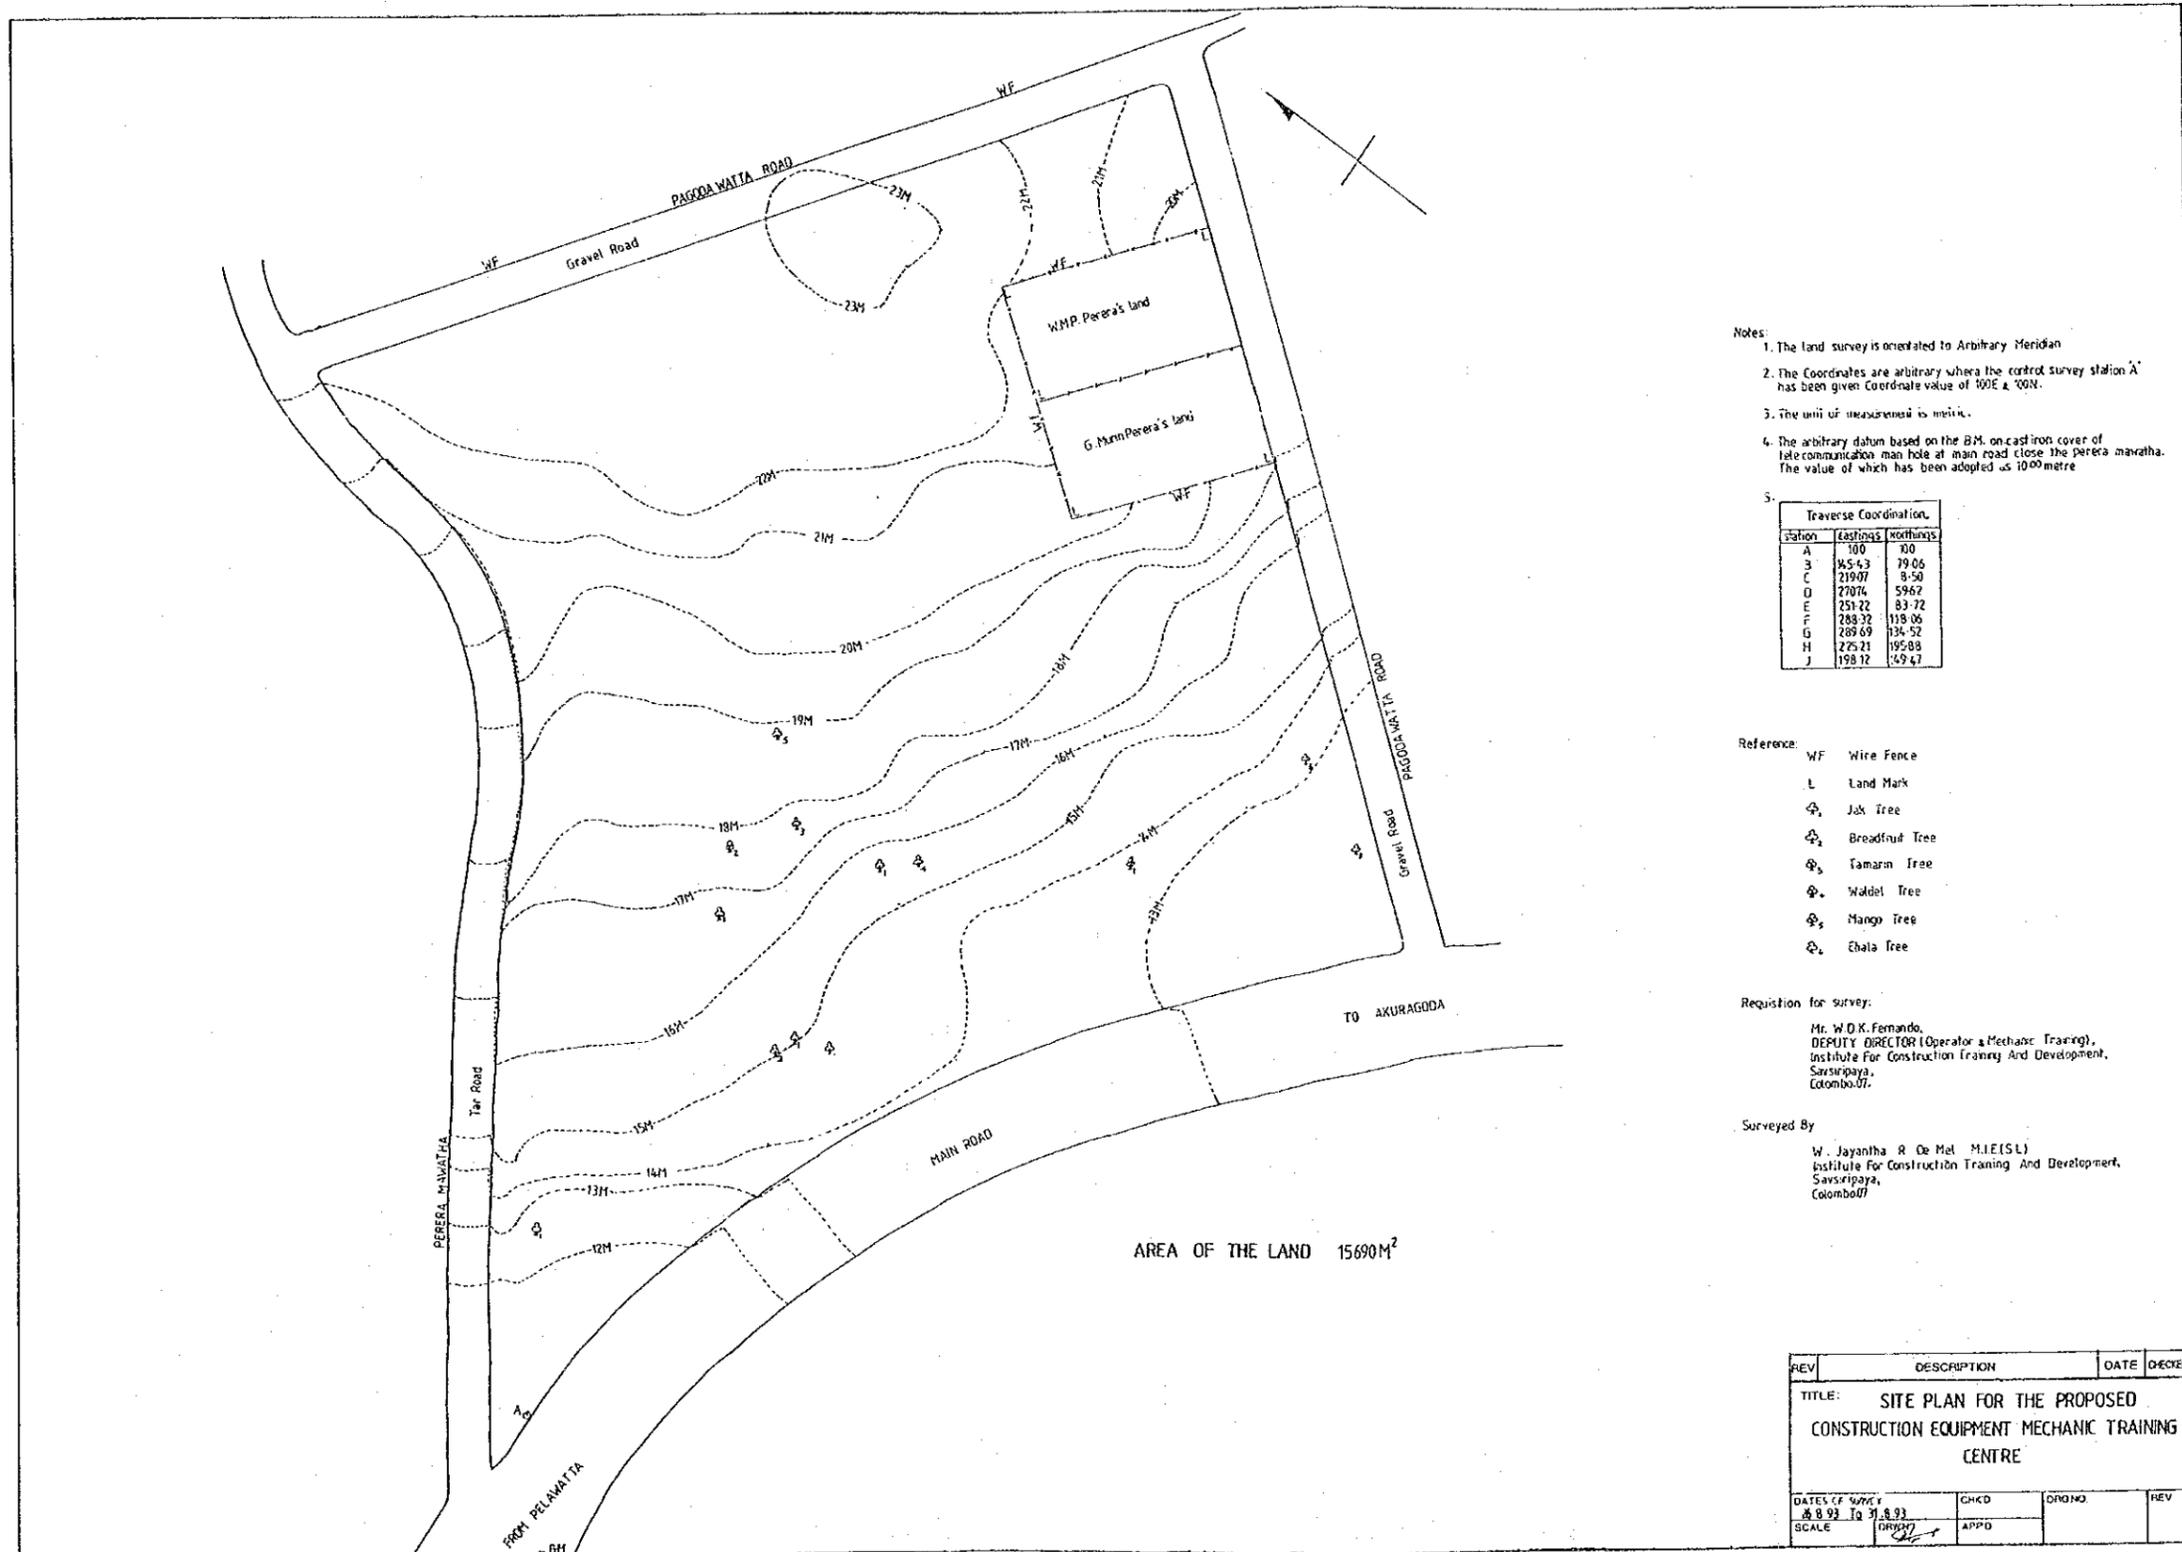
5-2. Site Survey Map

S. 1:1000

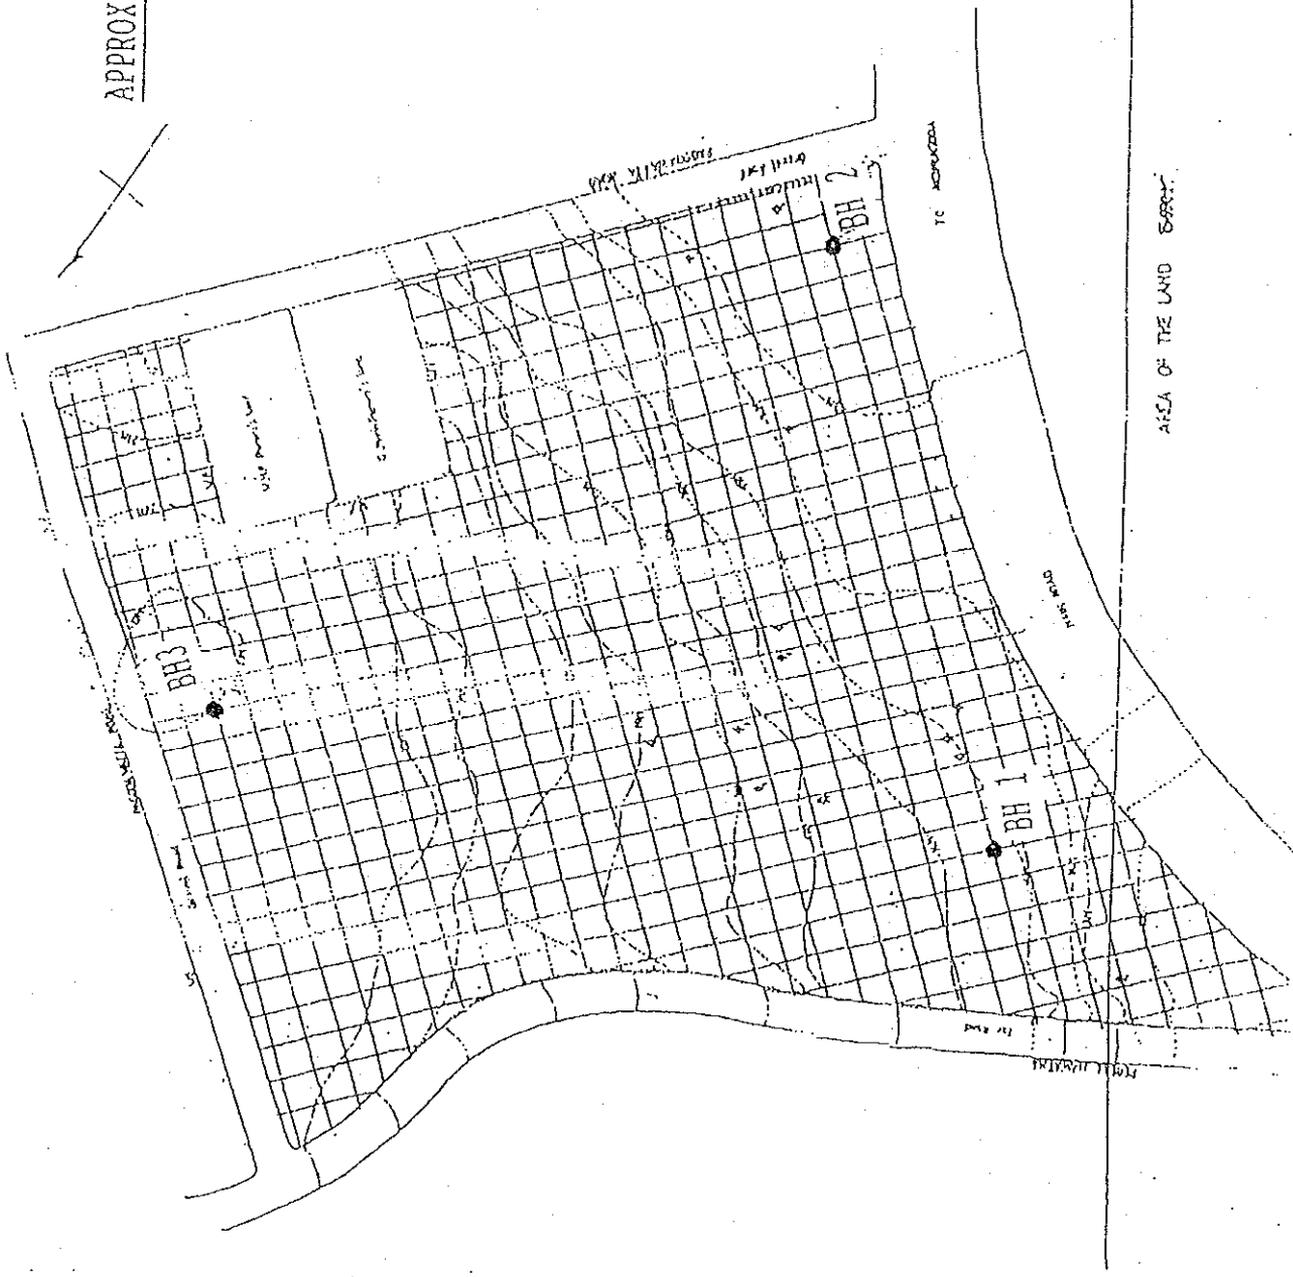
FIGURE I
APPROXIMATE LOCATION OF BORE HOLES
 (NOT TO SCALE)

- Notes:**
1. The land survey is indicated in solid line.
 2. The Contour lines indicate the ground surface elevations. The contour interval is 10 feet.
 3. The spot of measurement is marked.
 4. The boring was done on the spot indicated in the sketch. The boring was done by the method of auger and the depth of the boring is shown.

Approximate locations of the bore holes are shown in Figure I.
