The Study on Road Disaster Prevention Plan in The Kingdom of Thailand

**FINAL REPORT
SUMMARY**

VOLUME 1

Kingdom of Thailand
Ministry of Transport and
Communications
Department of Highways

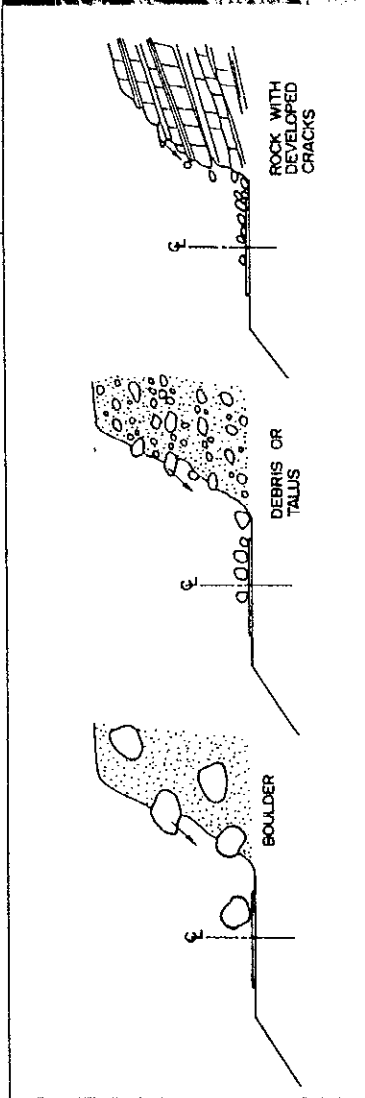
Table 3.2.2 Definition of Slope Damage (2)

Type of Damage	Definition	Cause
<p>Rockfalls</p> <ul style="list-style-type: none"> - A rockfall consists of any downslope movement of intact blocks of rock. - The falling of detached rock from the surface of a slope made up of bedrock having cracks, joints, and beddings. - The falling of unsupported pebbles, boulders from the surface of a slope made up of debris or talus.

<ul style="list-style-type: none"> - Stable boulders lose their balance and fall due to the scouring of matrix soil under the boulders by runoff water or seepage. - Rock blocks lose their balance and fall due to the development of cracks in rock by runoff water or seepage.

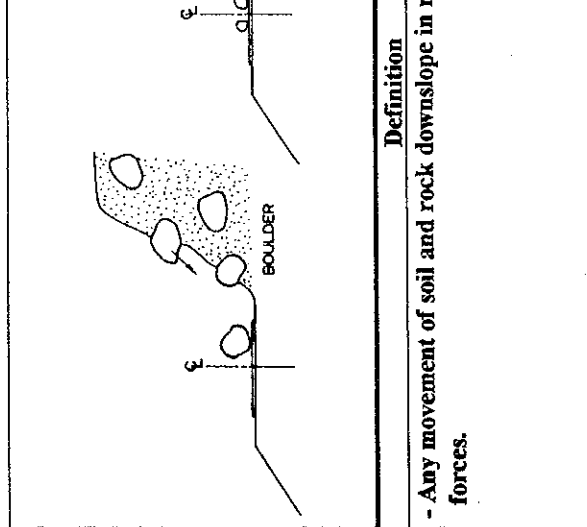
<p> Landslide</p>	<p>Definition</p> <ul style="list-style-type: none"> - Any movement of soil and rock downslope in response to gravitational forces.

<p>Cause</p> <ul style="list-style-type: none"> - Landslide result from the Gravitational driving forces exceed the frictional restraining force. - A decrease in the cohesion of soil due to an increase in pore water pressure from a rise in ground water, which results in a decrease in frictional restraining force.

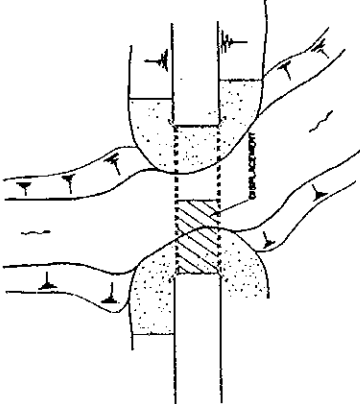
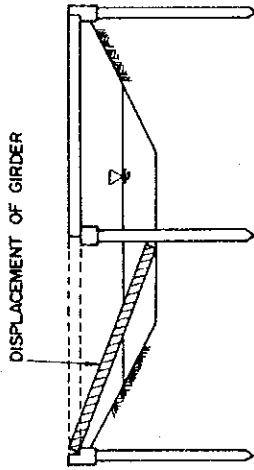
Table 3.2.3 Definition of Collapsing of Bridges (1)

Type of Damage	Definition	Cause
<p>Girder Displacement</p>	<ul style="list-style-type: none"> - The falling of a girder from the top of a substructure due to a loss of support. - Lateral movement of a girder on the top of a substructure. - Fracturing of girder. 	<ul style="list-style-type: none"> - Girder displacement occurs due to the collapsing, tilting, settlement and / or sliding of a pier and / or abutment. - Lateral movement of a girder is caused by lateral forces on the girder exerted by water, debris or mud flows, or floating timber. - Fracturing of girder due to girder displacement.

<p>Pier Collapsing</p>	<p>Definition</p> <ul style="list-style-type: none"> - Tilting, and settlement of pier. - Fracturing of column. 	<p>Cause</p> <ul style="list-style-type: none"> - Tilting of piers and fracturing of columns are caused by lateral forces on piers exerted by water flows, debris or mud flows, or floating timber. - The scouring of a foundation may result in the vertical settlement of a pier due to a loss of the side friction of piles.

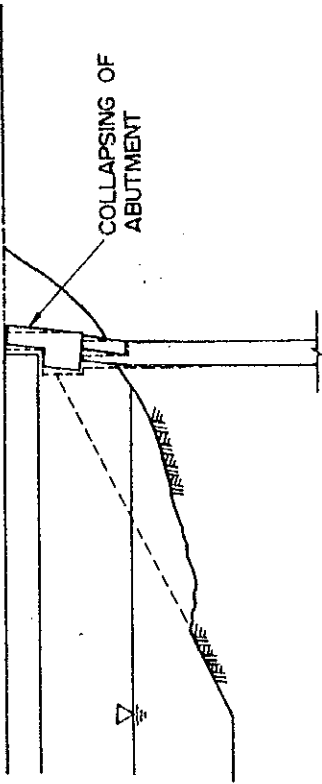
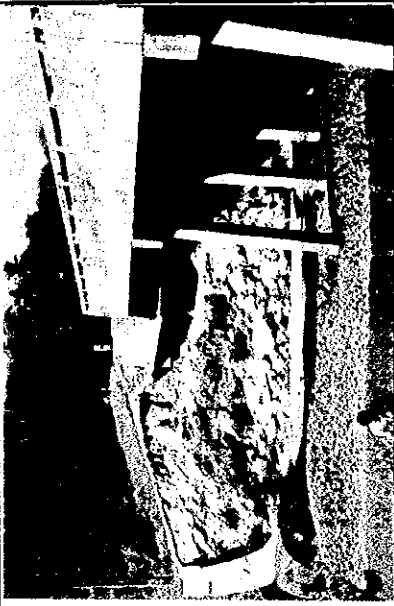
Table 3.2.3 Definition of Collapsing of Bridges (2)

Type of Damage	Definition	Cause
<p>Abutment Collapsing</p>	<p>- The collapsing, tilting, settlement and sliding of an abutment. - The collapsing of an abutment fill slope is included.</p>	<p>- The collapsing, tilting and sliding of an abutment occurs due to the loss of lateral resistance caused by the scouring of an abutment fill slope, etc. - The settlement of an abutment is caused by the loss of bearing capacity of a foundation due to scouring.</p>

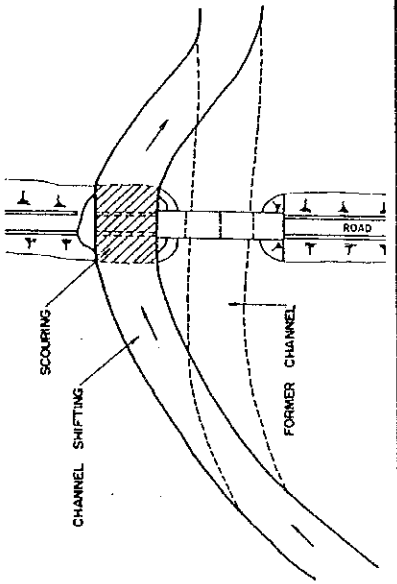
<p>Type of Damage Scouring of Approach Road</p>	<p>Definition - From partial scouring to the total collapse of an approach road.</p>	<p>Cause - The river flow collides with the approach road due to the diversion of the river channel.</p>

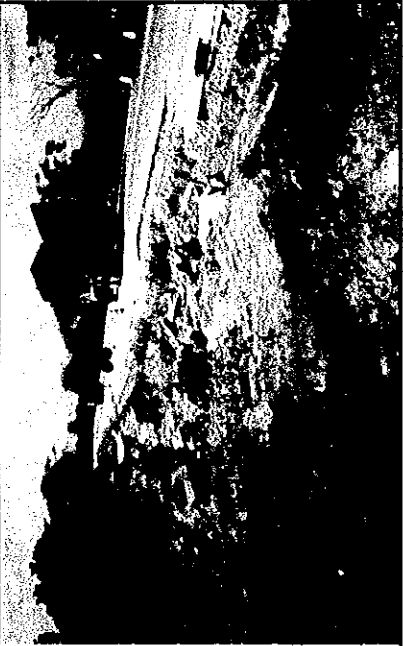
Table 3.2.4 Definition of Collapsing of Embankment Roads

Type of Damage	Definition	Cause
Scouring of Embankment Slope	<p>- From the partial scouring of an embankment slope to the total collapse of an embankment.</p>	<p>- Rapid water flows in parallel with the side of an embankment. - At the time of flooding, the portion of an embankment adjacent to a drainage opening is likely to be damaged by the above-mentioned water flows.</p>
Washing Out of Shoulder	<p>- Washing out of embankment shoulder on downstream side.</p>	<p>- When flood waters overflow an embankment, the downstream side of an road embankment is where the water flow is at its maximum velocity and is therefore the most vulnerable spot.</p>

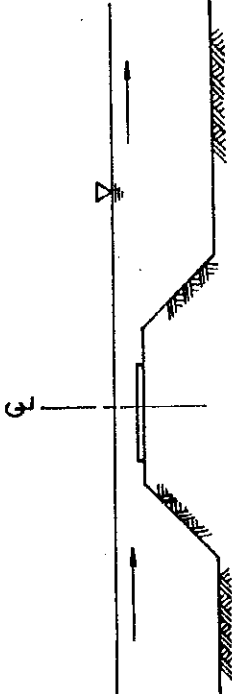
Table 3.2.5 Definition of Road Flooding

Type of Damage Inundation	Definition - Submergence of road surface with no damage to the road's embankments.	Cause - Elevation of the road surface is insufficient.

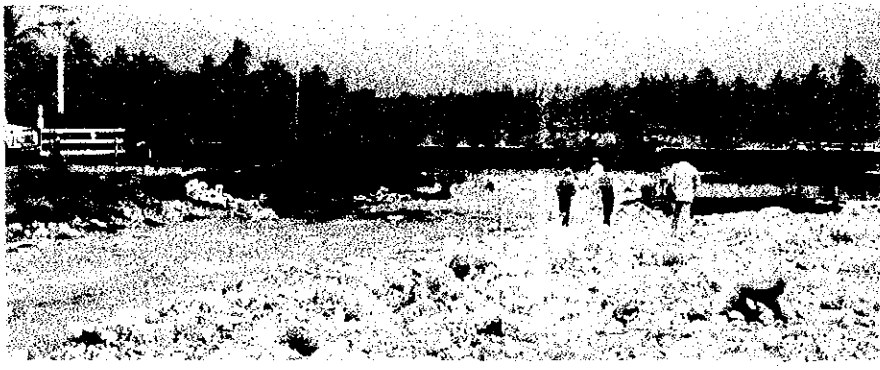
Fig. 4.2.4 Details of Damage Spot

SECTION A - A
(BEFORE REPAIR WORK)

SECTION A - A
(AFTER REPAIR WORK)

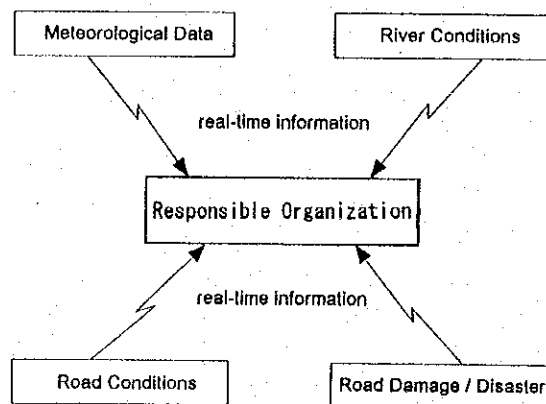
Fig. 5.1.1 Real-Time Information

To decide promptly on countermeasures for a disaster, real-time information shall be concentrated at the responsible organization (cf. Fig.5.1.1). Information shall come from other agencies and consist of such essential data as meteorological data and data on river conditions.
