6.2 Establishment of Present O-D Matrix

6.2.1 Road Traffic Survey for River Crossing Traffic

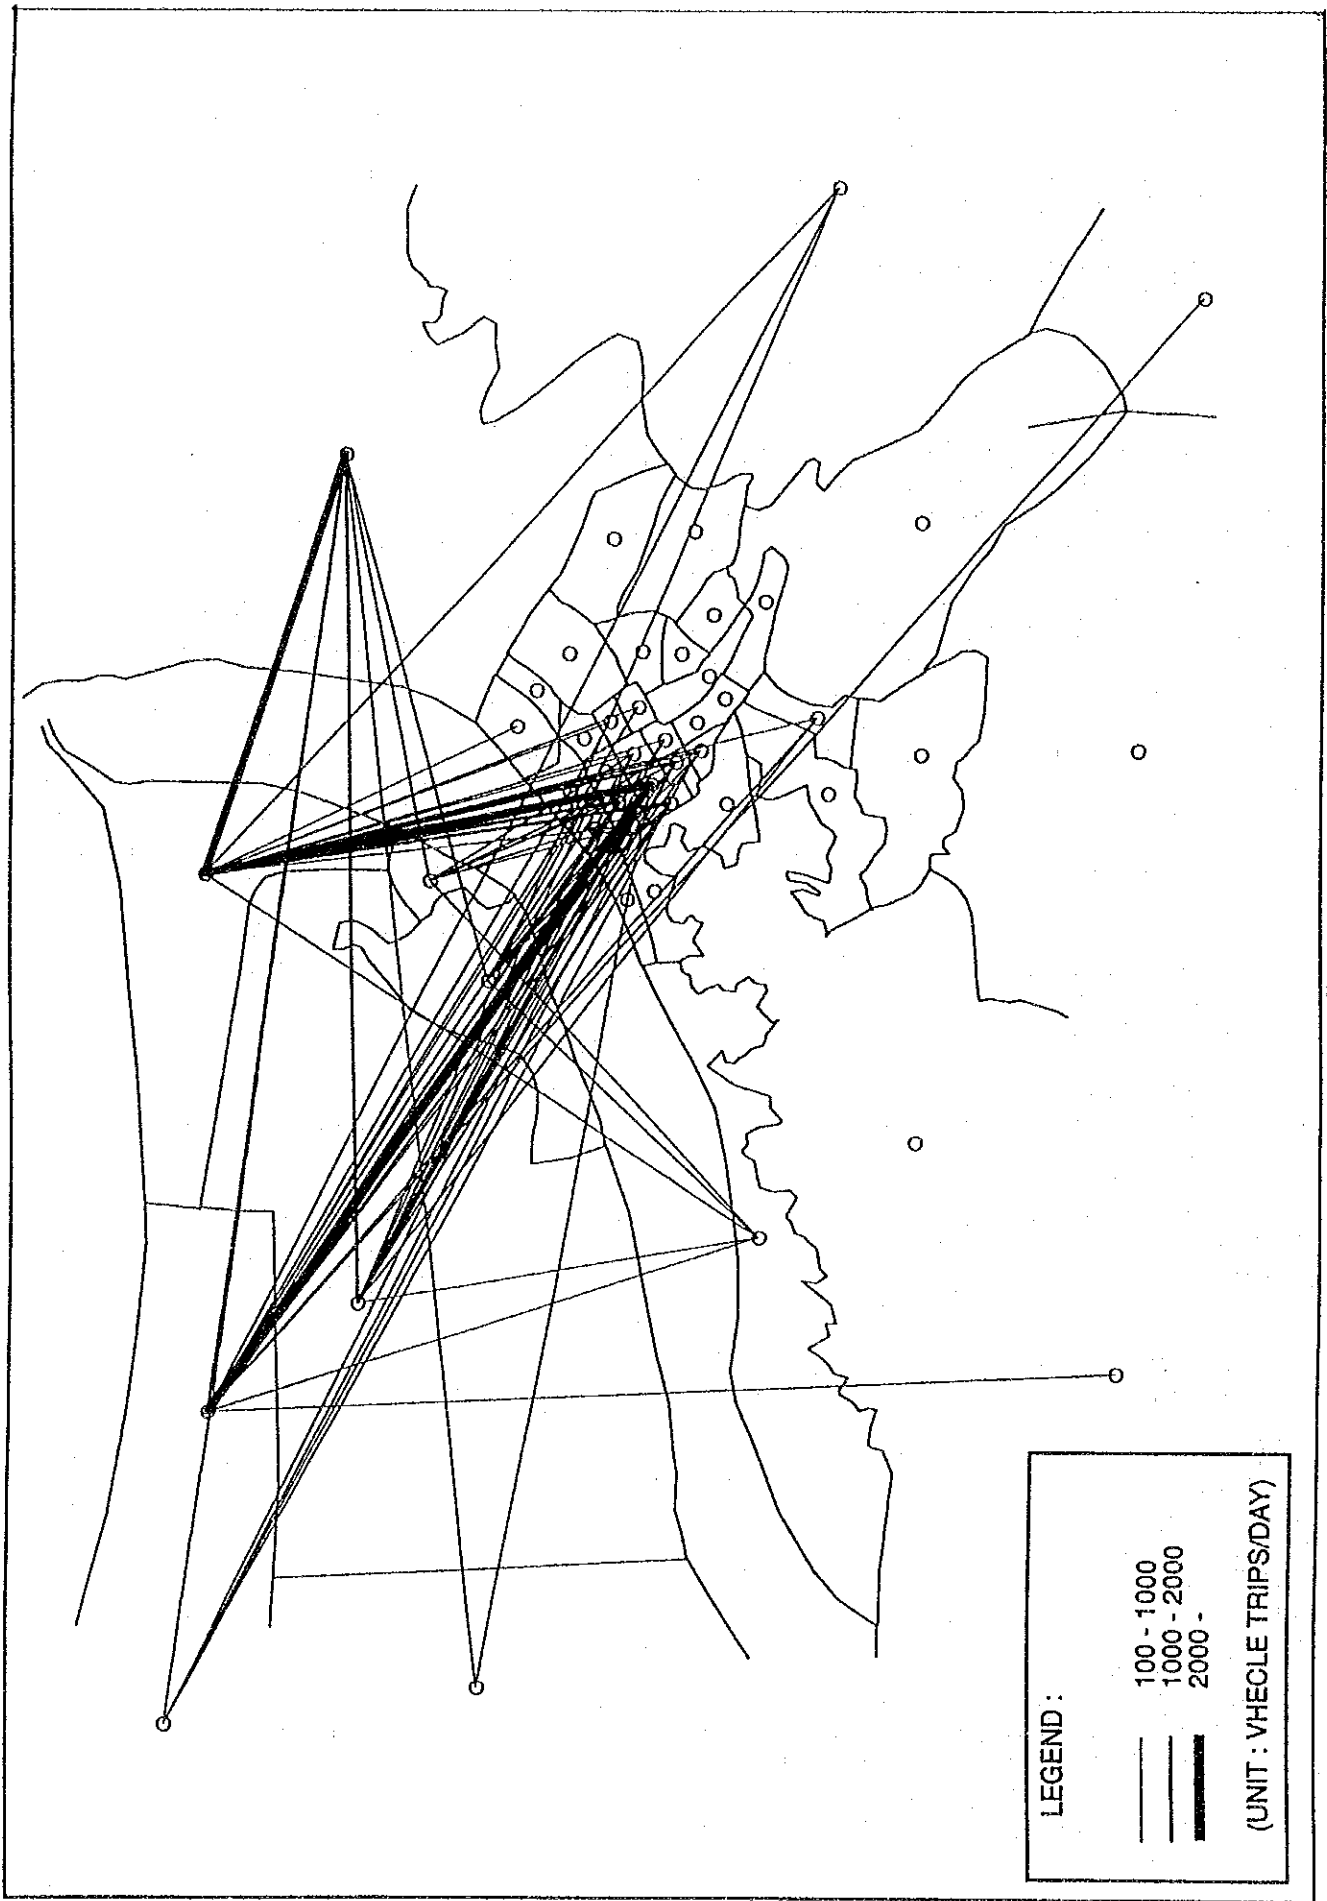
Fig. 6-4(1) Desired Lines for All Vehicles
 (River Crossing Traffic) 1993

The 49 zone base present O-D matrices by vehicle type are presented in Annex Table A.6-1 and desired lines are shown in Fig.6-4.

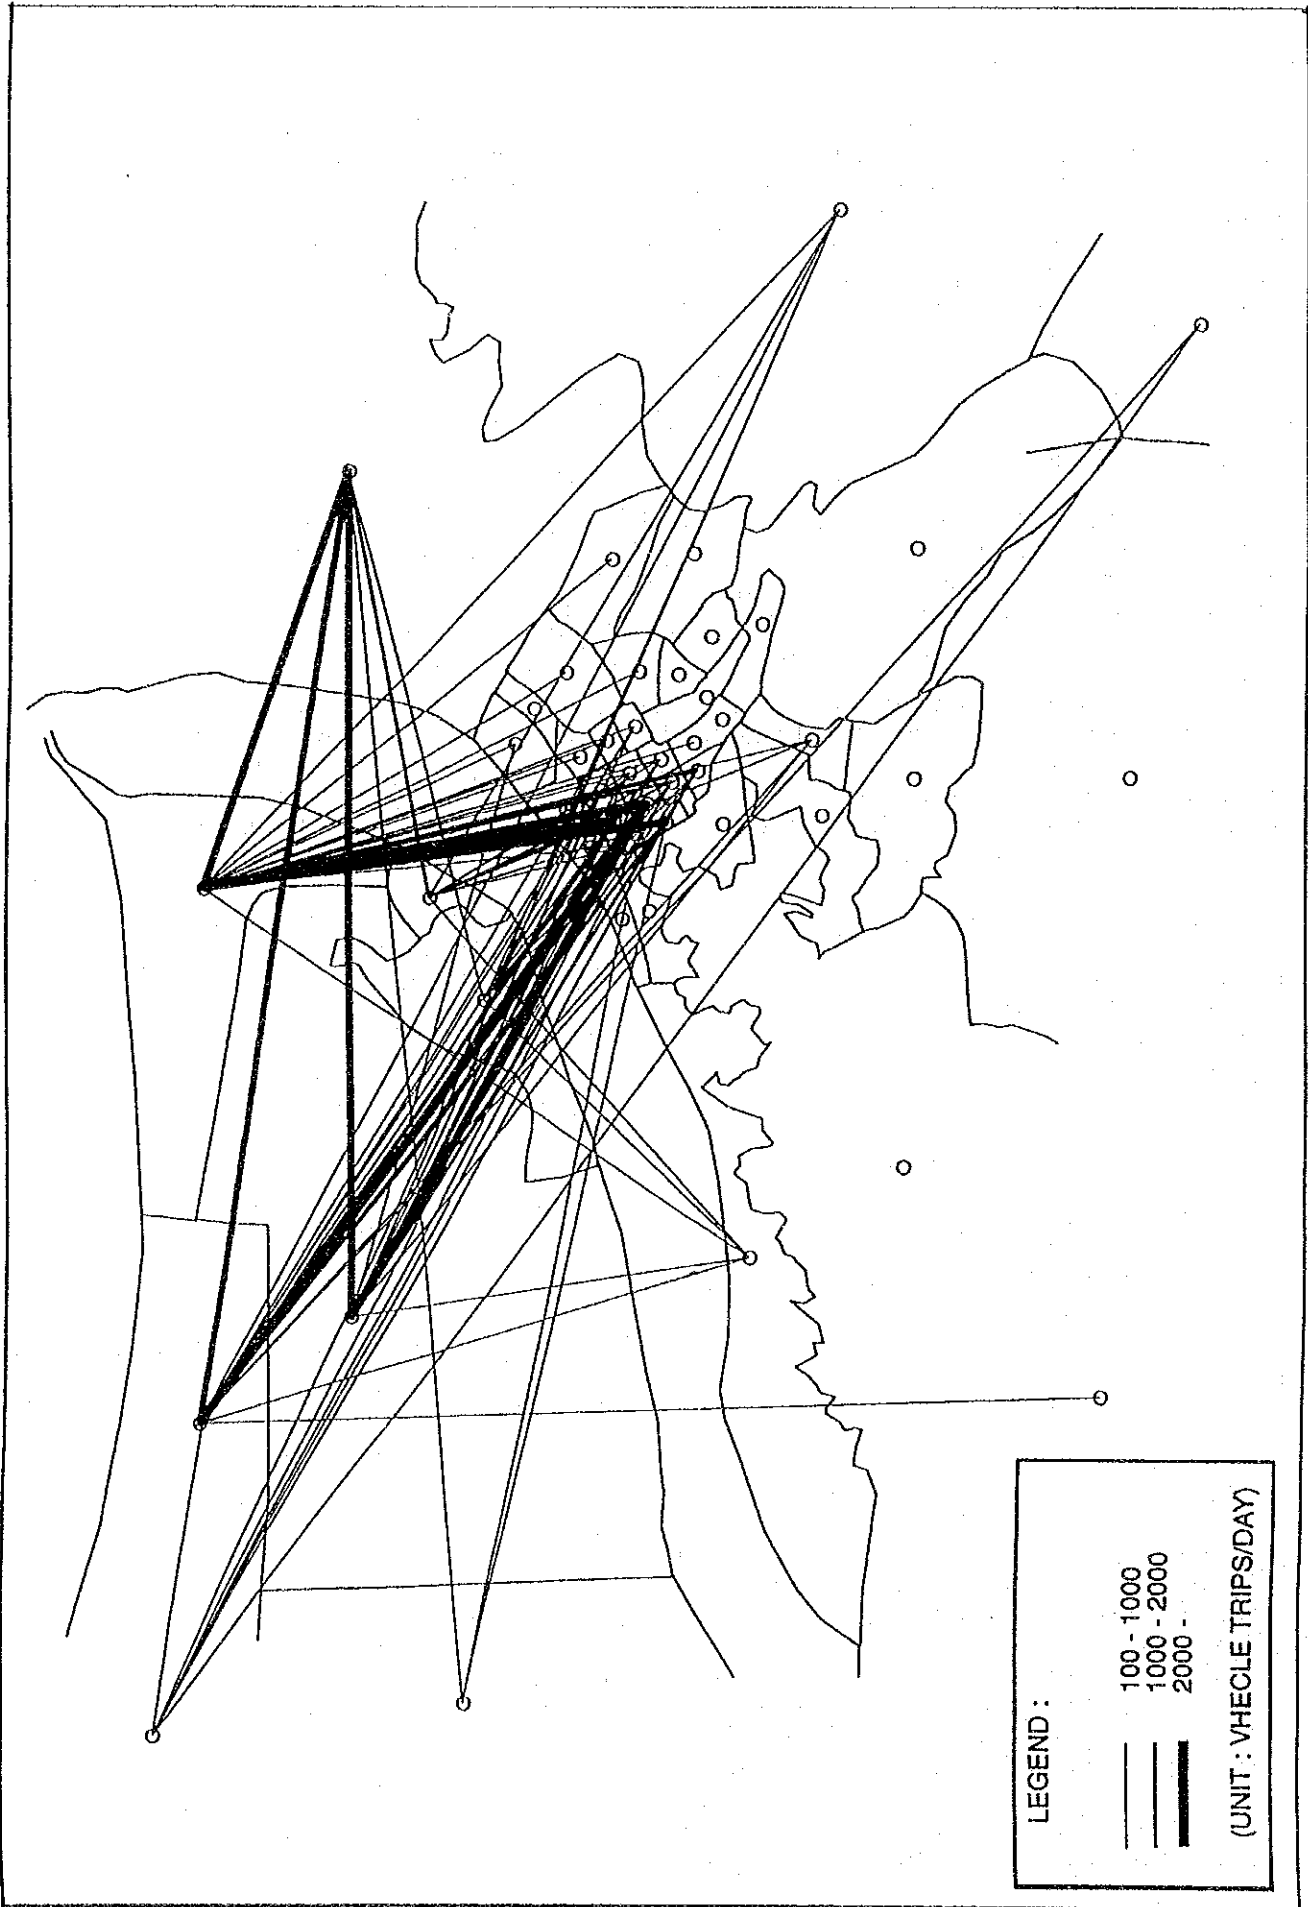
Fig. 6-5(1) Desired Lines for All Vehicles
 (River Crossing Traffic) 1999

The future river crossing O-D matrix was combined with the future vehicle O-D matrix derived from DICTUC's O-D matrix after the volume of corresponding O-D pairs of DICTUC base turned into zero. The finalized future O-D matrices of 2010 are presented in Annex Table A.6-2 and desired lines are illustrated in Fig.6-5 and Fig.6-6. The peak hour O-D matrix were prepared using the same peak hour rates in Table 6-4.

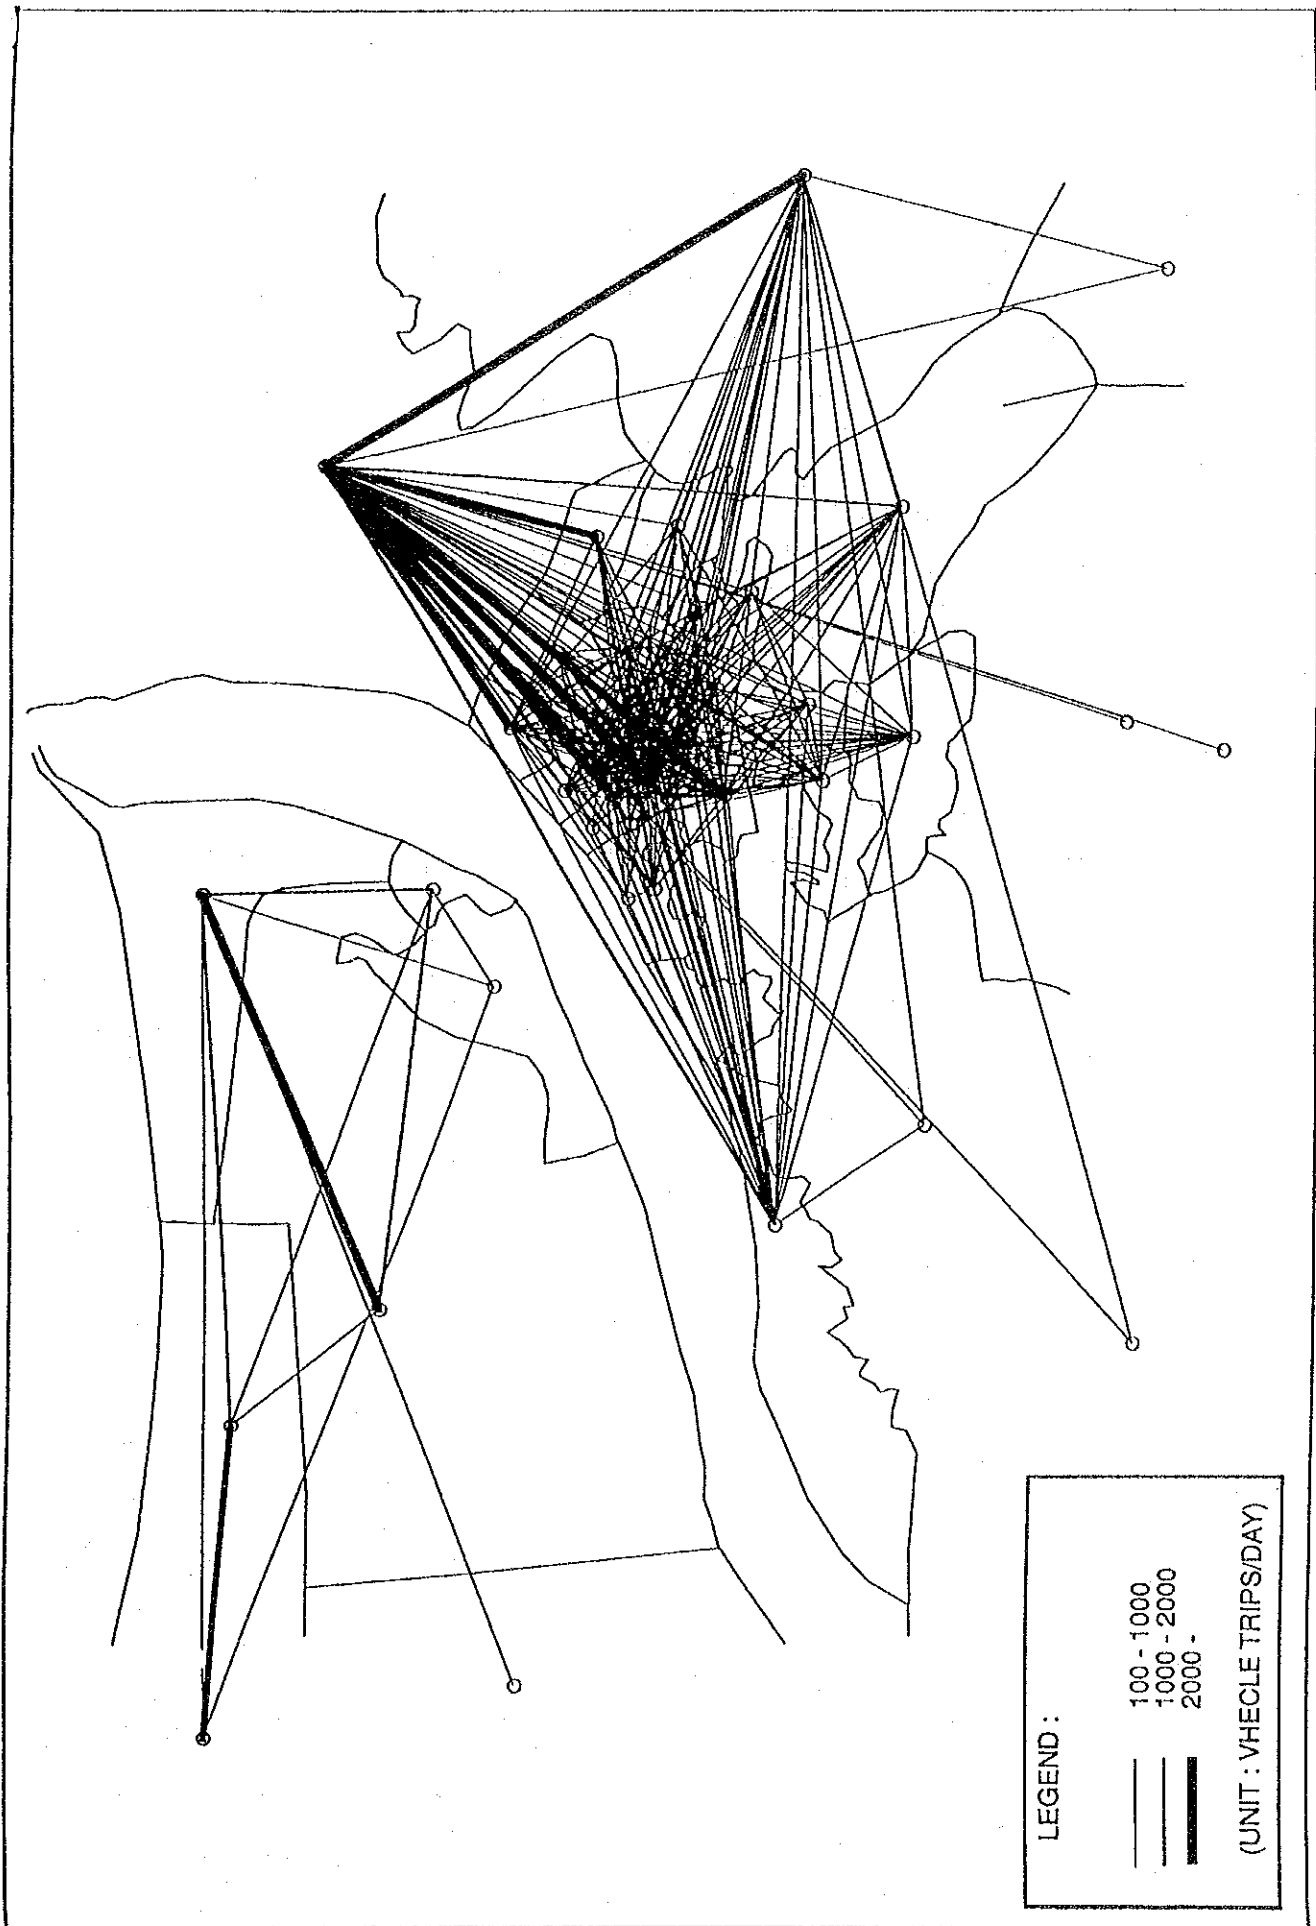
Fig. 6-6(2) Desired Lines for All Vehicles
 (Other than River Crossing Traffic) 2010

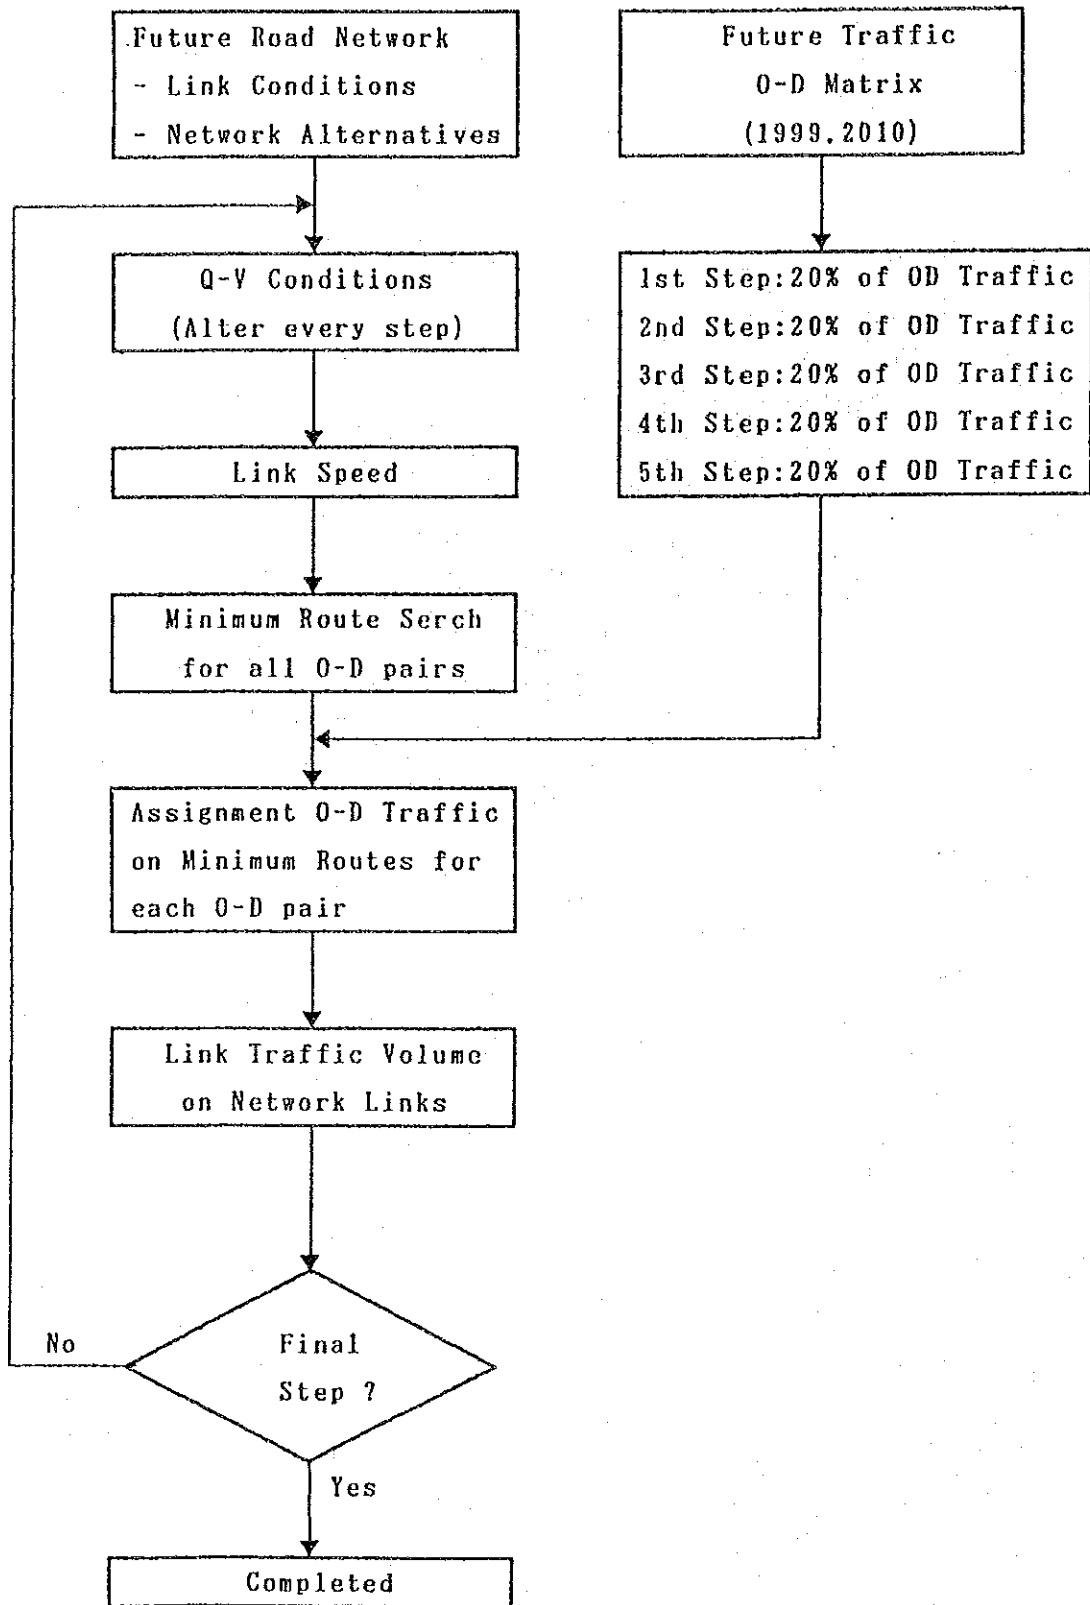
Fig. 6-7 Flow Diagram for Estimating Future Assigned Traffic Volume

The future O-D traffic was divided into 5 steps of 20% O-D traffic and assigning the first 20% O-D traffic to the network, and under the altered conditions by the Q-V Formula (a relationship between traffic volume Q and travel speed V) the second 20% of the O-D traffic was assigned to the network based on minimum time travel routings.
