Photographs
of
Working

Amount of Survey in 1995

Project & Result in 1995

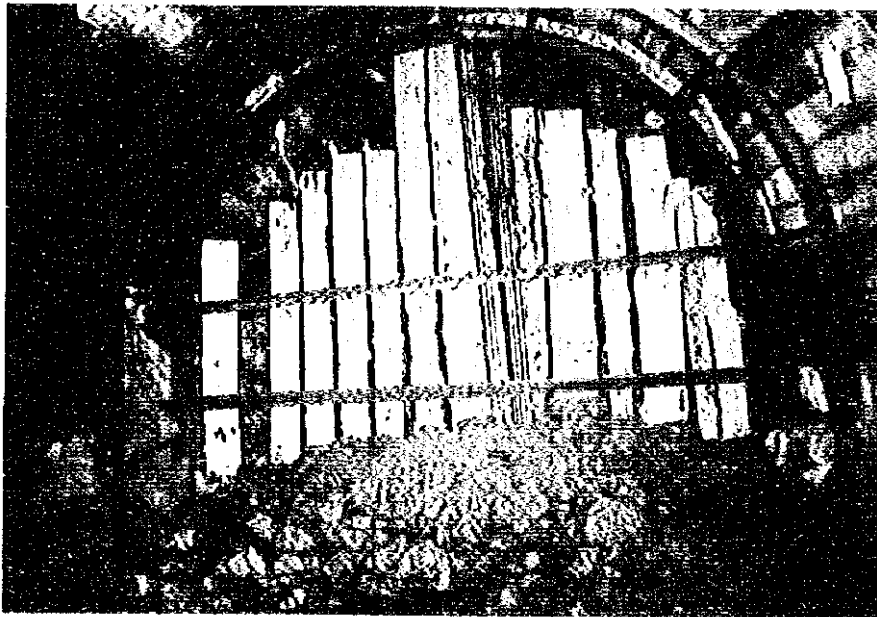
Timbering at face of No.5 Waste pit

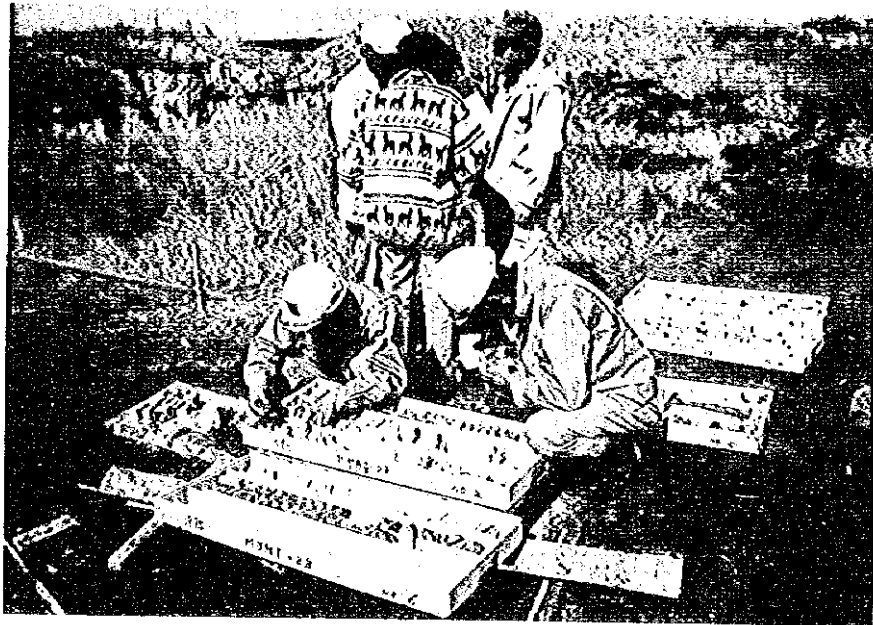
Core logging

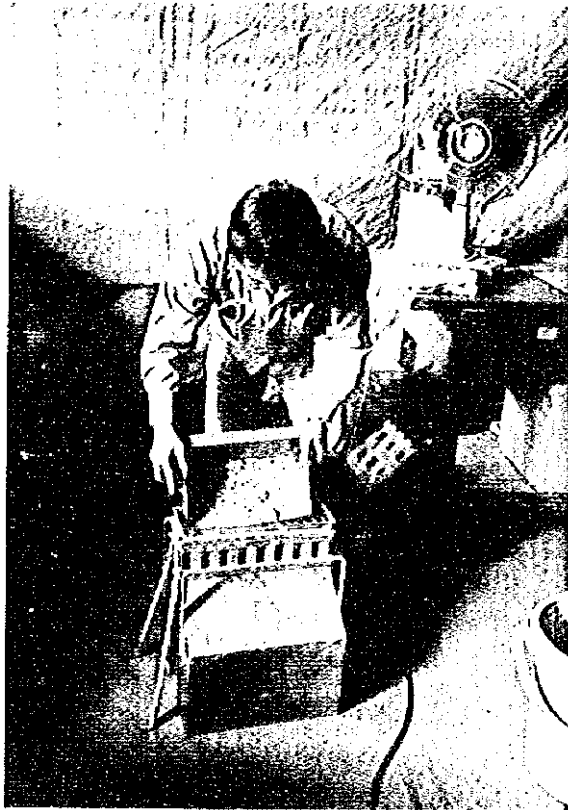
Sample adjustment
