#### A-6 Seismic Profile done by ICE

REPUBLIC OF COSTA RICA LOS LLANOS HYDROELECTRIC POWER A
DEVELOPMENT PROJECT Seismic Prospecting

## A-7 Seismic Profile of Reanalysis

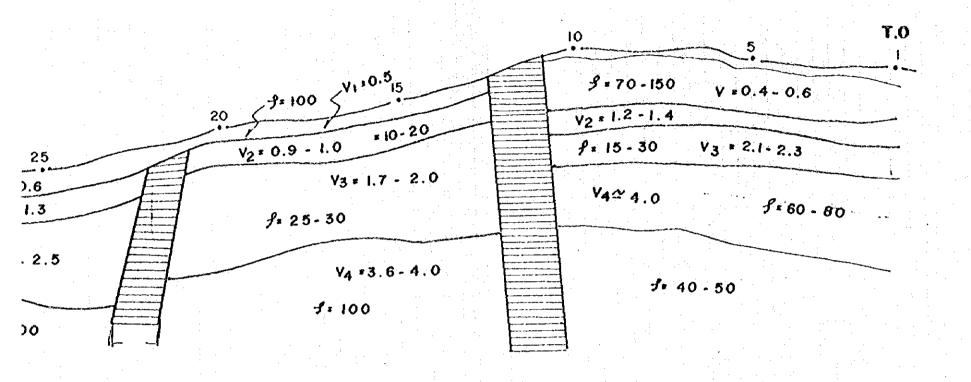
0-400 Fig.A-6-10 Date:

V2 2.8 Velocity of Elastic Wave (km/sec)

1.25-30. Resistivity (ohm-m)

Interpreted Profile with Resistivty Waterway Alignment Route

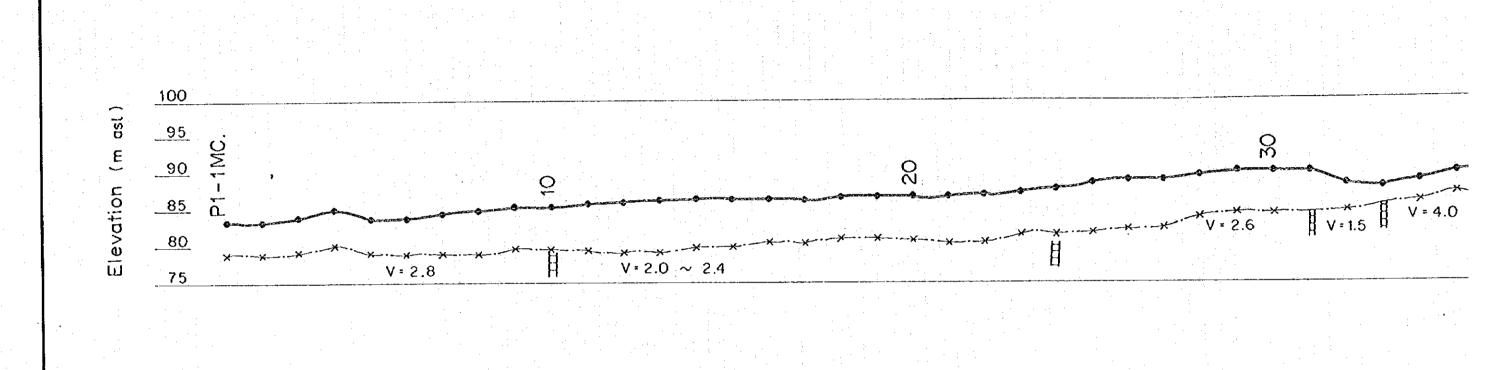
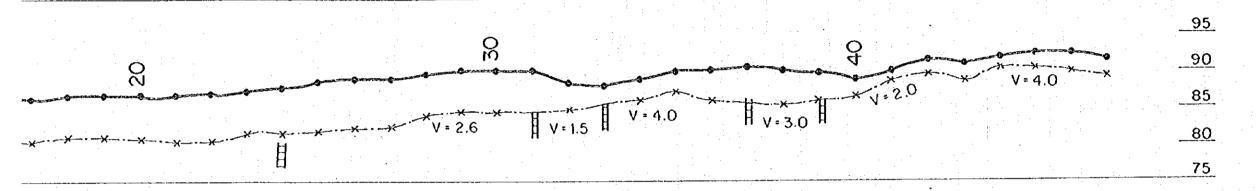
Fig. A-6-13 Dote:

Velocity of Elastic Wave (km/sec)

SEISMIC PROSPECTING INTERPRETED PROFILE POWER STATION SITE PC-1

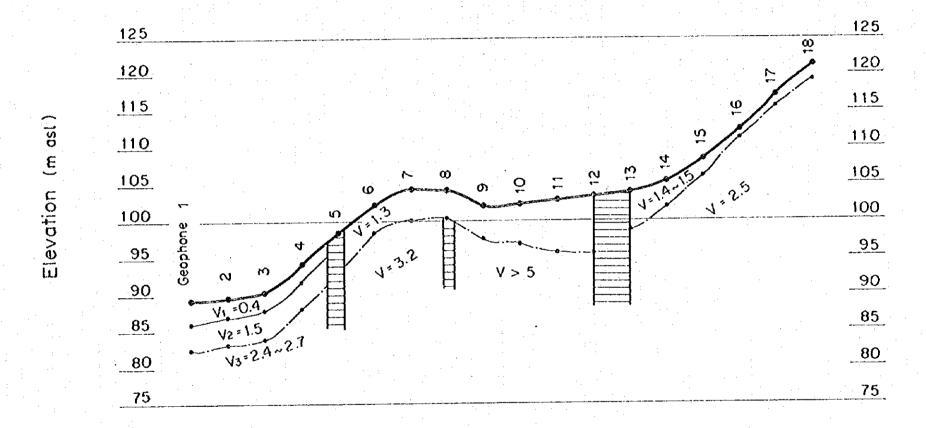
Fig. A-6-16 | Oote:

V= Velocity of Elastic Wave (km/sec)

SEISMIC PROSPECTING INTERPRETED PROFILE POWER STATION SITE PC-5

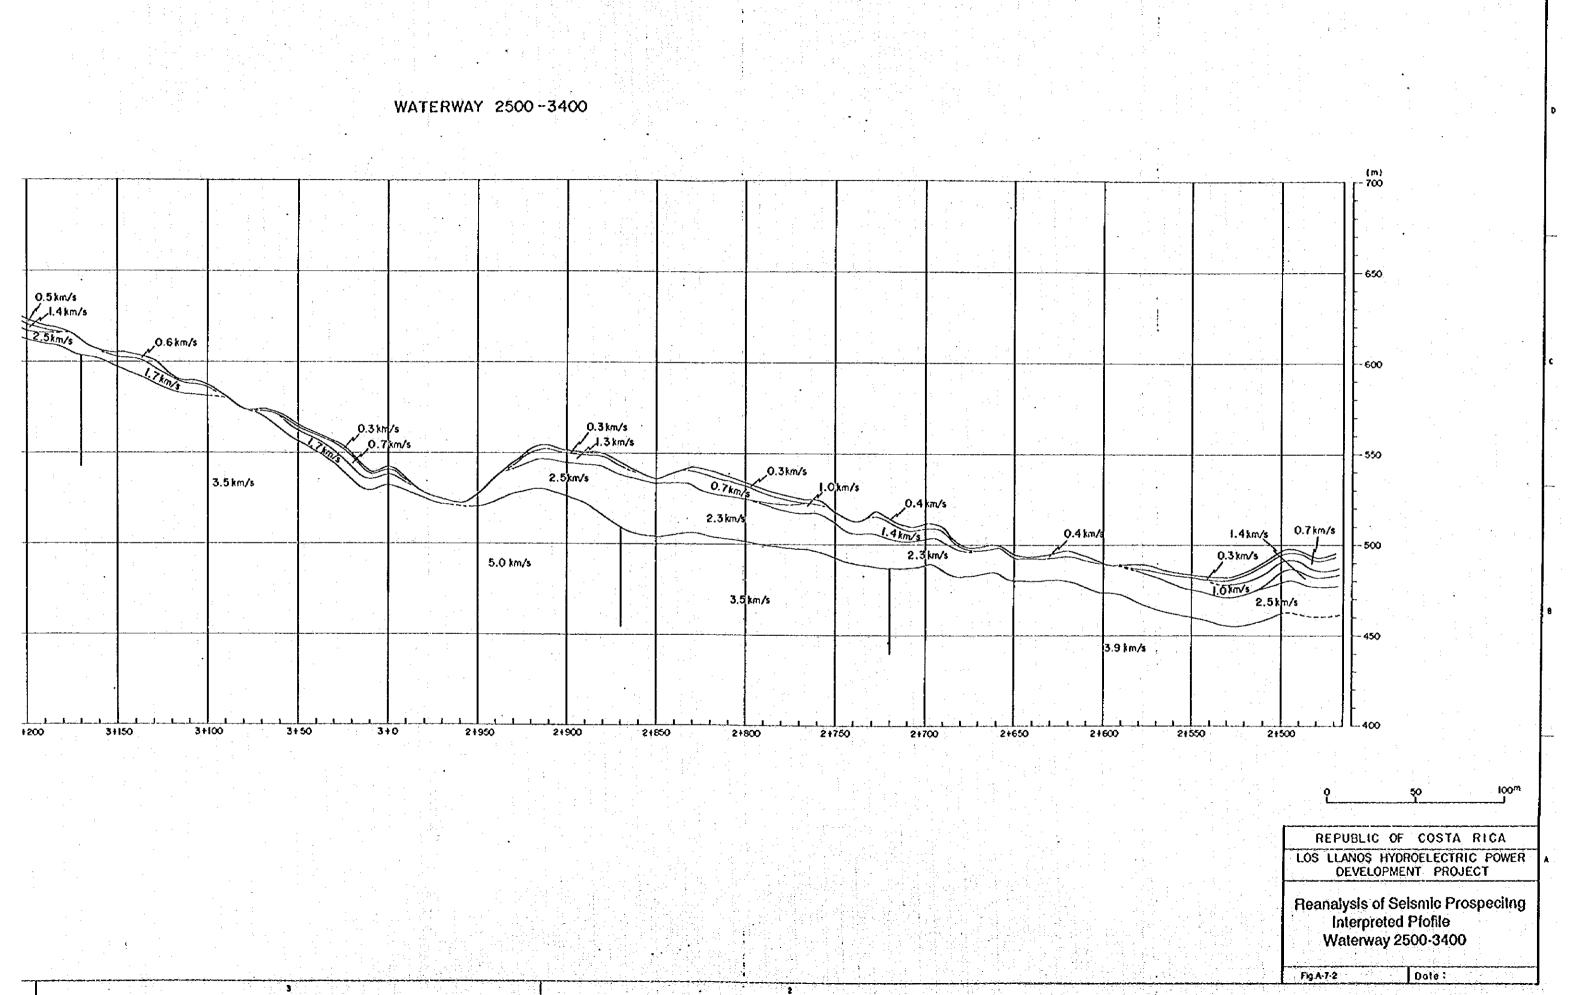
WATERWAY 2500 - 3400 Q.8km/s Q.6 km/s 0.5 km/s 0.3km/s 650-1.4 km/s 1.5 km/s 2.4 km/s 0.5 km/s 2.3km/s ,0.6 km/s 600 -3.5 km/s 4.5 km/s 0.3 km/s /\_1.3 km/s 0.3 km/s 0.7 km/s 550 ---0.3km/s 0.7km/s 3.5 km/s 2.3 km/s 500--5.0 km/s 3,5 km/s 450-400 - L\_L 31400 3+100 3+350 3+300 31200 31150 3150 2+950 21850

Fig.A-7-2 Interpreted Pfofile Waterway 2500-3400

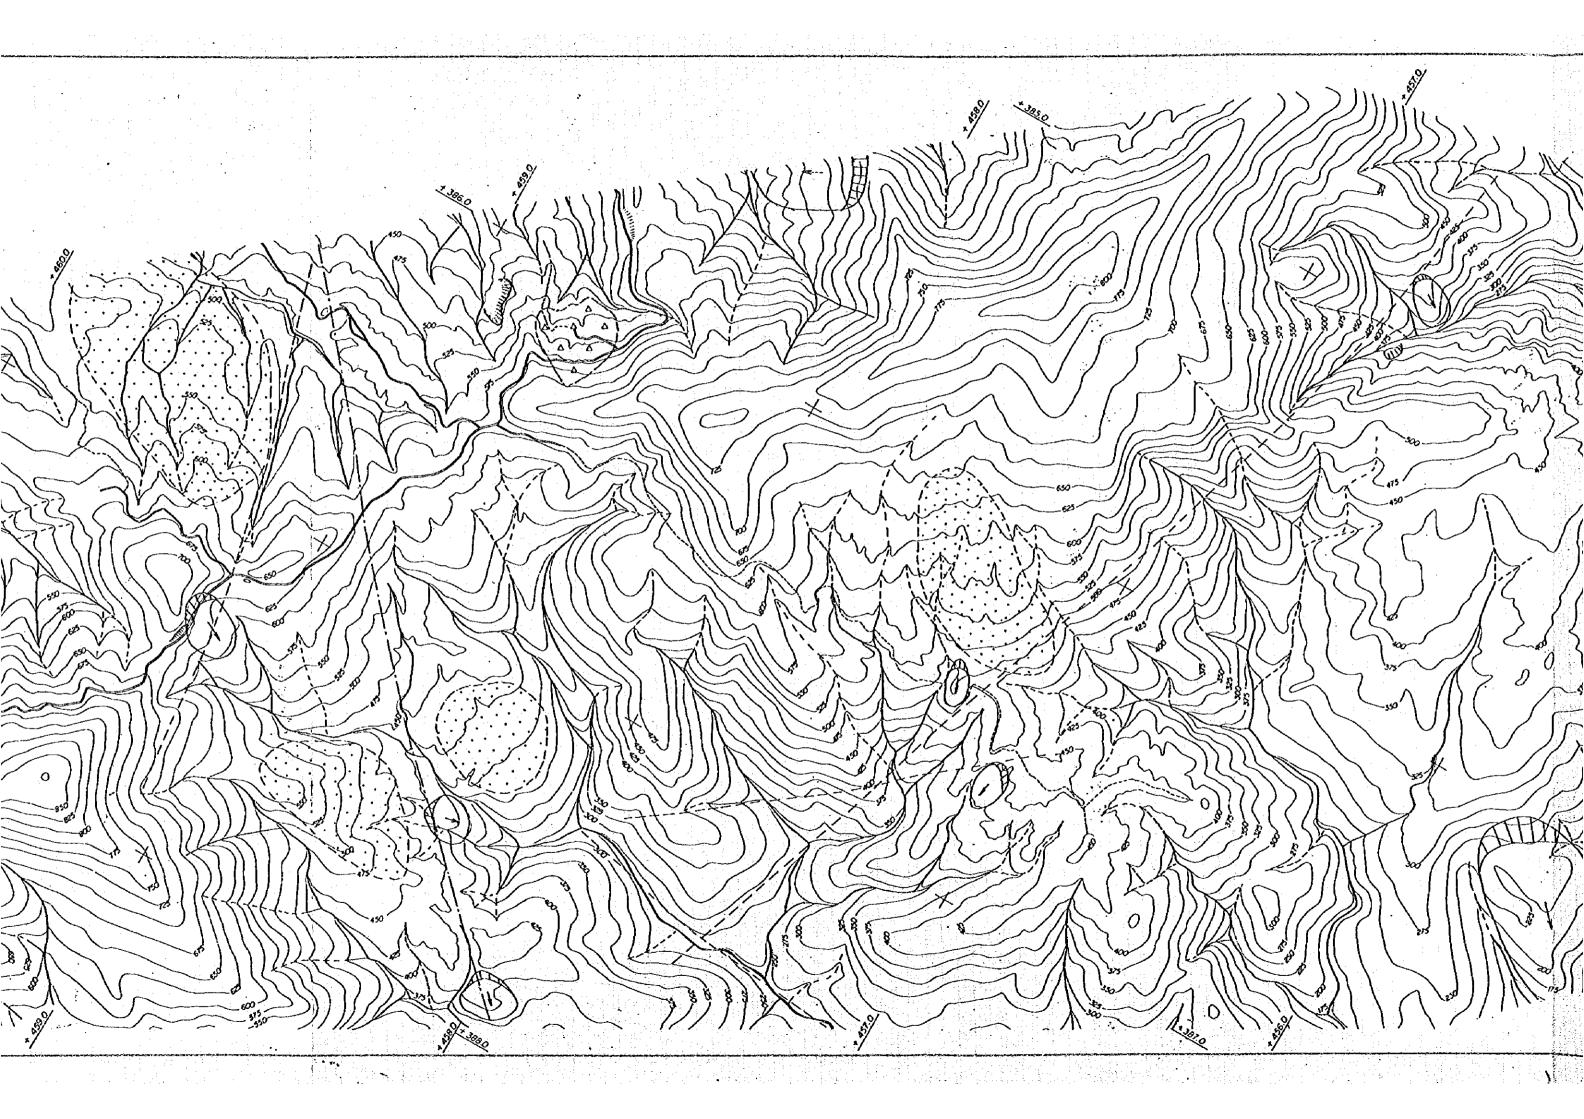
# A-9 Aero-photo Ineterpretation Fig.A-9-1 Aero-photo Ineterpretation of the Project Area
