THE STUDY ON FLOOD AND MUDFLOW CONTROL
FOR SACOBIA - BAMBAN/ABACAN RIVER
DRAINING FROM MT. PINATUBO

EXECUTIVE SUMMARY

May 1996

NIPPON KOEI Co., Ltd., Tokyo Japan
in association with
CTI ENGINEERING Co., Ltd., Tokyo Japan

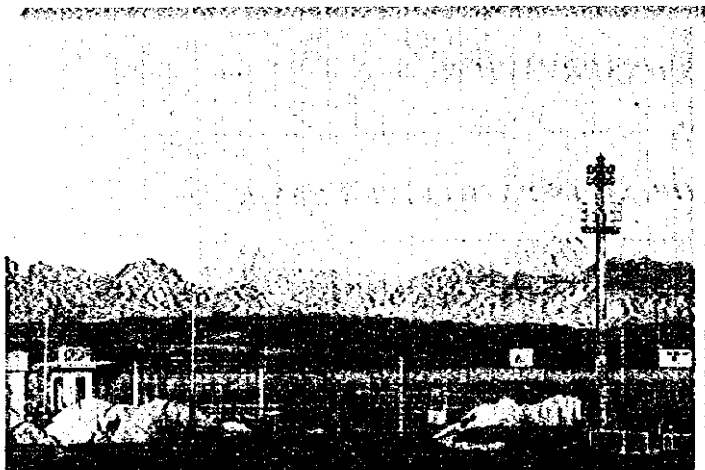
View from Clark Field on March, 1992 (by Dr. R.P. Hoblitt, USGS)

On June 15, 1991, after 460 years of dormancy, Mt. Pinatubo awoke with a climactic Plinian eruption. Mt. Pinatubo's summit was lowered from 1,745 meters to 1,449 meters resulting to a caldera with a diameter of 2 kilometers and a summit crater of 600 meters deep. The caldera floor was partially filled with water to form a lake. The eruption of Mt. Pinatubo also produced remarkable volume of pyroclastic flow and ash fall deposits. Hundreds of people were killed, thousands were injured or missing, and hundreds of thousands of families were rendered homeless. Strong winds induced by Typhoon "Diding" on June 15 aggravated the situation, scattering volcanic ash over thousands of square kilometers, including Metro Manila, which is about 90 kilometers away.

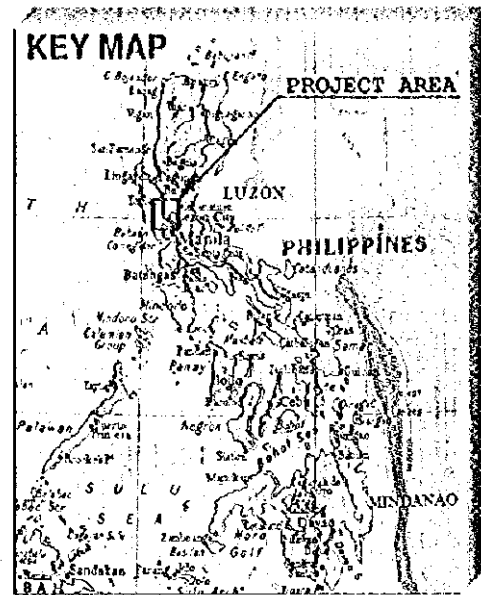
Pinatubo Disaster Map (November 1991)

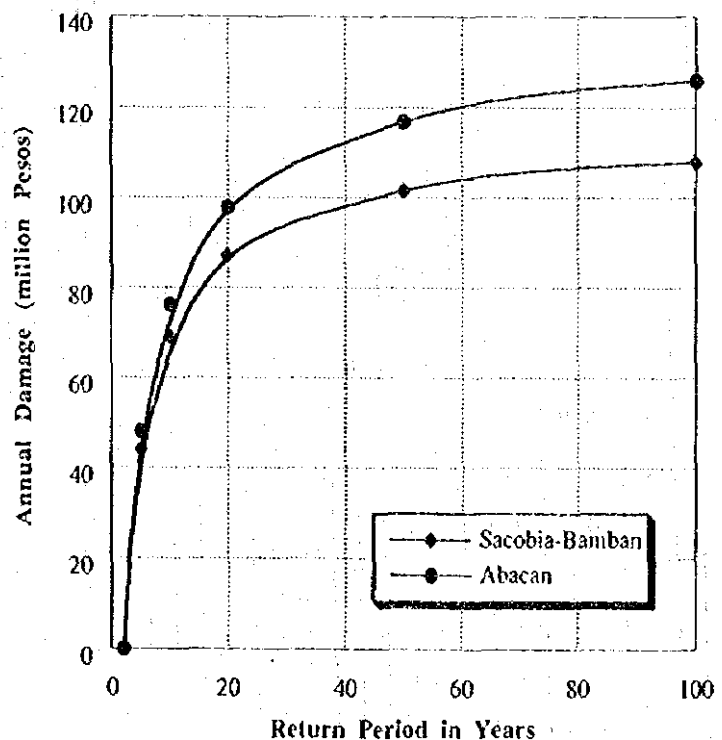
Annual Damage Curve

The probable direct damage value for building, agricultural crops and infrastructures was computed based on the percentage of the affected area to the total barangay area. The average annual direct damage was obtained for Sacobia-Bamban and Abacan river basin after aggregating each property damage. Judging from the gradient of the curves, the return period of 20 years can be considered reasonable for the planning scale of structures since that the incremental ratio of direct damage is not in direct proportion beyond the scale of the 20-year return period.

Return Period (years)	Annual Damage (million Pesos)	
	Sacobia-Bamban	Abacan
2	0.00	0.00
5	44.04	48.06
10	69.09	76.32
20	87.14	98.50
50	101.57	116.78
100	107.88	125.79

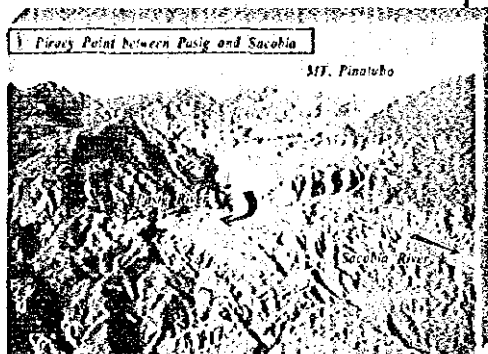
The upper catchment of the Sacobia river basin of 22 square km was annexed to the Pasig River Basin in October 1993.

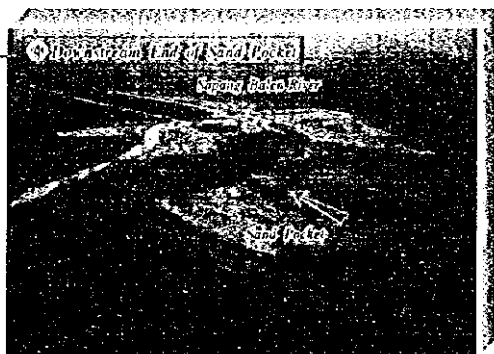
Sediment deposit of 8 million cubic meters was observed in the sand pocket structure in 1994.
