CHAPTER 8 SEDIMENT MONITORING IN PASIG RIVER BASIN

8.1 RIVER MORPHOLOGY

8.2 FIXED POINT OBSERVATION AT WATCH POINT NO.5

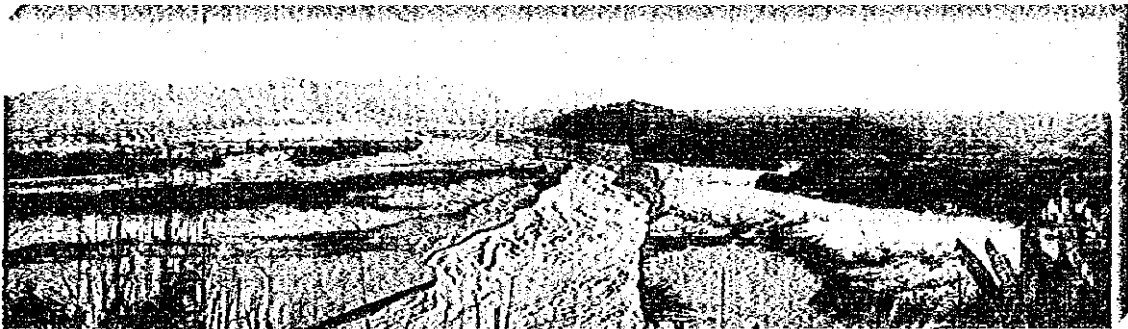
Small scale lahar supplied sediment causing gradual riverbed aggradation. (September 8, 1995)
